SERVICE BULLETIN

Service Bulletin No.: DA20-24-04 Rev 0

Title: Replacement of Battery Relay Contactor

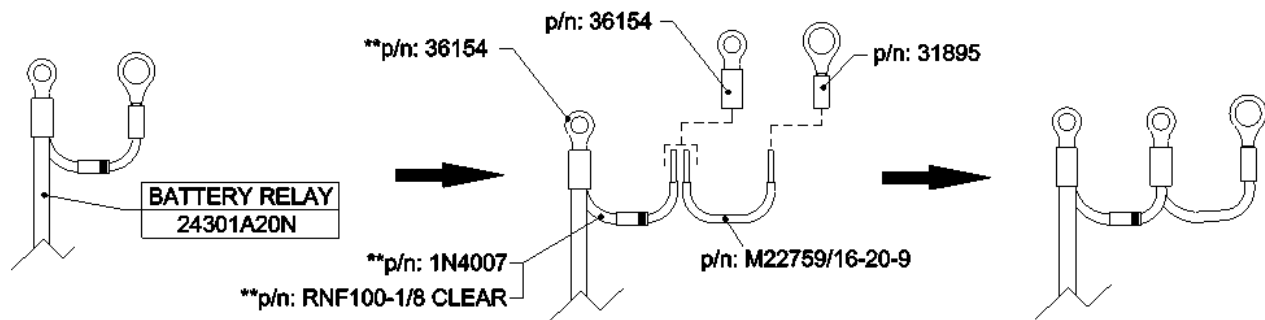
Figure 2: Relay Wire Modification

****PARTS ONLY REQUIRED IF EXISTING DIODE IS DAMAGED OR SHORT.**

10.3.1 Rework the battery relay wire 24301A20N as shown in Figure 2.
