**OPTIONAL SERVICE BULLETIN NO. DA20-24-05 REV. 0**

Type: DA20-A1

Replacement of the aircraft battery.

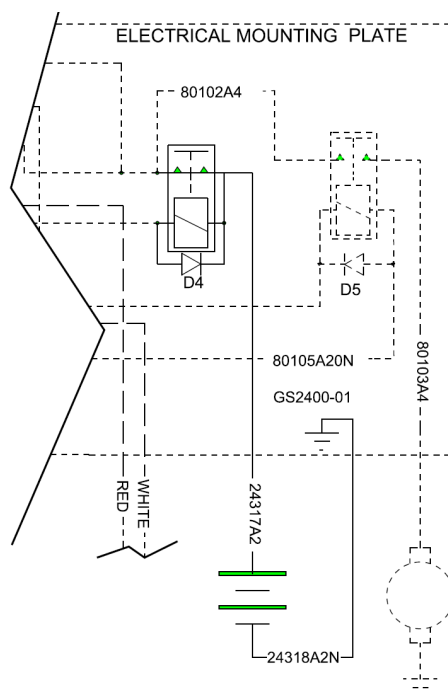
Figure 1. Schematic of battery cables

**CAUTION: 2 AWG WIRING IS REQUIRED TO BE INSTALLED WITH THE POWER SONIC BATTERY. OTHERWISE, DAMAGE MAY OCCUR IN THE EVENT OF A SHORT CIRCUIT.**

7. Install the new battery cables (items 3 and 4) to the electrical shelf. Refer to Figures 1 and 2.

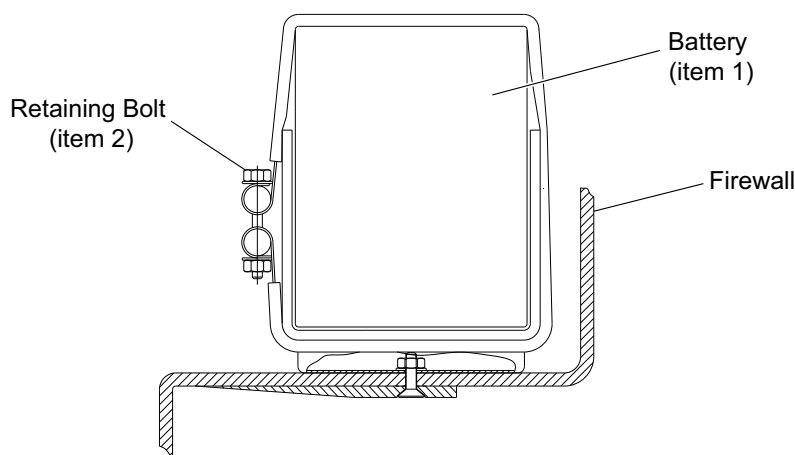
Figure 3. Battery installation (looking inboard)

This service bulletin introduces a new airplane battery due to the obsolescence of the previous one.

9. Install the new battery (item 1) using the existing strap with the new retaining bolt (item 2). Refer to Figure 3.
