ALERT SERVICE BULLETIN

Service Bulletin No.: DA20-27-04, Rev. 0 Date Issued: September 24, 1996

Title: Rudder Pedal Adjust Cable Page: 1 of 2

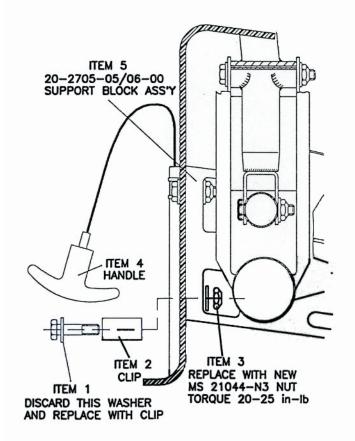
3. General: There is the possibility that, with the pedals adjusted towards the aft position,

the pedal adjust 'T'-handle might interfere with the control stick during and following negative 'g' maneuvres. This bulletin addresses the installation of

10.1 Remove seat cushion, control stick boot and seat pan to gain access to lower nut (Fig. 1, Item 3) which holds the support block assembly (Fig. 1, Item 5) in place. Remove lower bolt (Fig. 1, Item 1), discard the washer under the head of the bolt and insert the bolt through the retaining clip (Fig. 1, Item 2) and reinstall through support block assembly. Install new nut (Fig. 1, Item 3) and associated washer. Be sure that there is between 1 and 3 threads of the bolt exposed beyond the nut.
