Service Bulletin No.: DA20-27-05, Rev. 0

Date Issued: November 13, 1996

Title: Rudder Support Bracket Inspection

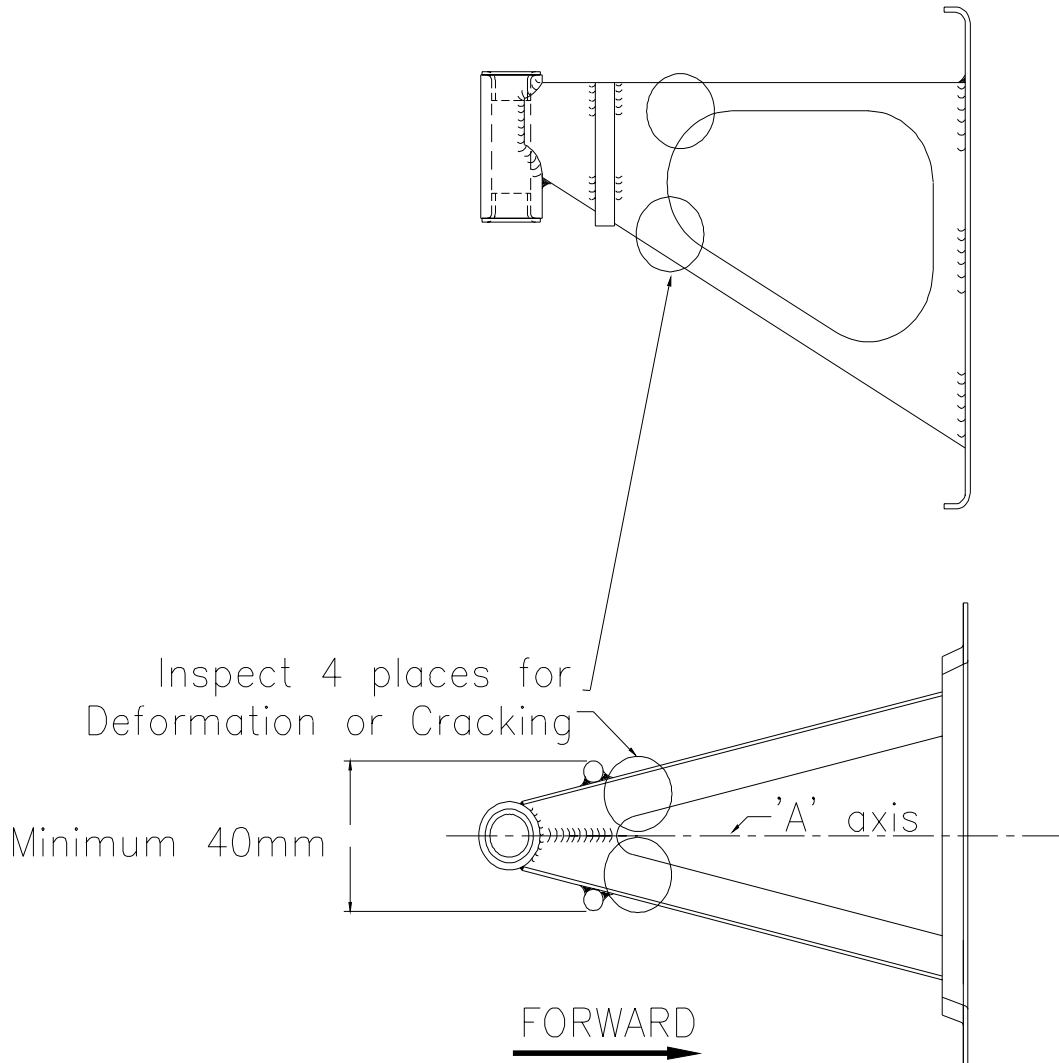
Figure 1.

- 10.1.1 Remove control lock if installed.
- 10.1.2 Use a flashlight and suitable inspection mirror to examine the entire 'Rudder Support Bracket' for damage, paying particular attention to the area around the rudder stops as shown in figure 1.
- 10.1.3 If no damage is present install the control lock.

- 10.1.4** If damage of any form is noted remove the rudder and check that the deformation of the rudder tower is within the following specified limits.
- a.) Check that the rudder tower has remained symmetrical along the 'A' axis as depicted in figure 1.
 - b.) Check that the dimension between the rudder stops is **not** less than 40mm.
 - c.) Check that there is no visible cracking of the metal.
- 10.1.5** If the Rudder Support Bracket is within the above limits but shows signs of deformation the aircraft may be operated for a period up to the next 100 hour inspection with 20 hour intermediate inspections after which time the part may be replaced at the operator's convenience.
- 10.1.6** If the deformation of the Rudder Support Bracket exceeds the limits described in 10.1.4 a,b or c replace it in accordance with 10.2 before further flight.

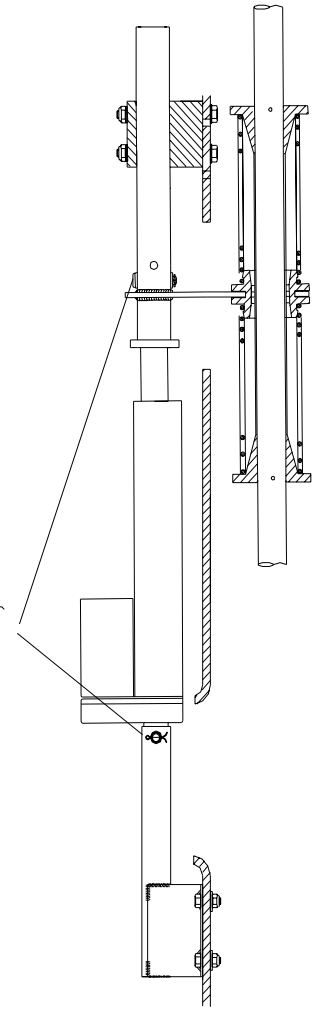
Figure 3

Lower and Upper Trim Actuator
Attachment Pins

- 10.2.4 Remove the upper and lower mounting bolts to remove the Rudder Support Bracket. Discard the MS21044N4 nuts.
- 10.2.5 For installation reverse the sequence of removal. Apply a torque of 65 in/Lbs. to the rudder support bracket mounting bolts.
- 10.2.6 Check the rudder cable tension, neutral position and travel of the rudder in accordance with the maintenance manual (Doc No. DA201) chapter 27-20-20 section 4. Adjustment.
