ALERT SERVICE BULLETIN

Service Bulletin No.: DA20-27-06A, Rev.0

Title: Hinges, Flight Controls

2. Effectivity: DA20-A1 aircraft S/N 10002 up to and including S/N 10300.

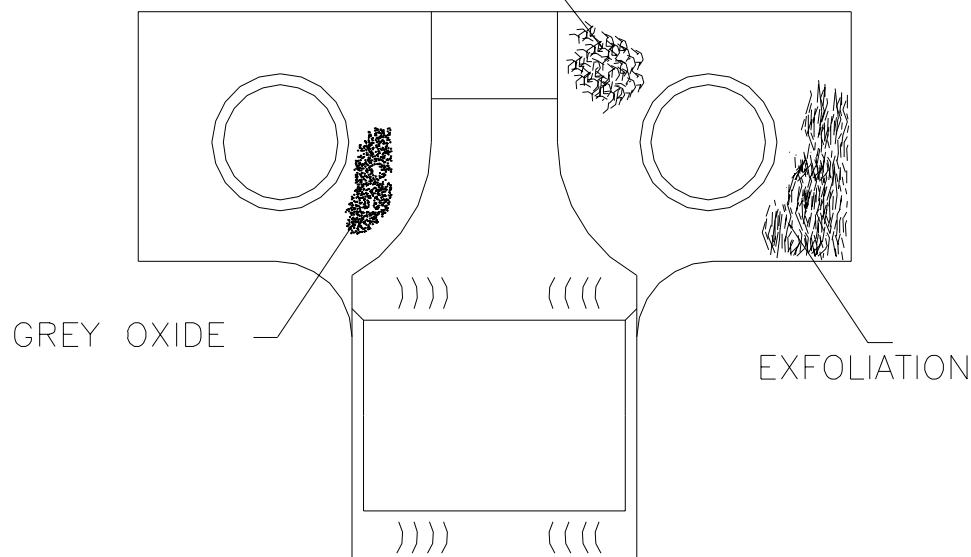
Figure 1

10.2 Using a suitable flashlight and 10x magnifying glass, inspect **all** hinge components on the flap, aileron and elevator for visible signs of corrosion. Check for grey oxide, blistering of the metal or paint and exfoliation of the metal. See figure 1 and 2 for areas where corrosion can be more easily detected.

If any of the corrosion described above is present on any of the hinges, suspect hidden intergranular corrosion of other hinge parts which appear normal.

BLISTERING OF PAINT OR METAL

- 10.4** Contact the Diamond Aircraft Customer Support Department for further instructions if corrosion is present.
- 10.5** Check for play between the fixed hinge and pin. Insert the pins which were removed from the hinge. Using a wire feeler gauge check that there is 0.020" (0.50mm) total play or less as shown in figure 3.

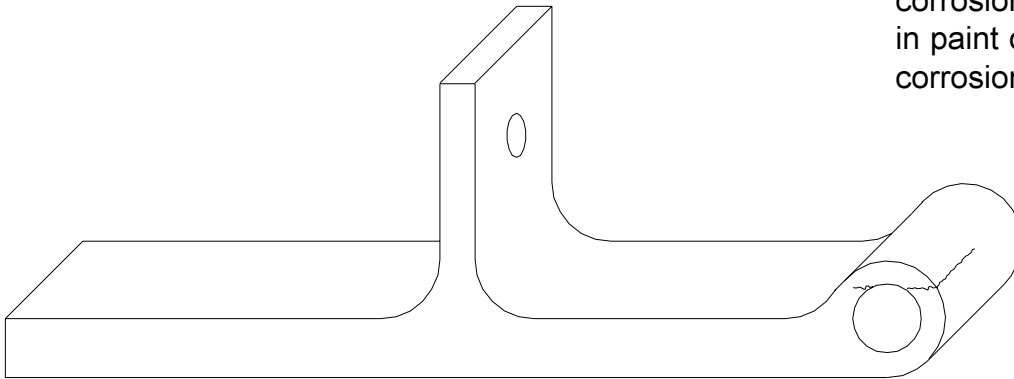
Figure 2

Advanced intergranular corrosion showing as cracks in paint or a thin line of corrosion in the bore.

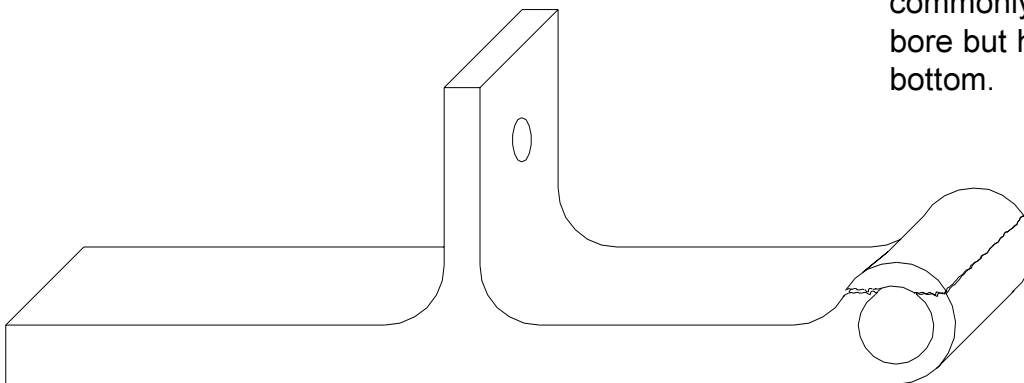
Cracking and beginning of separation. Corrosion is more commonly located at top of bore but has been found at bottom.

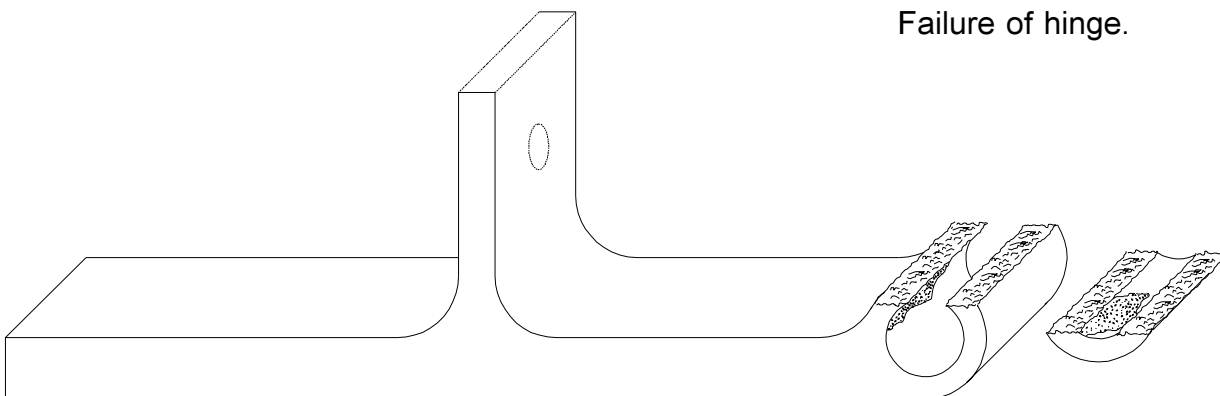
Failure of hinge.

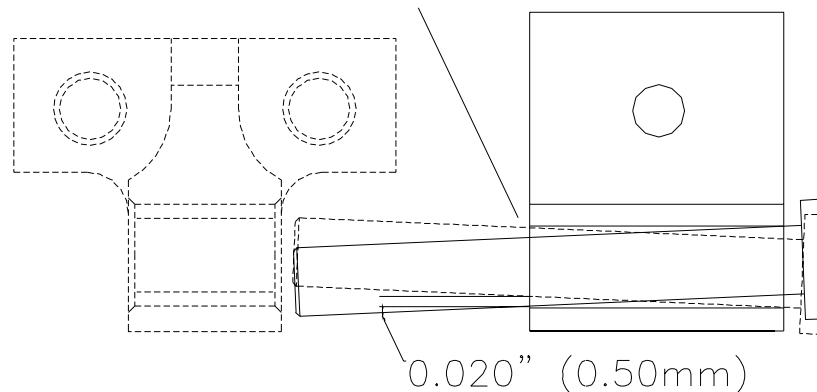
Figure 3

MEASURE PLAY ON CONTROL
SURFACE SIDE OF HINGE
