# ALERT SERVICE BULLETIN

Service Bulletin No.: DA20-27-08A Rev 1

Title: Control Surface Hinge Inspection

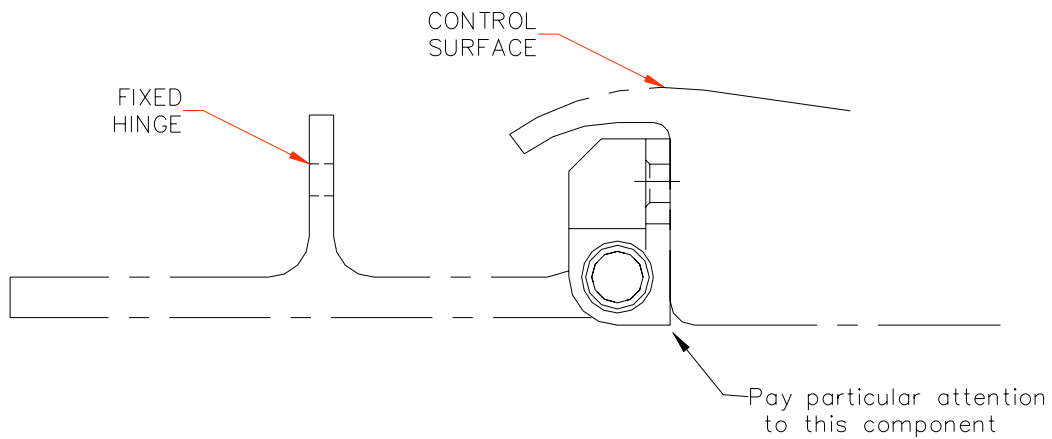
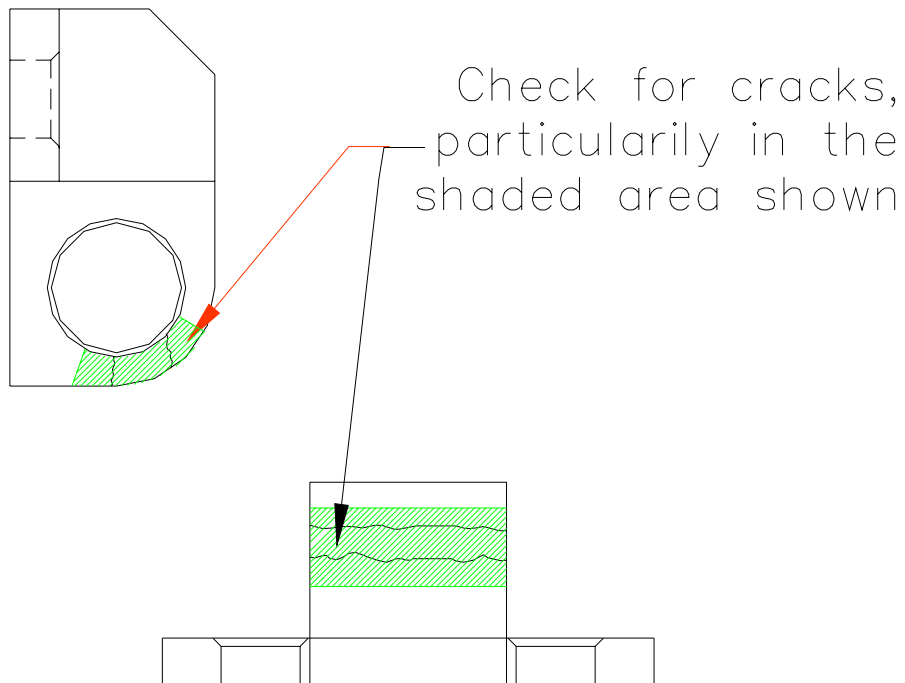
Figure 1

Information gathered from in-service reports has highlighted the necessity for a special detailed inspection of the control surface hinges. Specifically the hinge brackets located on the aileron, flap and elevator control surfaces. It would be advantageous also to comply with Alert Service Bulletin DA20-27-06A during the compliance of this service bulletin if not already accomplished.

If damaged components are found, replace parts prior to next flight.

**10.2** If no corrosion or cracks are found it is recommended that the hinge surface be protected. Use a small paintbrush and apply a polyurethane based paint to the hinge surfaces.
