OPTIONAL SERVICE BULLETIN NO. DA20-27-09 REV. 0

All DA 20-A1 aircraft.

Installation of the Diamond Aircraft flap control module unit and microswitch tray.

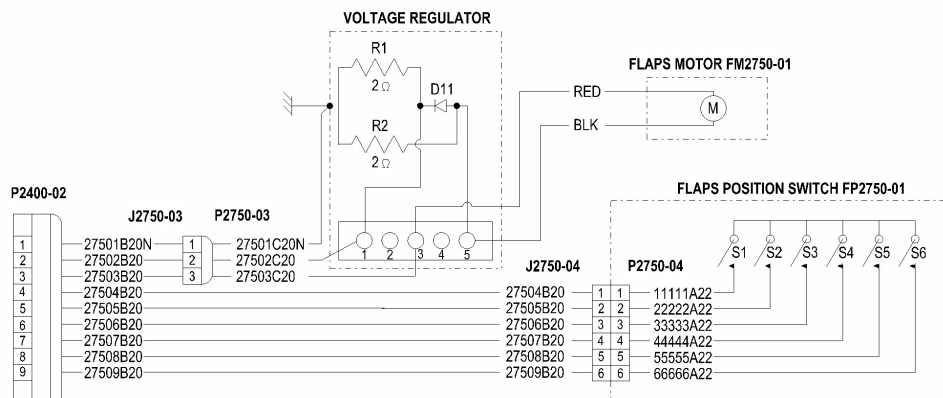
FIGURE 1.1 (SHOWS ORIGINAL WIRING CURRENTLY IN AIRCRAFT)

Figure 1.1 shows the original wiring currently in the aircraft, Figure 1.2 shows the original wiring with the proposed fix, and Figure 1.3 shows the wiring after all the work is done.

9. Disconnect all wires from the voltage regulator; reference Figures 1.2 and 1.3.
10. Swap flap motor wires 27502B16 and 27503B16 or RED and BLACK in connector P2750-03 in the aircraft; reference Figures 1.2 and 1.3. Connect the P2750-03 connector into the J3750-03 connector.
11. Connect the J2750-04 connector to the new flaps position switch assembly.

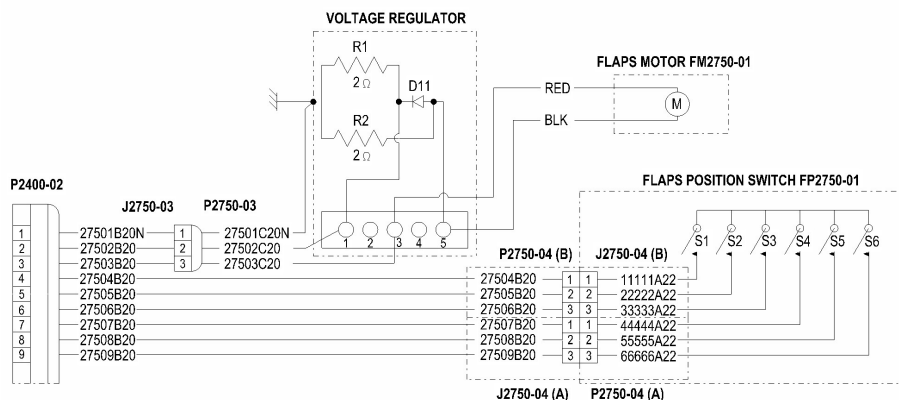
Figure 2.1 shows the original wiring currently in the aircraft, Figure 2.2 shows the original wiring with the proposed fix, and Figure 2.3 shows the wiring after all the work is done.

13. Disconnect all wires from the voltage regulator; reference Figures 2.2 and 2.3.
14. Swap flap motor wires 27502B16 and 27503B16 or RED and BLACK in connector P2750-03 in the aircraft; reference Figures 2.2 and 2.3. Connect the P2750-03 connector into the J3750-03 connector.
15. Connect the two 3-pin connectors (J2750-04 A and P2750-04 B) into the supplied adaptor harness (20-2753-22-00). Connect the other end (J2750-04 connector) of the supplied adaptor harness (20-2753-22-00) new flaps position switch assembly.
