# SERVICE BULLETIN

**Service Bulletin No.:** DA20-28-01 Rev 0  
**Title:** Fuel Cap, Safety Chain

**Date Issued:** August. 26, 1996  
**Page:** 1 of 3

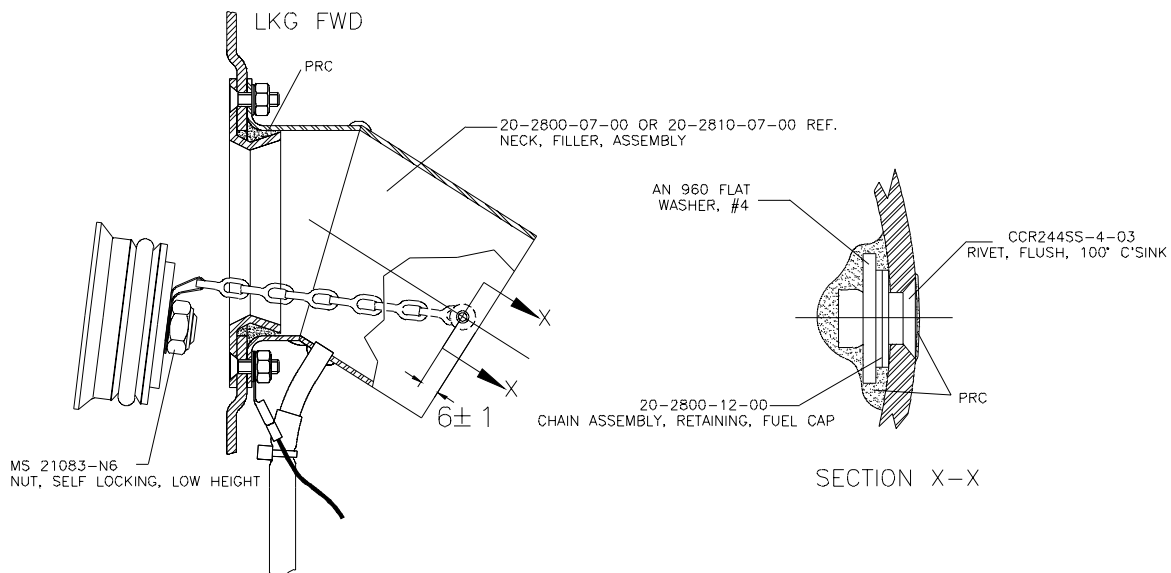
FIGURE 1.

**3. General:** The existing Fuel Filler Cap (P/N UD-3F) requires frequent lubrication of the O-ring seal, under high usage conditions. Failure to lubricate the seal may cause loss of fuel cap security. This bulletin describes the installation of a fuel cap safety chain.

- ### 10.2. Filler Neck Modification:
- 10.2.1 On the aft side of the filler neck (i.e. closest to the B-Bulkhead) drill a .125" / .129" hole in the filler neck shown in Figure 1.
  - 10.2.2 Countersink the .125" / .129" hole so that the rivet will just sit flush to the filler neck O.D. Deburr the hole.

- 10.2.3 Rivet the chain assembly to the filler neck as shown in the section view.
- 10.3 Resealing the Installation:**
  - 10.3.1 Seal rivet with PRC fuel sealant inside and out as shown in section view.  
The coating on the filler neck O.D. should be spread flush.
  - 10.3.2 Ensure all grounding straps and vent tubes are properly installed and sealed per the maintenance manual.
  - 10.3.3 Re-install the filler hose apposite to 10.1.2.
  - 10.3.4 Attach fuel cap to chain tab and re-install nut. Nut is in safety when one thread is showing. Note: Inspect nut locking element. If it can be fully finger tightened replace. (ref AC 43.13 1A/2A)
  - 10.3.5 Lubricate fuel cap O-Ring (Fuelube or Vaseline is recommended) and install fuel cap.
  - 10.3.6 Re-install baggage floor
