# ALERT SERVICE BULLETIN

**Service Bulletin No.:** DA20-28-04A  
**Title:** Inspection for Twisted Fuel Hoses

**Date Issued:** November 8, 2000  
**Page:** 1 of 2

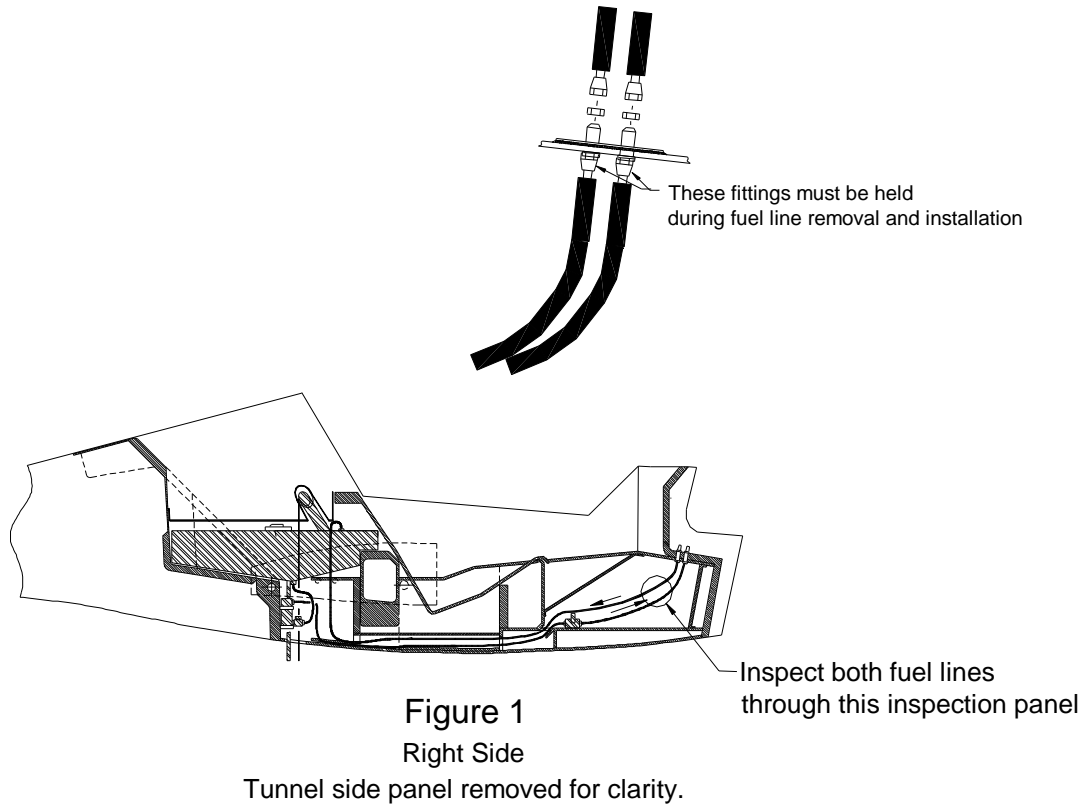
- 
- 1. ATA Code:** 2800
  - 2. Effectivity:** All DA20 A1 Aircraft S/N 10002 - 10331
  - 3. General:** There has been a report of a twisted fuel hose inside the fuselage tunnel near the firewall. This situation arises from the bulkhead fuel fittings at the firewall not being held during fuel line removal and installation. This condition may lead to restricted fuel flow to the engine.

- 9. Accomplishment Instructions:**
    - 9.1.** Remove the inspection panel located on the co-pilot side the fuselage tunnel.
    - 9.2.** Using a flashlight and a mirror, inspect the fuel hoses that are routed through the tunnel and connect to the firewall. Reference figure 1.

- 9.3.** If either of the hoses appear twisted or kinked, do not operate the aircraft. Replace the affected hose immediately.
    - 9.4.** If no abnormalities are found, no further action is required.

During any subsequent fuel system maintenance the firewall bulkhead fuel fitting must be properly held to prevent the fuel lines in the fuselage from becoming twisted.  
Reference figure 1.
