SERVICE BULLETIN

Service Bulletin No.: DA20-32-04 Rev 1
(supersedes DA20-32-03 Rev 0)

Date Issued: 09 JUN 2008

Title: Inspection of NLG Elastomer Spring and
Installation of Replacement Elastomer Elements

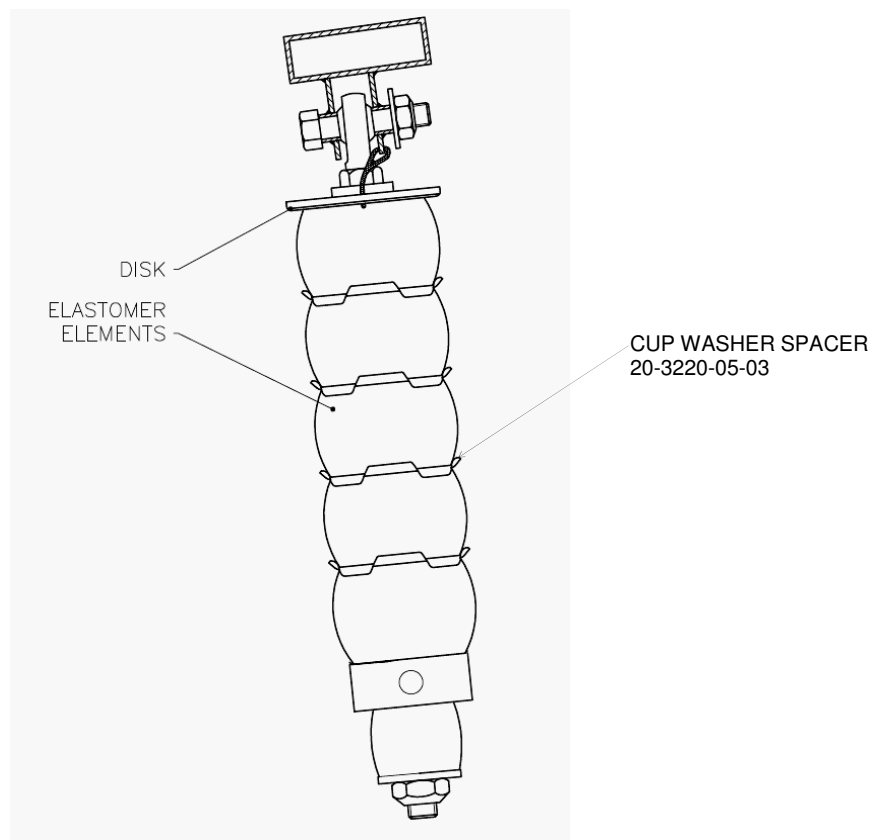
**Figure 1 - NLG Spring after Assembly
(NLG Strut not shown)**

- 10.3.1** Remove engine cowlings in accordance with AMM.
- 10.3.2** Inspect NLG elastomer spring assembly for shrinkage or damage of the elastomer elements and damage to the cup washer spacers, part number 20-3220-05-03.
- 10.3.3** Push down on fuselage in front of vertical stabilizer to hold nose landing gear above the ground.
- 10.3.4** Push elastomer elements down until seated. If there is no gap between the elastomer springs and the disk (Figure 1), check for other possible causes for reduced propeller clearance such as a bent or damaged nose landing gear strut.
- 10.3.5** If there is a gap, proceed to Part 4.

- 10.4.1** Replace all five elastomer elements with five replacement elements, part number DV2-9032-23-01. Refer to AMM Chapter 32-20 page 4 and 5 for replacement instructions. If the two spacers 20-3220-05-07 were installed per service bulletin DA20-32-03 (at the bottom of the strut assembly), remove them.
