# SERVICE BULLETIN

**Service Bulletin No.:** DA20-52-01 - Rev. 0

**Date Issued:** 10 December 2012

**Title:** Canopy Locking Mechanism Inspection and Adjustment

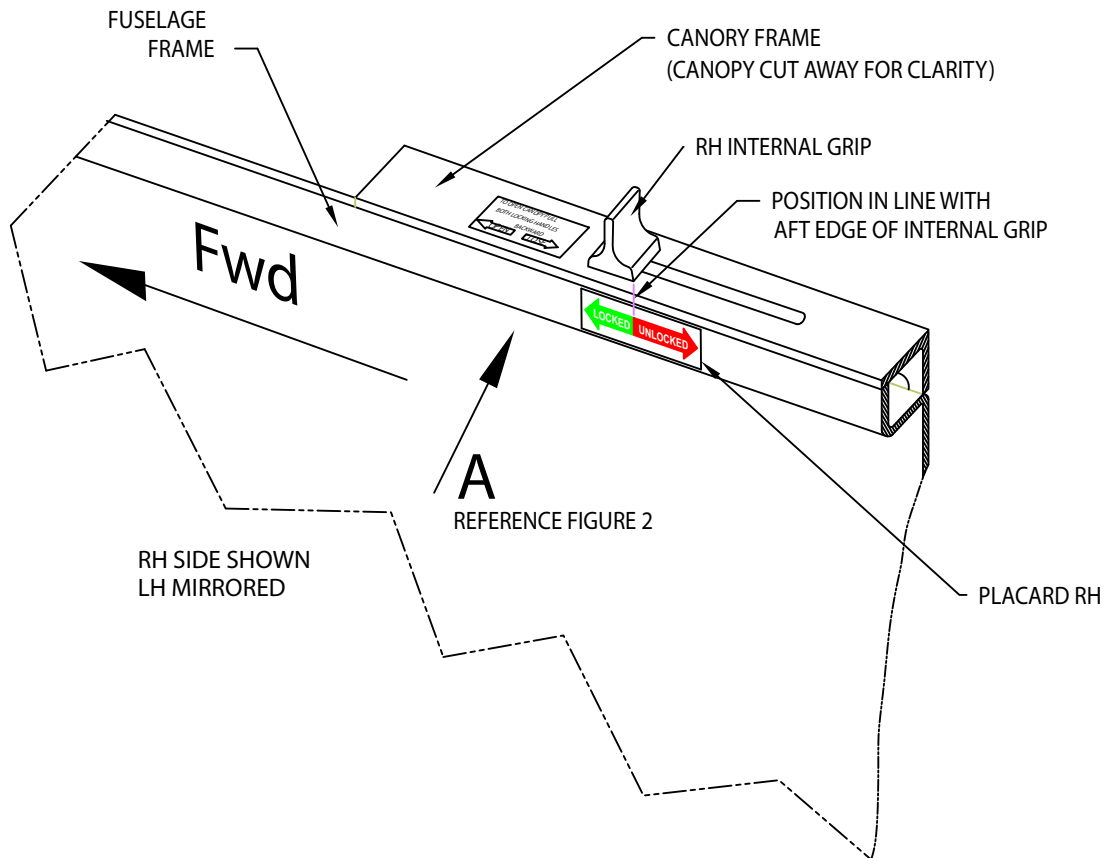
Figure 1 – Canopy Locking Mechanism Placard Installation

- 
- 1. ATA Code:** 5200
- 2. Effectivity:** All DA20-A1 Aircraft.
- 3. General:** This Service Bulletin addresses the introduction of:
- a. the canopy locking mechanism position placard.  
This is done to make sure that the canopy is closed and locked correctly.

10.3.3 Move the LH internal grip aft to the point when the annunciator starts to illuminate but before the bushing on the aft locking pin passes the top of the cam on the locking shoe (defined by the increase in unlatching force).

10.3.4 Move the LH internal grip forward 1 to 2 mm.

10.3.5 Install Placard LH, Locking Mechanism Position (P/N 20-1130-00-28) as shown in Figure 1.  
Make sure that the aft edge of the green sector on the placard is in line with the aft edge of the internal grip.

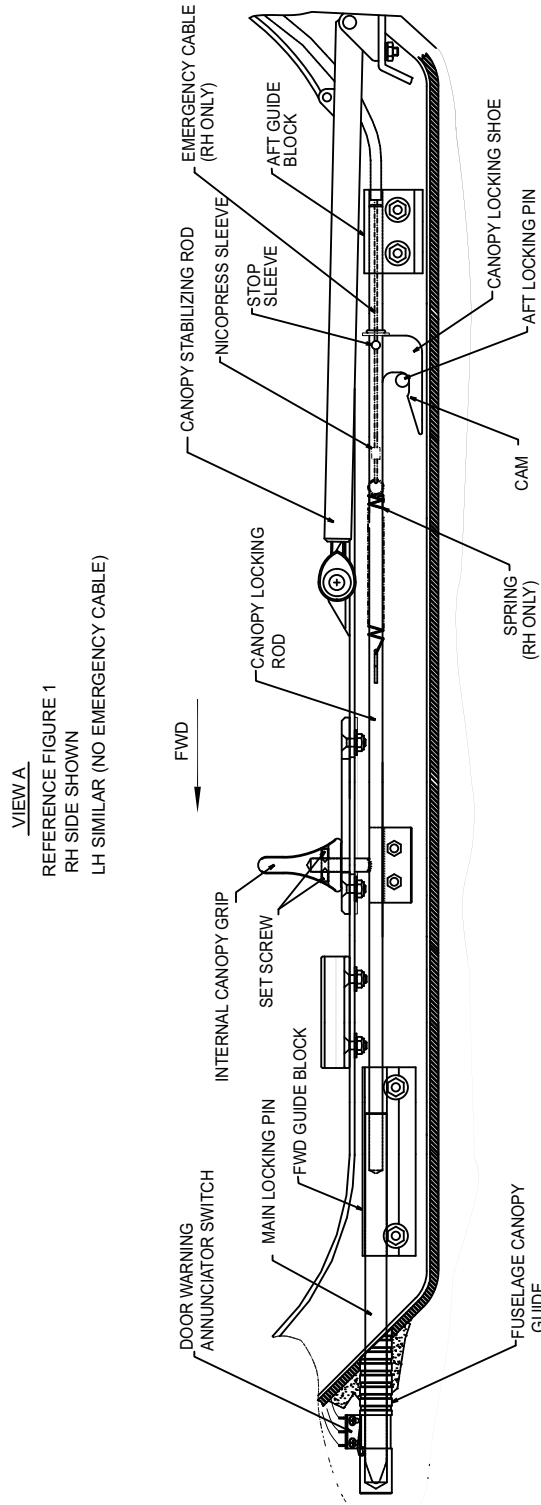
Figure 2 – Canopy locking Mechanism

- c. the procedure for the canopy locking mechanism adjustment and test.  
This is done to improve the inspection criteria and to make sure proper operation of the canopy locking mechanism.

10.1.8 Measure the force required to unlatch the LH locking mechanism using a calibrated spring scale on the LH external grip, pulling directly aft. The unlatching force must be 58-80 N (13-18 lbf).

NOTE: During unlatching movement of the handle, there should be a distinct increase in unlatching force when the aft locking pin passes the cam on the canopy locking shoe.

10.1.9 If necessary, replace the bushing on the aft locking pin with oversized pin Ø10.2mm (P/N 20-5650-00-05) or pin Ø12.2mm (P/N 20-5650-00-06) to achieve required unlatching force.
