# ALERT SERVICE BULLETIN

Service Bulletin No.: DA20-53-01A, Rev. 0

## Title: Interference, Rudder Pedal/Foot

Date Issued: June 5, 1997

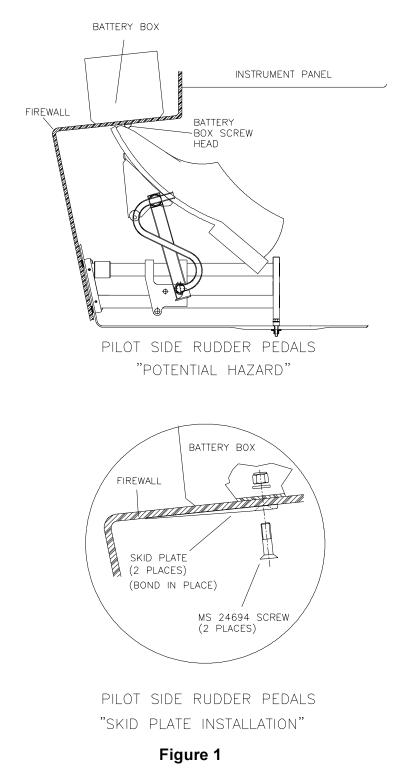
- 2. Effectivity: DA20-A1 aircraft S/N 10002 to 10287
- **3. General:** This service bulletin addresses the possibility of a jammed rudder control system. The toe of the pilots shoe could catch on the screw head(s) which mount the battery box to the firewall (See fig.1). The installation of skid plates and new mounting hardware prevent the above condition from occurring.

- **10.4** Peel the PRC away from the nuts on the bottom of the battery box so that you are able to hold the nut with a wrench or socket.
- **10.5** Remove the existing battery box mounting hardware. Clean the old PRC from the bottom of the battery box.
- 10.6 Use acetone to remove the grease from the surface area where the skid plates are to be installed. Make sure the area of the bond has sufficient roughness.Use acetone to remove the grease from the top surface of the skid plates. Make sure the area of the bond has sufficient roughness.
- **10.7** Apply a sufficient amount of DP110 epoxy adhesive (or equivalent 5 minute epoxy cement) to the skid plate face opposite the countersink. Install the skid plates using the hardware provided to locate the holes. **Ensure that the skid plates are oriented in the forward direction as shown in figure 1.**

Reinstall the battery box. Tighten the screws to pull the skid plates tight to the firewall. Ensure the head of the screw does not protrude below the surface of the skid plate.
