ALERT SERVICE BULLETIN

Service Bulletin No.: DA20-53-02 Rev 0

Title: A-Bolt Washer Size

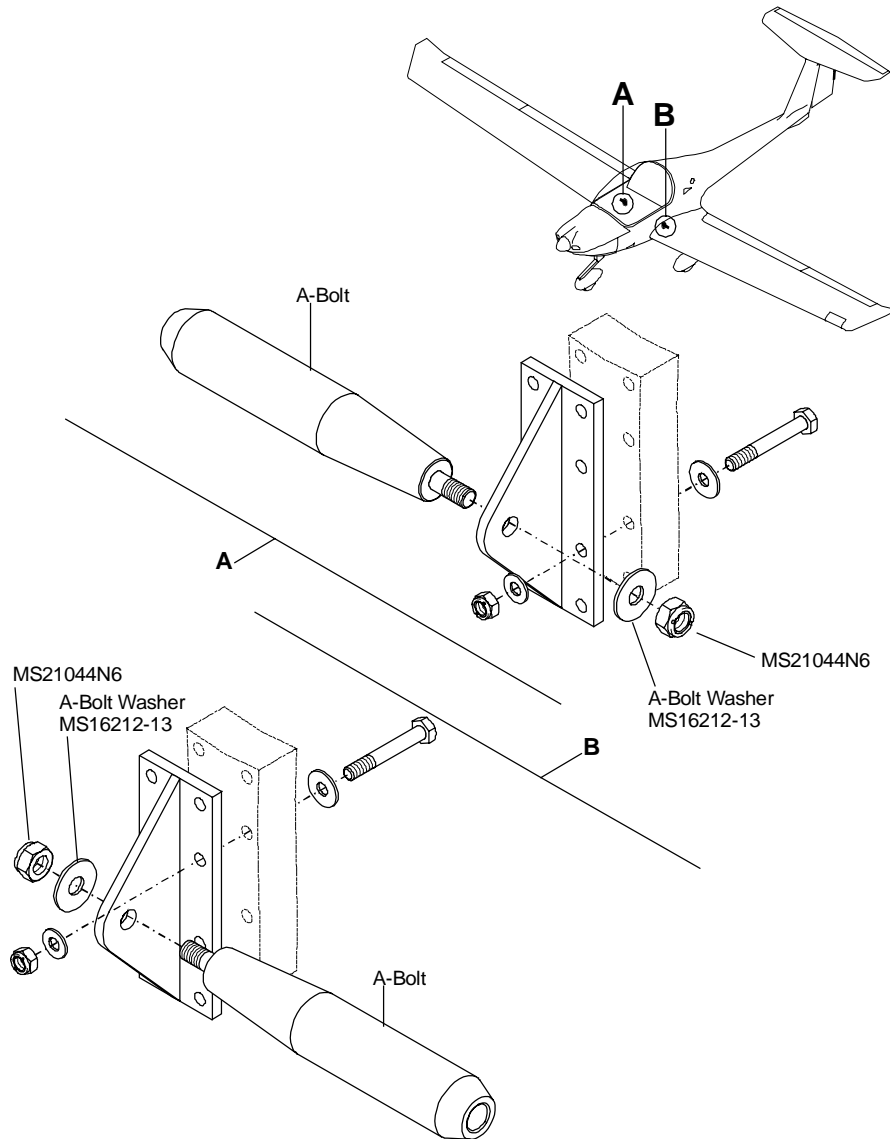
Figure 1

Procure parts listed above locally.
8. **Special Tools:** N/A
9. **References:** DA20 Maintenance Manual, Document number DA201.
10. **Accomplishment Instructions:**
 - 10.1 Remove seats from the aircraft (reference DA201).
 - 10.2 Measure outside diameter of A-Bolt washers.
Correct installation is shown in Figure 1.
 - 10.3 If diameter is not greater than 5/8", remove existing nuts and washers and replace with new washers (P/N MS16212-13) and new nuts (P/N MS21044N6). Torque nuts to 15.4 ft.lbs. (20.8 Nm).
 - 10.4 Reinstall seats (reference DA201).
