# SERVICE BULLETIN

Service Bulletin No.: DA20-56-1, Rev. 0

Date Issued: January 10, 1996

Title: Canopy, Side Window Water Drain

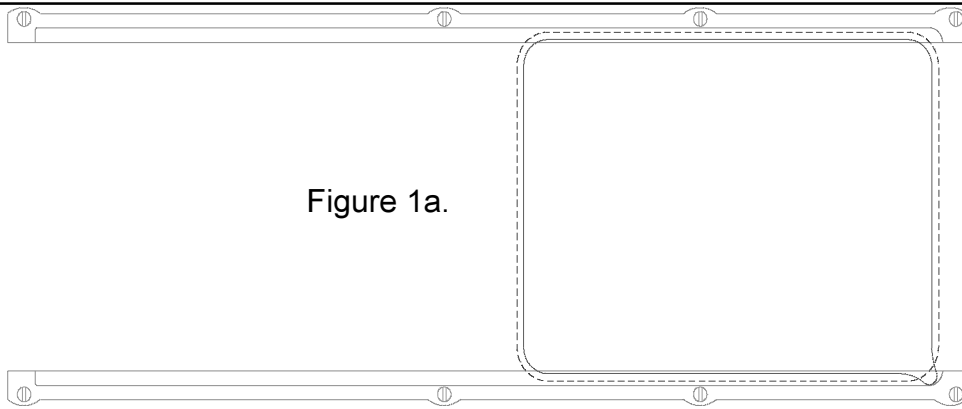
Figure 1a.

9. **References:** DA 20 Katana Maintenance Manual Doc. No. DA201
10. **Accomplishment Instructions:**
- 10.1 Determine the trough style installed on the aircraft, either Figure 1a or 1b.

10.3 If the window style shown in Figure 1a then the modification is as per Figure 3. A template of the router fixture is depicted in Figure 9, page 6 which locates on the two forward trough screws. Fashion a routing template based on the attached drawing. Locate the the template on the two forward screws and using a 1/16" or 1/8" tapered router bit route the canopy as shown in Figure 3 using the template as a guide. Carefully remove any sharp edges with a small round file.
