ALERT SERVICE BULLETIN

Service Bulletin No.: DA20-57-02-A, Rev. 0

Title: Aileron Control Fairing Modification

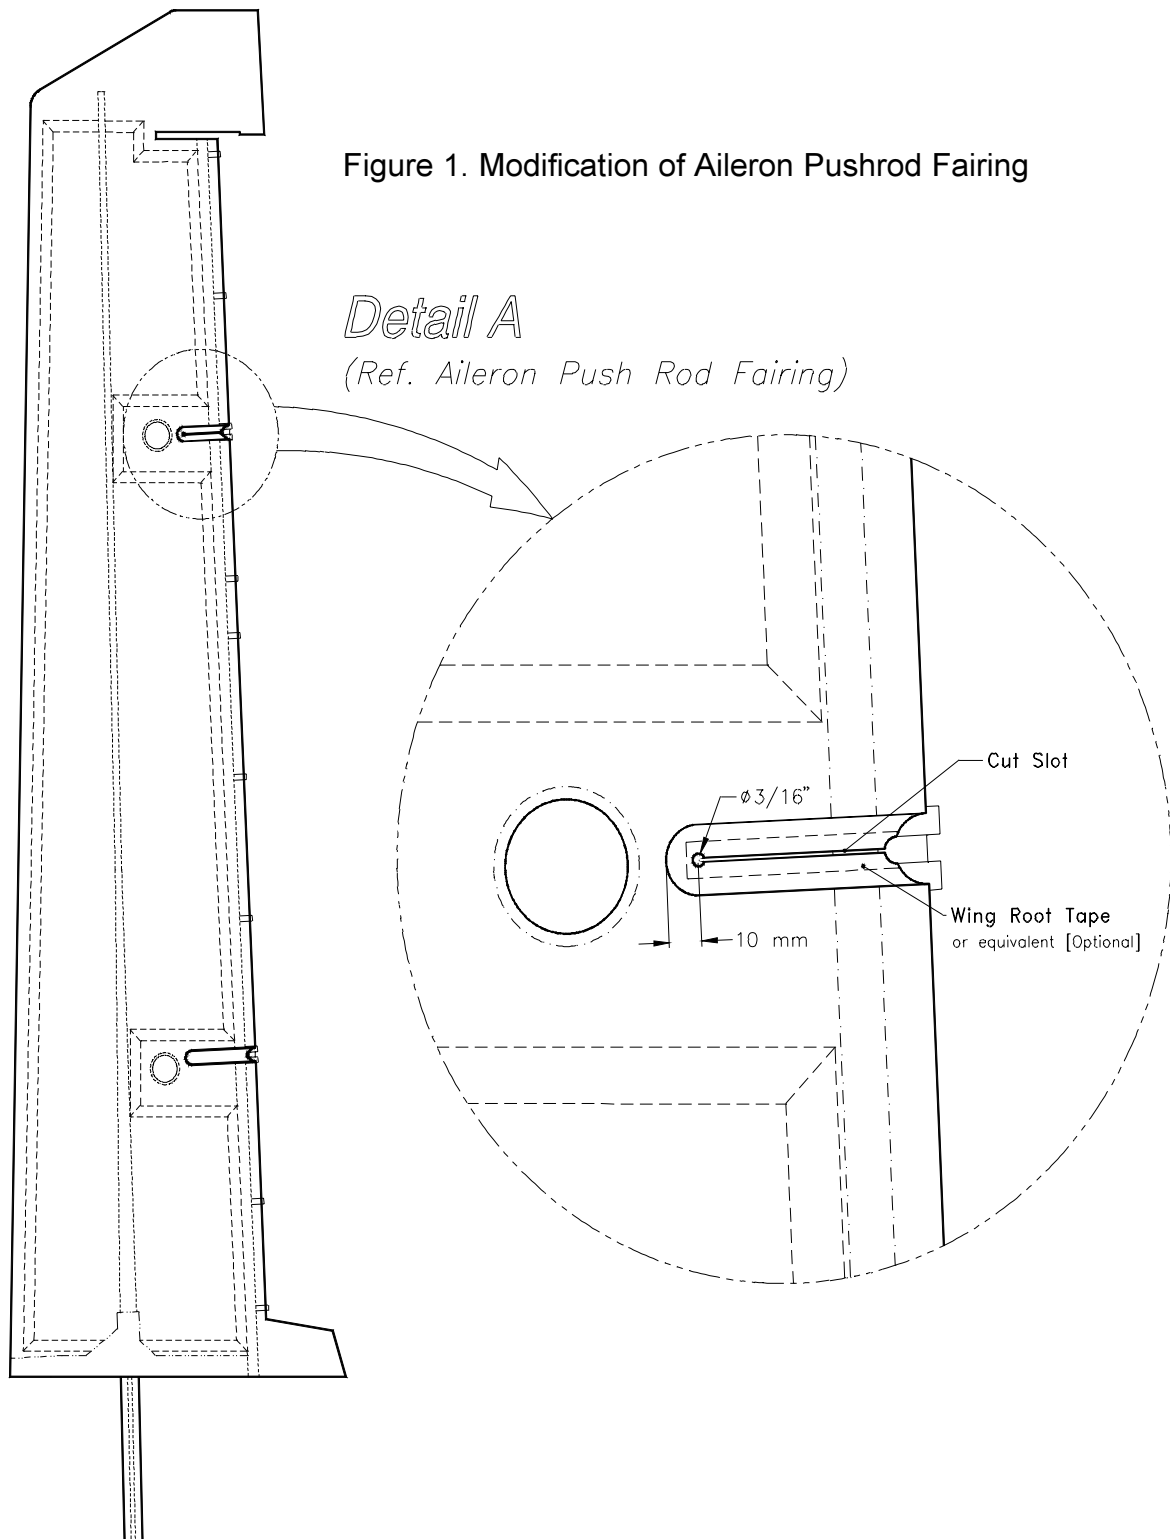
-
1. **ATA Code:** 5700
 2. **Effectivity:** All DA 20 Katanas , aircraft serial number 10002 to 10110.
 3. **General:** There have been several cases of aileron controls being partially blocked due to foreign objects becoming jammed between the short aileron pushrod and the pushrod exit fairing of both left and right wings.
This Bulletin describes a one time foreign object inspection of the aft wing cavities and a modification to the aileron pushrod fairings to allow them to flex to prevent foreign objects from jamming the pushrods.

- 10.4 Drill 3/16" diameter holes in the aileron pushrod fairings (both wings) as shown on detail A of Figure 1.
- 10.5 Remove short pushrods in accordance with Maintenance Manual procedures (ref. Chapter 27-10), if required by method of cutting the fairing.
- 10.6 Cut slots in the fairings as shown on detail A of Figure 1 with hacksaw blade, cutting disk, etc. taking care not to contact the pushrod if it has not been removed.
- 10.7 Reinstall aileron pushrods in accordance with Maintenance Manual procedures (ref. Chapter 27-10), if applicable.
- 10.8 Apply wing root tape (or equivalent), if desired, as shown on detail A of Figure 1.
