SERVICE BULLETIN

Service Bulletin No.: DA20-78-01, Rev. 1

Title: Exhaust System, Improved Joint Sealing

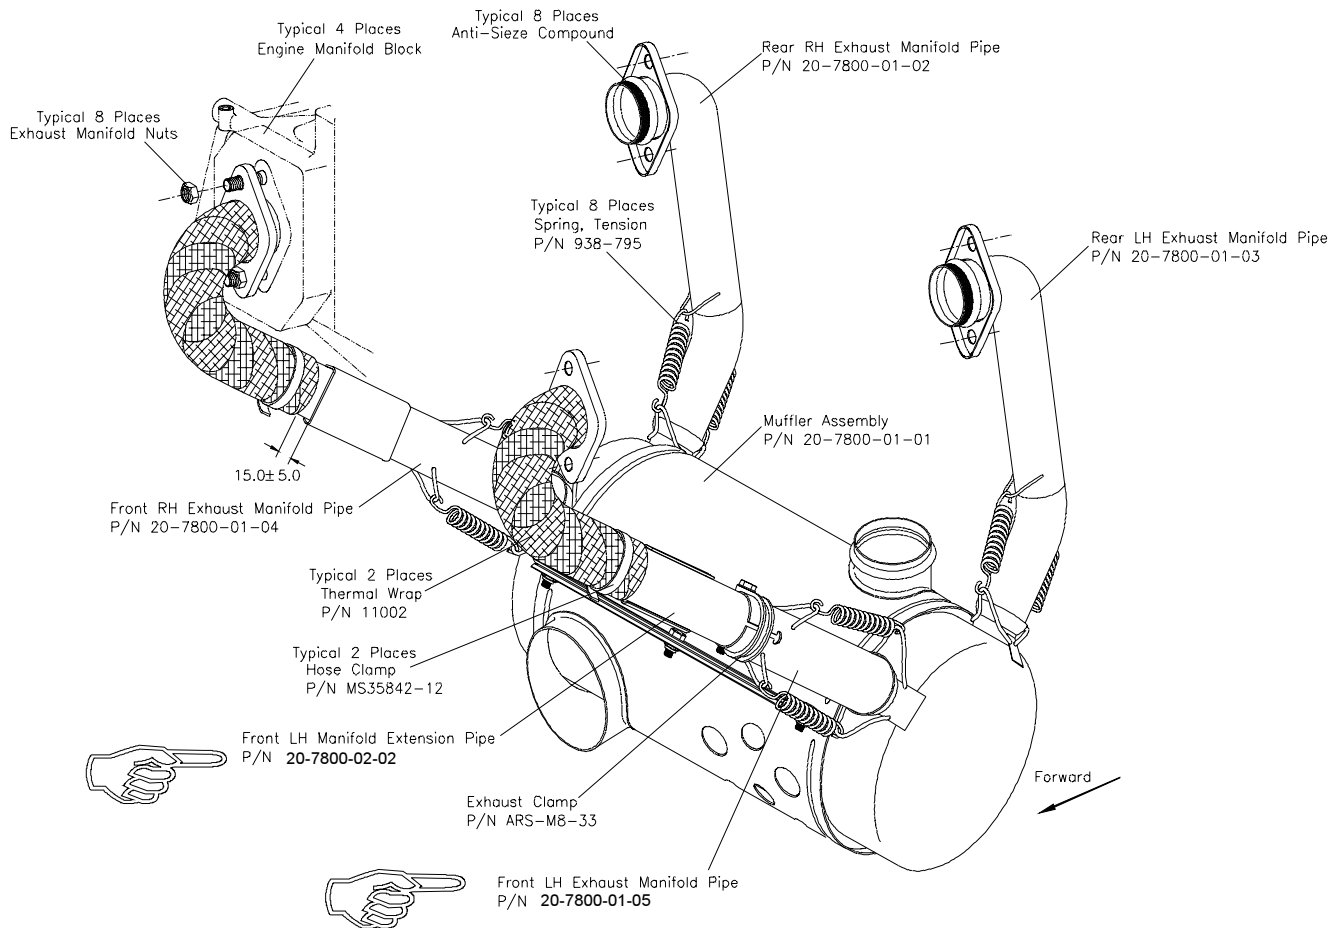
Figure 1.

3. **General:** Exhaust leakage may occur as a result of misalignment or deformation of the exhaust joints. This bulletin specifies replacement of the existing exhaust system with a new variant, incorporating improved exhaust joint sealing.

- 10.2 Disconnect all ducting from the muffler shroud (Air Intake, Carb Heat, Heat Box). Unbolt the exhaust system from the engine, by removing the exhaust manifold nuts (ref. figure 1).

- 10.3 Use the tension springs (p/n 938-795) to attach the front RH exhaust manifold pipe (p/n 20-7800-01-04), the front LH exhaust manifold pipe (p/n 20-7800-02-02), and the rear RH and LH exhaust manifold pipes (p/n 20-7800-01-02 and 20-7800-01-03) to their respective positions on the muffler assembly (p/n 20-7800-01-01) (ref. figure 1).

- 10.4 Apply loctite anti-seize compound (p/n 76764) to all four (4) exhaust pipe ends, as indicated in figure 1. Bolt the above assembly (ref. paragraph 10.3) to the engine, and lightly tighten the exhaust manifold nuts as they are reinstalled.

- 10.8 Slide the exhaust clamp into position as shown in figure 1, and torque it down to 20 ft/lbs. Re-install all ducting connections to the muffler shroud (Air intake, Carb Heat and Heat Box).
