ALERT SERVICE BULLETIN

Service Bulletin No.: DA20-79-04A, Rev. 1

Title: Defective Oil Filter

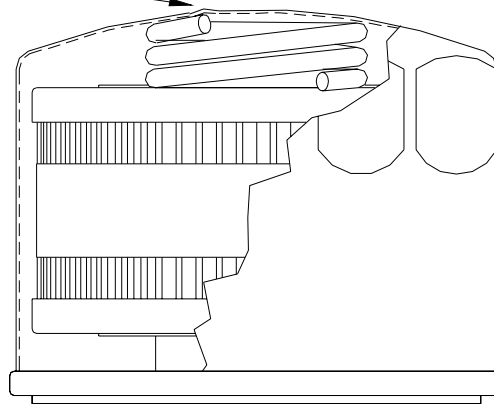
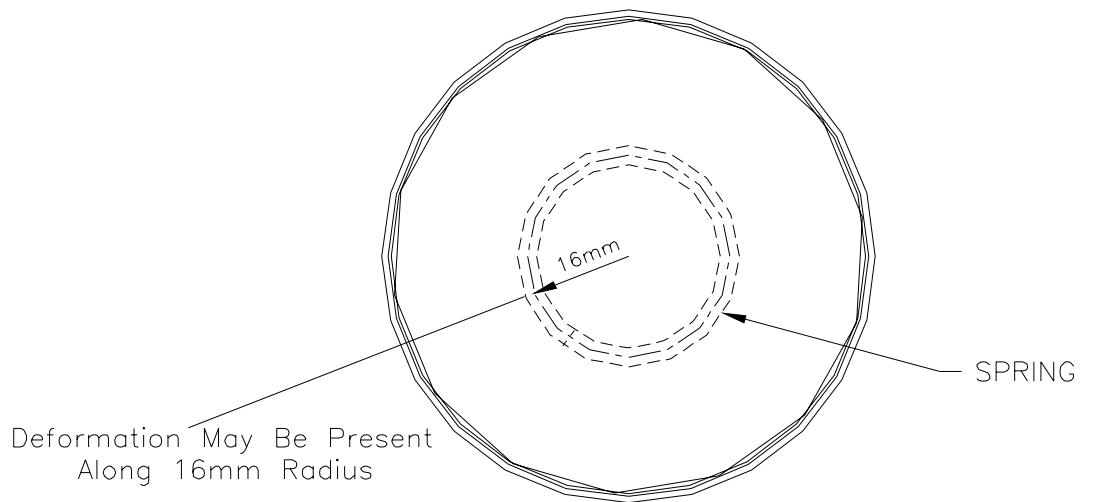
Figure 1

1. **ATA Code:** 7920
2. **Effectivity:** DA 20A-1 Aircraft S/N 10002 through 10300.
3. **General:** This service bulletin address the inspection and replacement of oil filters Rotax P/N 825-700. Some oil filter outer cases have defects caused by an internal spring. There is a possibility that a crack will develop in the outer casing resulting in the loss of oil from the engine lubricating system.

Only a slight defect may be visible
Inspect carefully along the 16mm radius

4. **Compliance:** Inspect immediately and replace if necessary upon receipt of this service bulletin.
Replacement of the oil filter is required immediately upon receipt of this bulletin if the filter has been in service for longer than 50 hours.
Oil filter replacement is required upon reaching 50 hours since last filter replacement and every fifty hours thereafter until the new filter, Rotax P/N 825-701 is installed.

<u>Item</u>	<u>Qty</u>	<u>Part Number</u>	<u>Description</u>
1	1	825-701	Oil Filter
8. **Special Tools:** Not Applicable.
9. **References:** Doc #DA201 Maintenance Manual.
10. **Accomplishment Instructions:**
 - 10.1 Remove the upper and lower cowling.
 - 10.2 Clean the filter casing.
 - 10.3 Using a light carefully inspect the surface area shown in figure 1.
 - 10.4 If the defect described in figure 1 is present on the outer casing replace the oil filter.
 - 10.5 Replace the oil filter every 50 hours thereafter until the new type oil filter is installed on the aircraft.
