SERVICE BULLETIN

Service Bulletin No.: DA20-79-05 Rev 4

Title: DA20 A1 - Oil Line Retrofit – F3 Engine

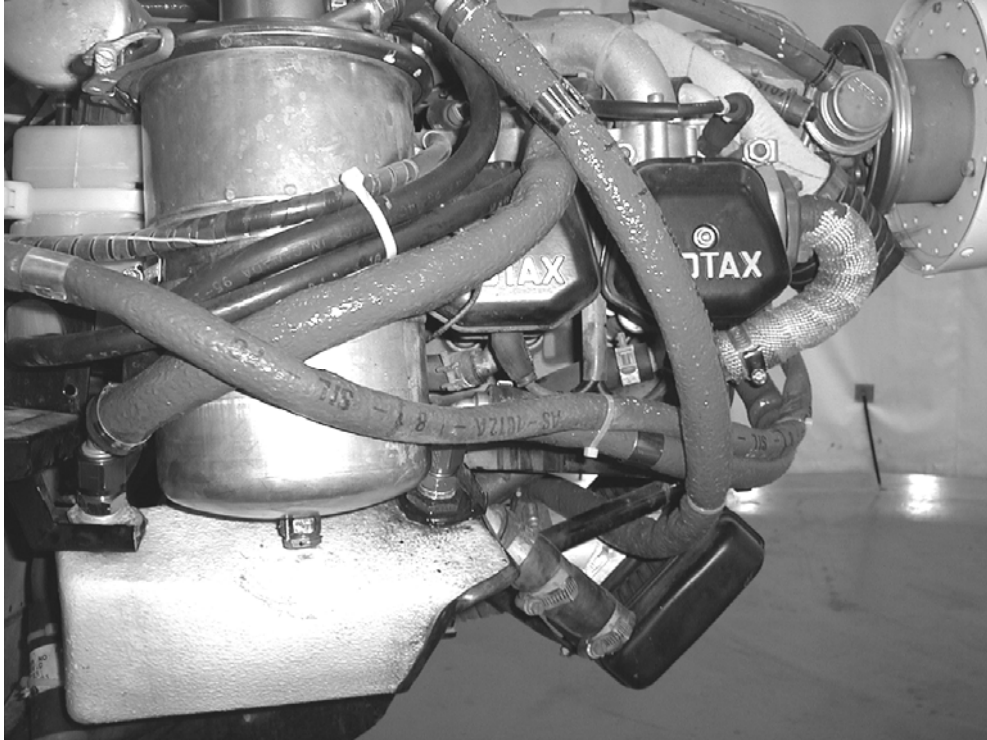
Figure 2: Routing and securing oil lines (RH, looking inboard).

- 10.8** Route and secure oil lines as shown in Figures 2 and 3 using supplied tie-down straps, MS3367-5-9. ORIENT FITTINGS AND HOSES TO AVOID CONTACT WITH RADIATOR, ENGINE MOUNT AND CABIN HEATER SHROUD.
- 10.9** Ensure reservoir is in lowest position on engine mount. Do not allow reservoir to contact oil cooler shroud or upper surface of coolant overflow bottle.
- 10.10** Connect oil reservoir vent line.

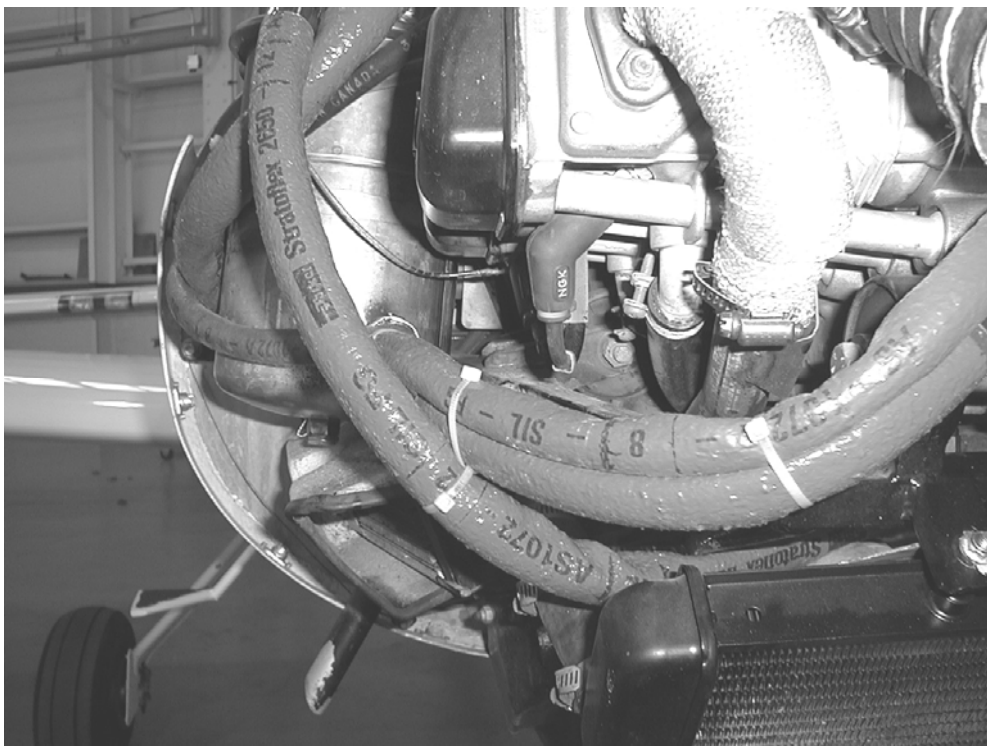
Figure 3: Routing and securing oil lines (front, looking aft).
