# ALERT SERVICE BULLETIN

**Service Bulletin No.:** DA20-79-06A Rev 1

**Title:** Inspection of Oil Tank Cover

- 1. ATA Code:** 7900
- 2. Effectivity:** All DA20-A1 aircraft which have been retrofitted with Service Bulletin DA20-79-05, Oil Line Retrofit .

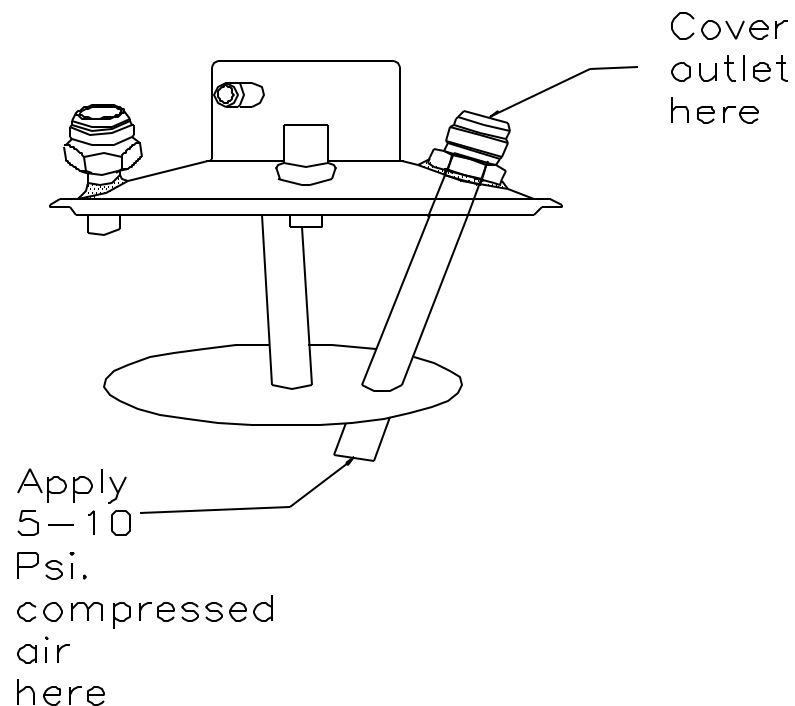
**Figure 1**  
**(Oil Tank Lid Testing)**

**3. General:** There has been a report of a partial loss of oil pressure due a defective oil tank cover assembly. This Alert Service Bulletin addresses the inspection of potentially affected covers for such defects.

- 9.5. Connect a 5-10 psi. compressed air supply to opposite end of tube.
- 9.6. Submerge cover in water and check for leaks (bubbling). If no leak is noted during the test, the oil cover may be disconnected, cleaned and returned to service.
- 9.7. If a leak is found the cover is defective and will have to be replaced.
- 9.8. Make a log book entry stating that "A.S.B DA20-79-06A Rev 1 Inspection of Oil Tank Cover has been complied with".
