SERVICE BULLETIN

Service Bulletin No.: DA20-79-07 Rev 0

Title: Oil Quantity Placard DA20-A1/DA20-100

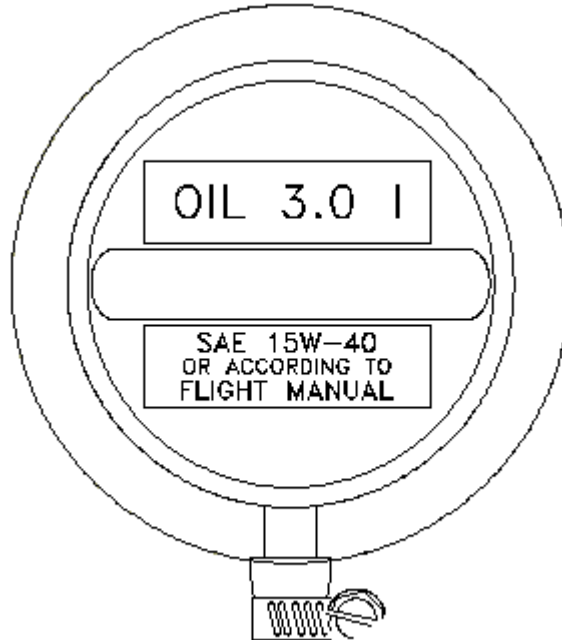
Figure 1
Old Placard

- 10.1 Remove the existing placard from the oil reservoir cap.
- 10.2 Clean the surface of the oil cap, removing all traces of adhesive, oil or dirt.
- 10.3 Remove the foil backing from the new placard and apply the placard to the oil reservoir cap in the same location and orientation as the existing one.

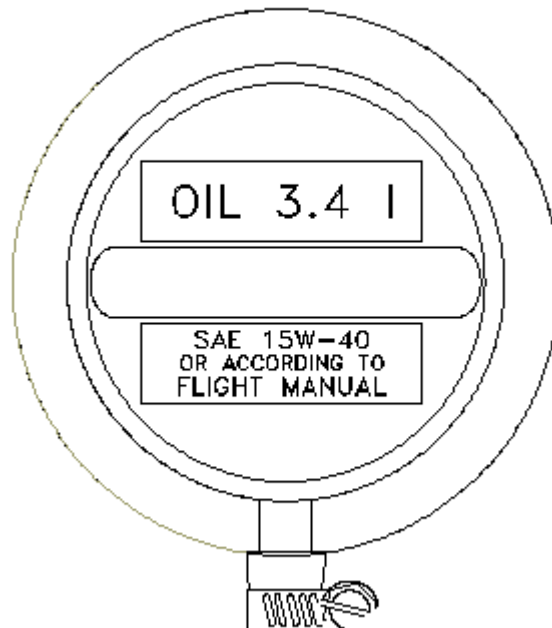
Figure 2
New Placard
