## SERVICE INFORMATION LETTER

# **SERVICE BULLETIN**

## **CHECKING OF MAGNETIC PLUG**

**SB-912-051**  
**SB-914-034**

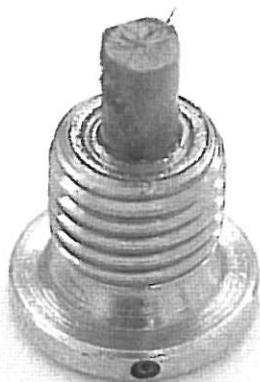
fig. 1

acceptable

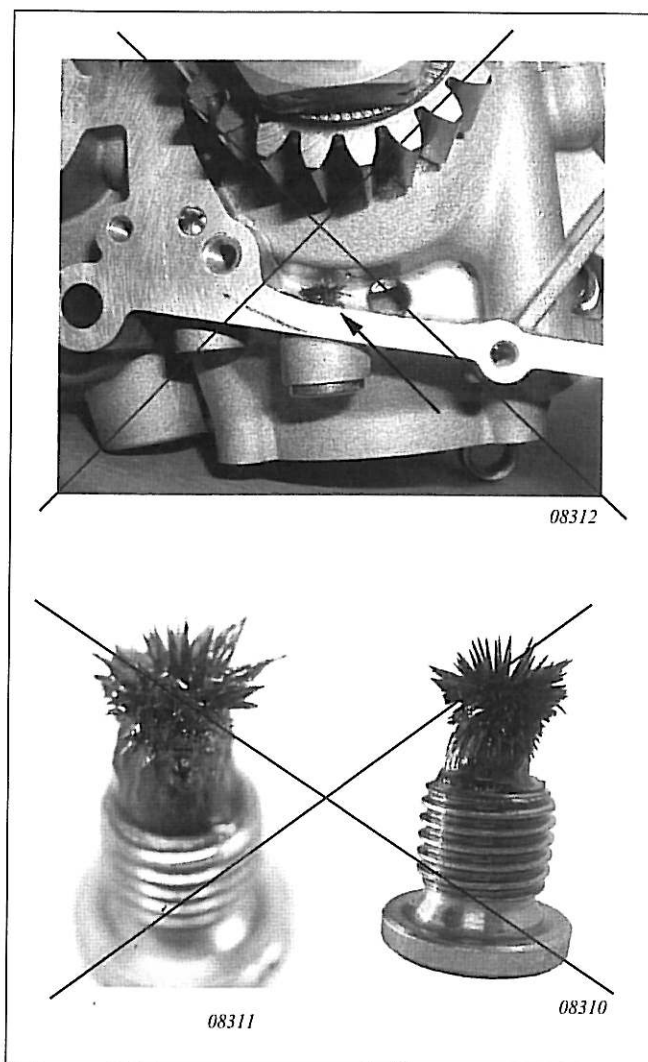
fig. 2

■ **CAUTION:** If a greater quantity of metal particles (more than 3 mm (1/8")) is detected, consultation of an authorized distributor regarding further action is necessary. The engine must not be taken into operation until the cause has been identified and eliminated.

not acceptable
