## **SERVICE INFORMATION LETTER NO. SIL20A1-006**

Federal Aviation Administration (FAA) Airworthiness Directive (AD) "2010-20-23 Bombardier-Rotax GmbH (formerly Rotax, Motorenfabrik): Amendment 39-16458. Docket No. FAA-2010-0342; Directorate Identifier 2002-NE-08-AD" for inspection of engine crankcase for cracks especially in the area of cylinder 1 upper side, between cylinder 1 and 3 upper side, cylinder 4 lower-right side and detailed inspection in the area identified in Figure 2 of this AD (attached).

#### **Airworthiness Directives; Bombardier-Rotax GmbH Type 912 F, 912 S, and 914 F Series Reciprocating Engines**

**2010-20-23 Bombardier-Rotax GmbH (formerly Rotax, Motorenfabrik):** Amendment 39-16458.  
Docket No. FAA-2010-0342; Directorate Identifier 2002-NE-08-AD.

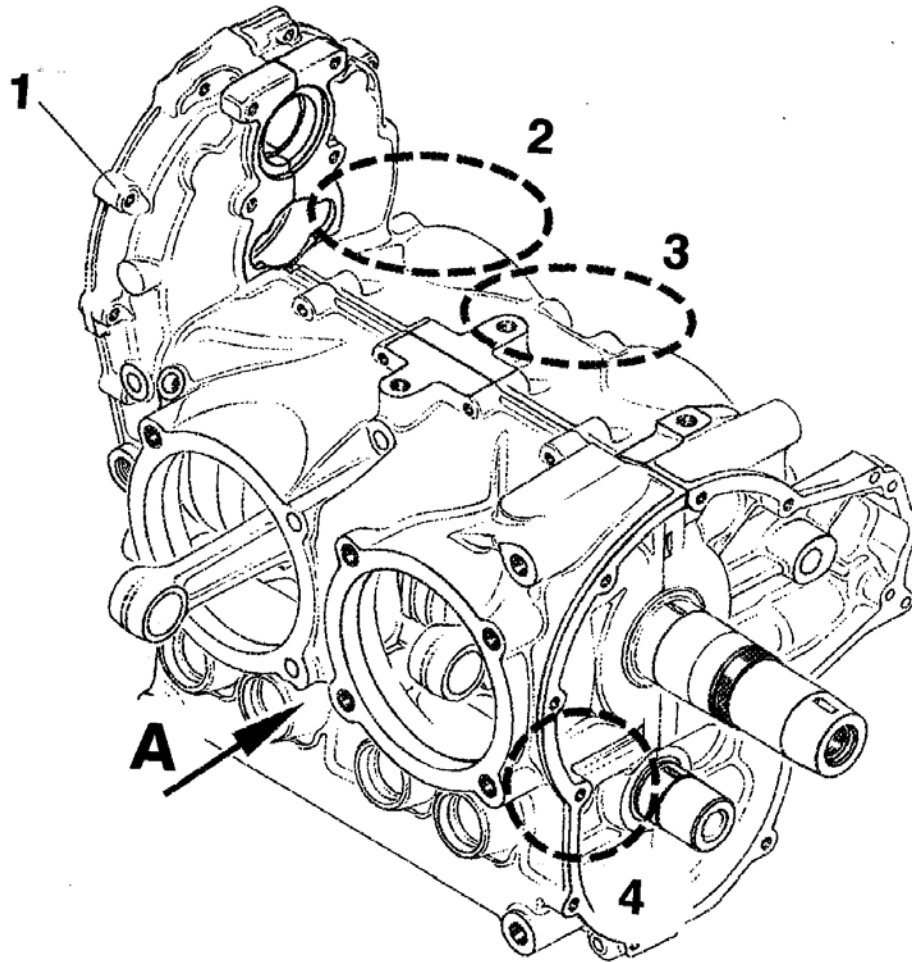
**Figure 1. Engine Crankcase Inspection Areas**

- (1) Inspect the engine crankcase (item 1, Figure 1 of this AD) for cracks especially in the area of cylinder 1 upper side (item 2), between cylinder 1 and 3 upper side (item 3), cylinder 4 lower-right side (item 4) and detailed inspection in the area identified in Figure 2 (item 5) of this AD.

(2) Cracks in crankcases of engines with a ROTAX cooling air baffle may not be easily visible, and oil leaks may be an indication of cracks. Visually inspect for oil leaks in areas of cylinder 1 upper side (item 2, Figure 1 of this AD) and between cylinder 1 and cylinder 3 upper side (item 3).

(3) If you find oil leaks, determine the source by either using a borescope or removing the object blocking the view such as the air baffle or accessory, and perform the inspection.

(4) If the engine crankcase is cracked, remove the engine from service before further flight.

(h) Visually inspect the engine crankcase (item 1, Figure 1 of this AD) for cracks at each 100-hour, annual, or progressive inspection, or within 110 hours TIS since last inspection, whichever occurs first, in accordance with paragraphs (g)(1) through (g)(4) of this AD.

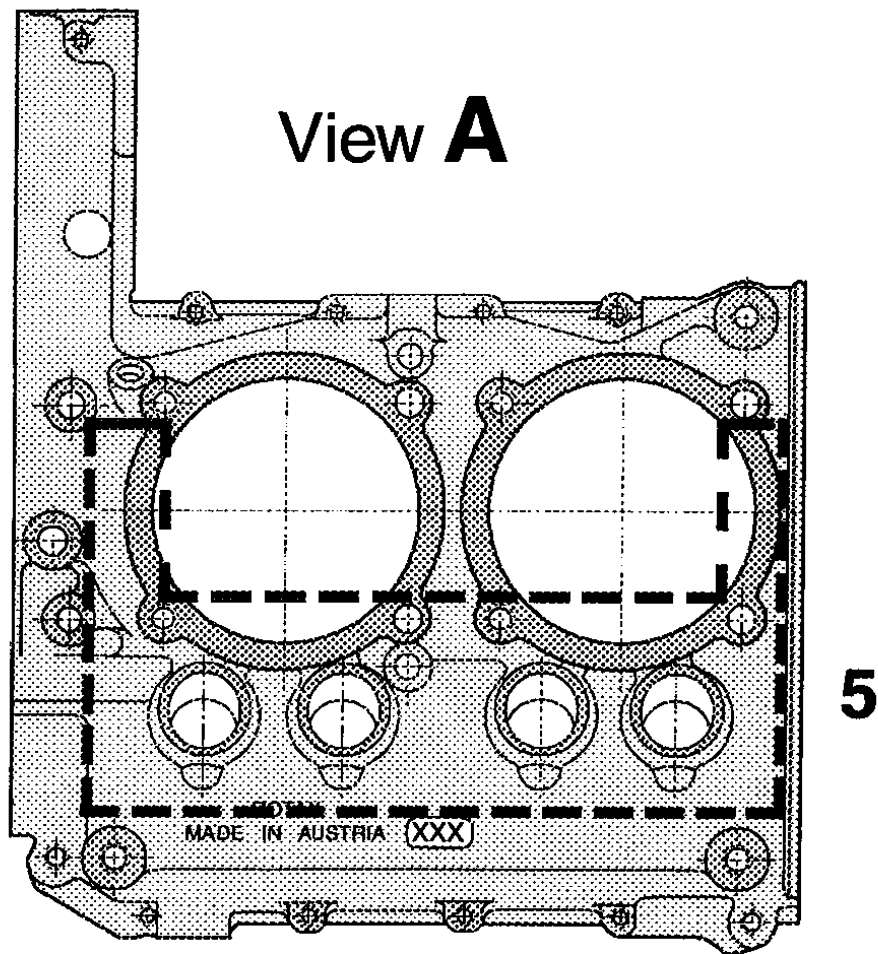
**Figure 2. Engine Crankcase Inspection Areas – View A**

(f) Determine if your crankcase is affected by looking at the S/N in the area indicated by XXX, following "Made in Austria," as shown on Figure 2 of this AD. The marking is on both crankcase halves.
