SERVICE INFORMATION LETTER NO. SIL20A1-007

Replacement of oil dipstick.

INTRODUCTION OF A NEW OIL DIPSTICK FOR ROTAX® ENGINE TYPE 912 AND 914 (SERIES)

SB-912-040 R1

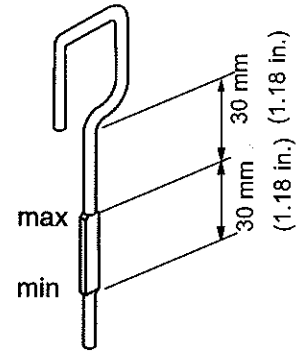
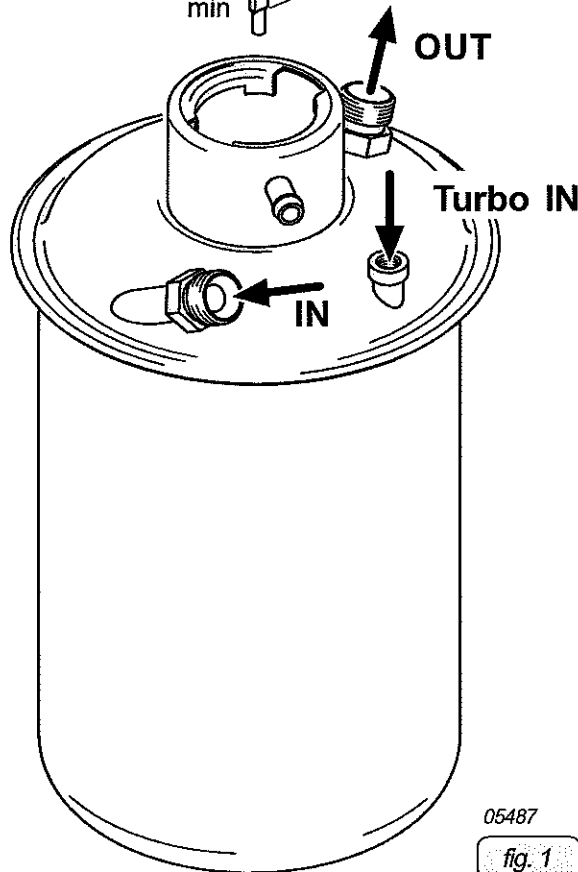
oil dipstick, new version

◆ **NOTE:** By changing the oil dipstick, the minimum oil level is raised by approx. 40 mm (1.57 in.) and the height between the "min." and "max." level is reduced to 30 mm (1.18 in.) (approx. 0,45 litre).

- Remove the oil dipstick part no. 956150 and replace by new oil dipstick part no. 956151.
- Inspect the oil level to be performed SI-27-1997 "Oil level check", current issue.
- Add oil if necessary.
