## SERVICE INFORMATION LETTER NO. SIL20A1-008

All DA20-A1 aircraft.

The improvement in the design of the Nose Landing Gear (NLG) Fork assembly. The old P/N 20-3220-08-00 has been replaced with the new NLG Fork assembly, P/N 20-3220-08-00\_1.

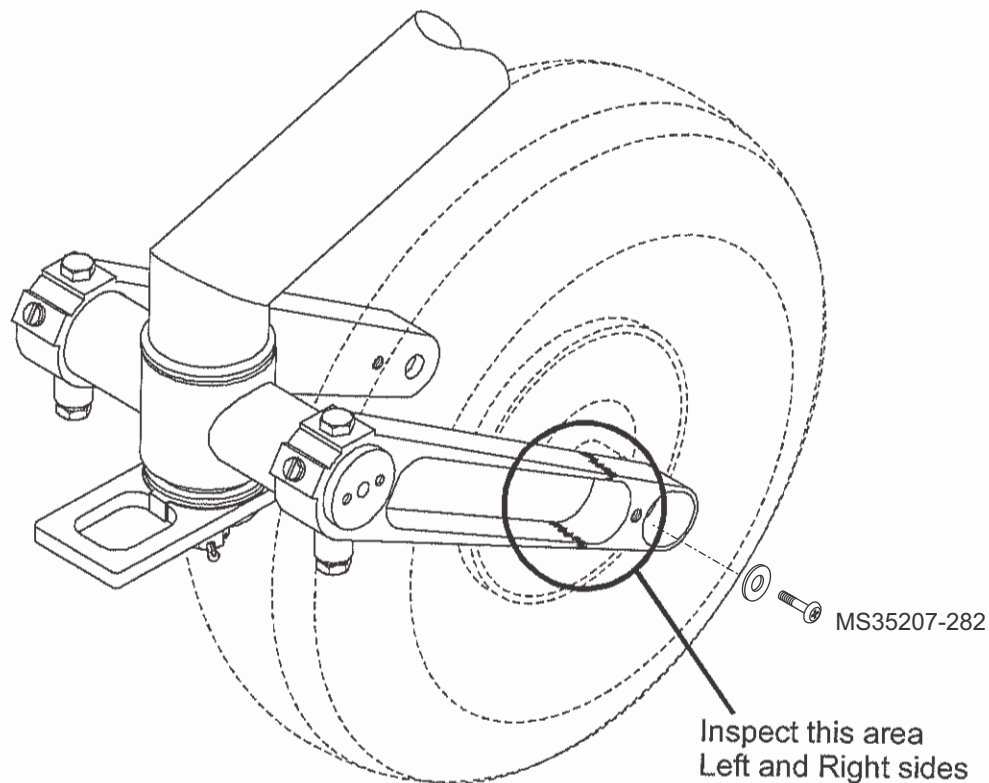
Cracks have been found on some NLG Fork assembly, P/N 20-3220-08-00 during routine inspections. Cracking usually occurs on higher time aircraft but could occur sooner with rough field operations or hard landings. Figure 1 shows where the cracking has normally occurred. Also, the machine screw, pan head, P/N MS35207-282 (see Figure 1) should be installed with Loctite 242 when the wheel fairings are not used to avoid any potential cracking that may occur at that location.

Refer to DA20-A1 Aircraft Maintenance Manual (AMM) Document No. DA201-A1, Revision 15 dated 01 August 2011 or later revisions for new inspection requirements for the NLG and the Illustrated Parts Catalogue (IPC), Document No. DA203-A1, Revision 4 dated 15 September 2011 or later approved revisions.
