SERVICE INFORMATION LETTER NO. SIL20A1-010

FAA Airworthiness Directive No 2011-14-09
ATA Code: 74 - Ignition

REPLACEMENT OF WASHER PART NO. 944072 (FLY WHEEL HUB) FOR ROTAX® ENGINE TYPE 912 AND 914 (SERIES)

SB-912-058

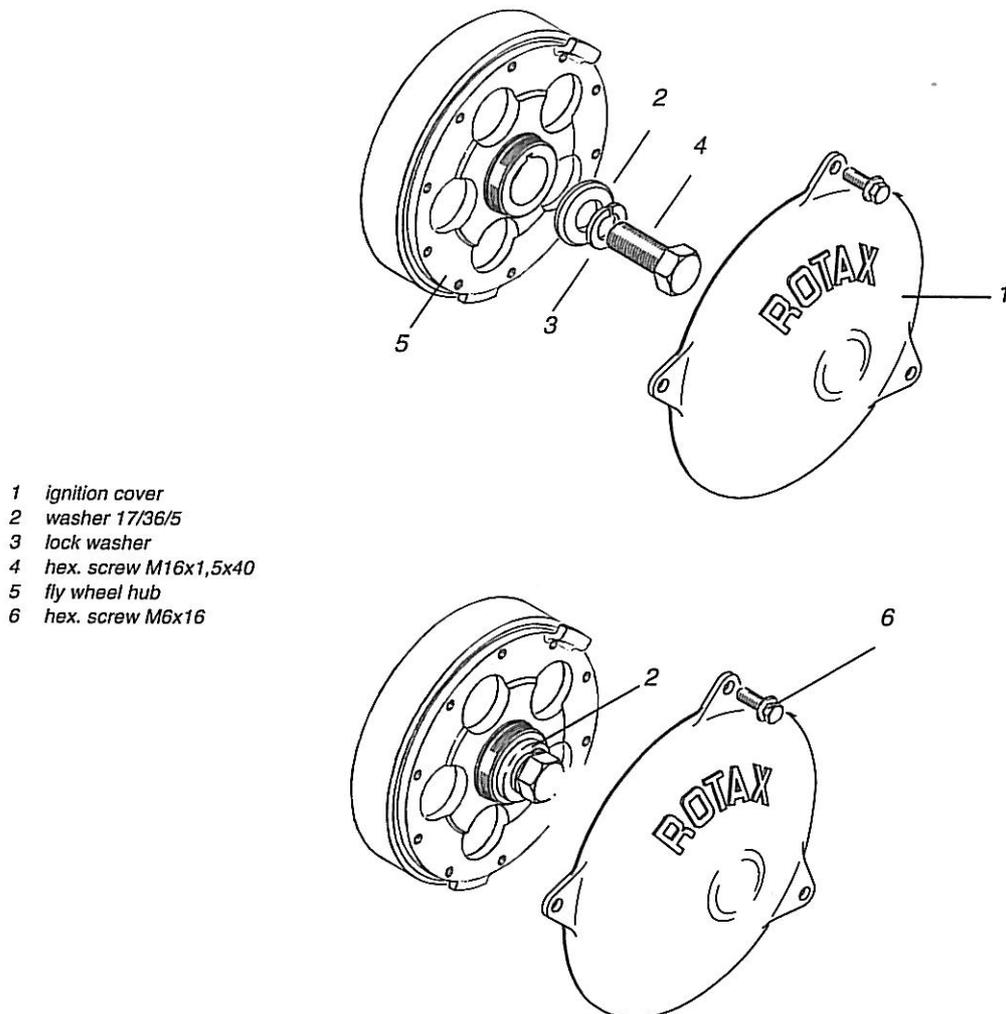
Fig. 1

magneto ring, fly wheel hub, ignition cover

See fig. 1.

1. Remove ignition cover (1).
2. Lock the crankshaft in accordance with the relevant Maintenance Manual (Line).
3. Remove hex. screw (4) in accordance with the relevant Maintenance Manual (Heavy).

4. Install hex. screw (4). **Tightening torque 120 Nm (89 ft.lb).**

■ CAUTION: During installation the new washer (2) part no. 944072 must be used.

5. Remove locking pin of crankshaft in accordance with the relevant Maintenance Manual.
6. Check trigger coil gap, if necessary adjust it in accordance with the relevant Maintenance Manual.
7. Install ignition cover (1). The hex. screws (6) are locked with Loctite 221. Tightening torque 5 Nm (44 in. lb.).
