SERVICE INFORMATION LETTER NO. SIL20A1-012

Rotax Alert Service Bulletin ASB 912-059
ATA-Code: 72-20

CHECKING OF THE CRANKSHAFT JOURNAL (POWER TAKE OFF SIDE) FOR ROTAX® ENGINE TYPE 912 AND 914 (SERIES)

ASB-912-059
ASB-914-042

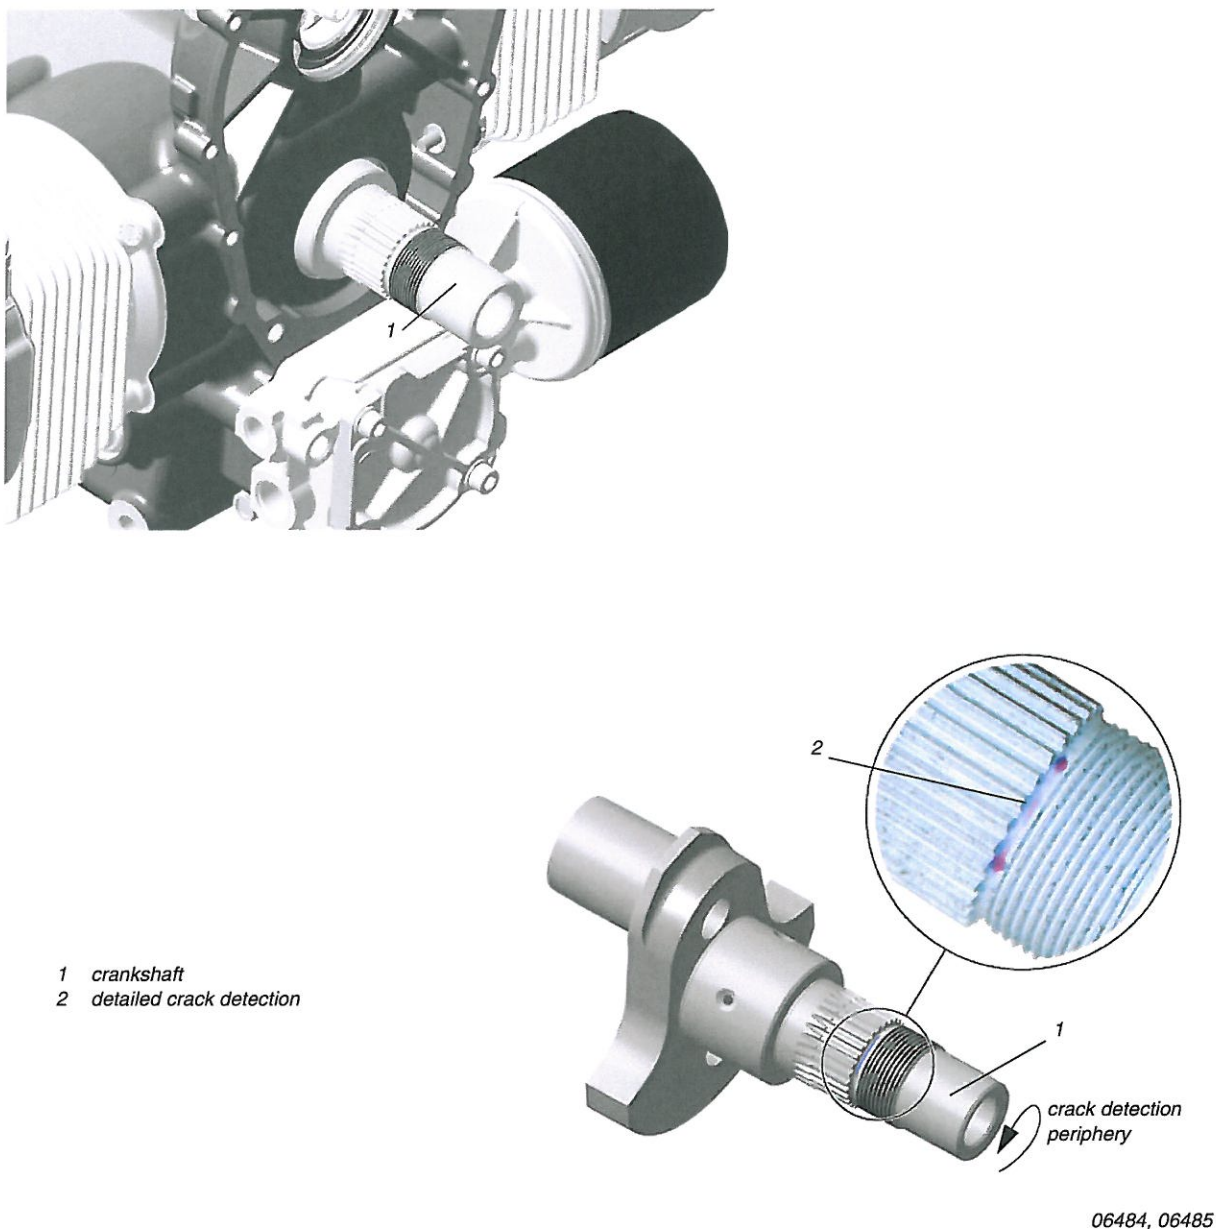
Fig. 1

Due to a deviation in the manufacturing process some crankshafts may have a crack formation occur on the power take off side. These cracks can cause a breakage of the crankshaft support bearing and may lead to engine stoppage.

6. Unlock the crankshaft to do the check on the entire periphery of the crankshaft.
 - Detailed crack detection in the area (2) of the thread runout using penetration test. Perform this test in accordance to the requirements of the applicable aviation authority in your region for non destructive testing (NDT) and according to DIN EN 571 or equivalent.

crankshaft journal

1. Lock the crankshaft in accordance with the relevant Maintenance Manual (Line).
2. Remove the propeller gear box. Use puller assy part no. 877660 or puller tool part no. 877540.
3. Remove the drive gear in accordance with the relevant Maintenance Manual (Heavy).
4. Clean and degrease the test area of the crankshaft journal.
5. Crack detection can be carried out with engine installed in aircraft.

- CAUTION: In case of crack or doubt contact your aircraft manufacturer and your nearest authorized ROTAX aircraft engine distributor. The engine must not be taken into operation until the cause has been identified and eliminated.

7. If no cracks can be found, then the reassembly has to be conducted in accordance with following steps:
 - Lock the crankshaft in accordance with the relevant Maintenance Manual (Line).
 - Clean and degrease crankshaft journal, threads and splines.
 - Install the drive gear with a new friction washer in accordance with the relevant Maintenance Manual (Heavy).
 - Clean the sealing surface of crankcase and gear cover.
 - Install the propeller gear box.
 - Remove locking pin of crankshaft in accordance with the relevant Maintenance Manual (Line).
- Restore aircraft to original operating configuration.
- Connect negative terminal of aircraft battery.
