SERVICE INFORMATION LETTER NO. SIL20A1-015

Rotax Alert Service Bulletin ASB-912-061R1
ATA-Code: 73-00

Replacement of the pressure side fuel hose at fuel pump part no. 893114 for ROTAX® Engine Type 912 (Series)

ATA System: 73-00-00 Fuel system

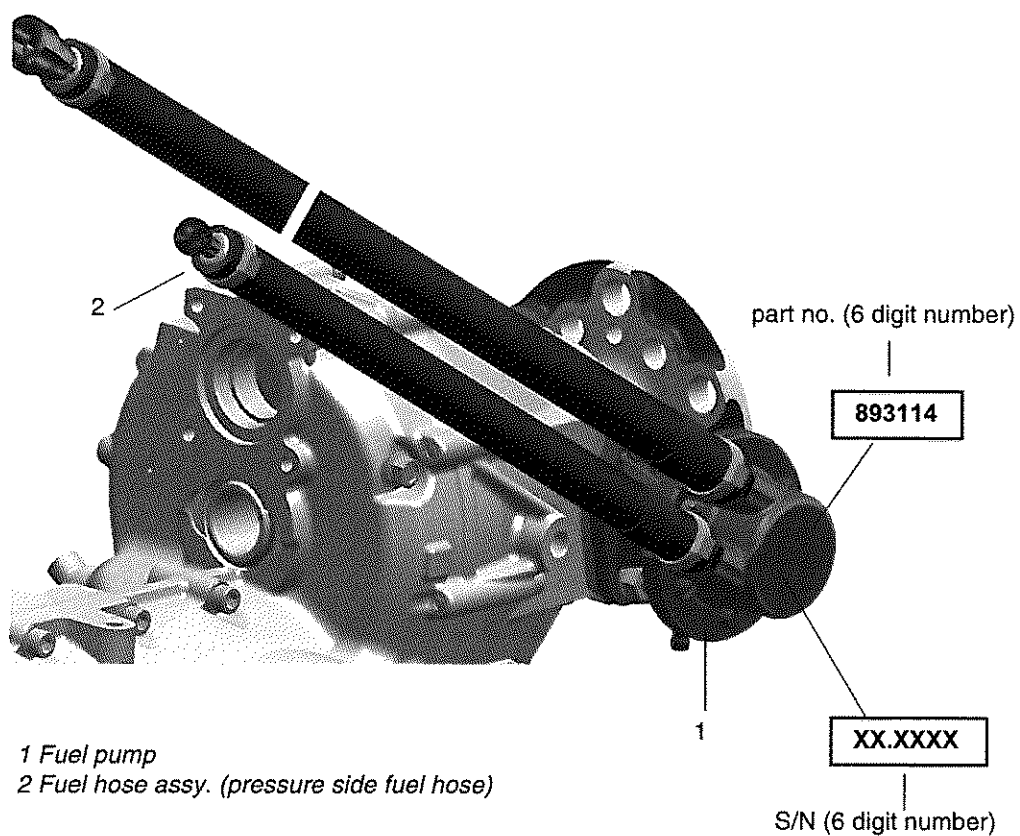
Fig. 1
Fuel pump

if they are equipped with the genuine ROTAX® fuel pump part no. 893114.
See Fig. 1

Due to variations in the manufacturing of the fuel hose, rubber particles may become detached.
These particles can interfere or suppress the fuel mixture in the carburetor. This disturbance in the
fuel mixture may lead to rough engine operation, engine misfire and can cause an engine shut
down.

- **Required before the next flight, the "replacement of the pressure side fuel hose" identified by the engine or fuel pump serial number (S/N) listed in section 1.1) must be conducted according to the following instructions in section 3.**

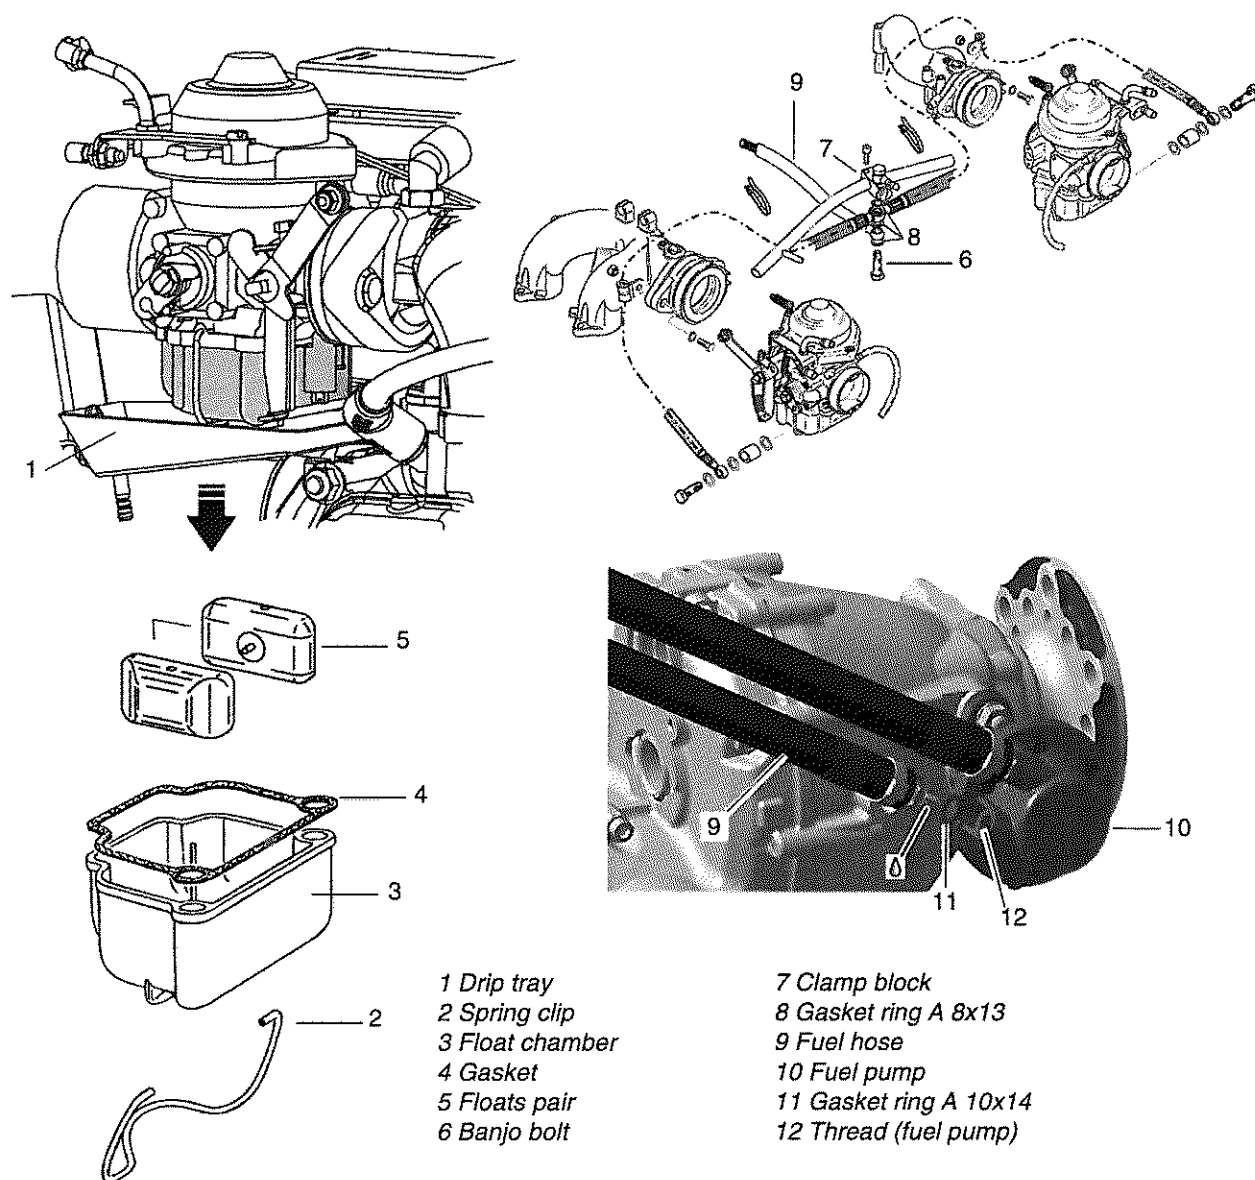
Fig. 2
Carburetor, Fuel pump

General Several carburetors have been found with contamination (dirt, remains of rubber from fuel lines etc.) in the float chamber.

This contamination could possibly cause a partial or complete blockage of the idle or main jet or of other ducts vital for operation, leading to poor performance or stoppage of engine.

In case of contaminations of the float chambers first the cause must be found and the relevant measures need to be taken. Possibly the whole fuel system including carburetors needs to be cleaned and checked.

Step	Procedure
1	Remove banjo bolt (6) from clamp block (7) together with 3 gasket rings (8).
2	Remove the fuel hose (9).
3	Remove the fuel hose (9) from the fuel pump (10) together with gasket ring (11).

Step	Procedure
1	Inspection of the thread (12) from the fuel pump and remove possible sealing materials.
2	Clean and degrease thread (12) of the fuel pump.

Step	Procedure
1	Install the new fuel hose (9) and new gasket ring A 10x14 (11) with LOCTITE 243 on the fuel pump. Tightening torque 10 Nm (90 in.lb).
2	Install fuel hose (9) and the banjo bolt (6) with new gasket ring (8) on the clamp block (7). Tightening torque of banjo bolt (6) 10 Nm (90 in.lb). Check that the fuel hose is not under strain or tension.

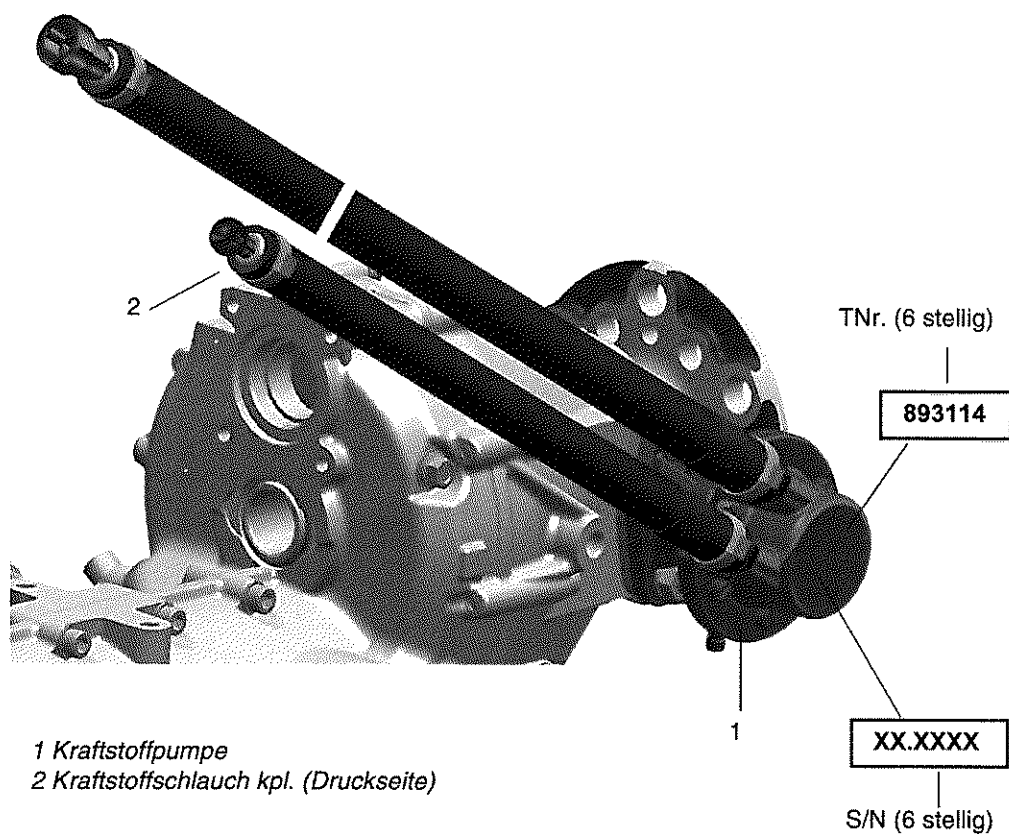
Bild 1
Kraftstoffpumpe

sofern diese mit der ORIGINAL ROTAX® Kraftstoffpumpe TNr. 893114 ausgestattet sind.
Siehe dazu Bild 1.

Aufgrund von Abweichungen im Herstellprozess des betroffenen Kraftstoffschlauchs, kann es zu Ablösungen von Gummipartikeln kommen. Diese Partikel können die Gemischaufbereitung im Vergaser behindern bzw. unterbinden. Diese Störung in der Gemischbildung führt unter Umständen zu rauen Motorlauf, Motoraussetzer und eventuell zum Motorstillstand.

- Vor dem nächsten Flug, ist ein „Austausch des druckseitigen Kraftstoffschlauches“, der unter Betreff 1.1 angeführten Motoren bzw. Kraftstoffpumpen, gemäß nachstehender Arbeitsanweisung Kap. 3 durchzuführen.

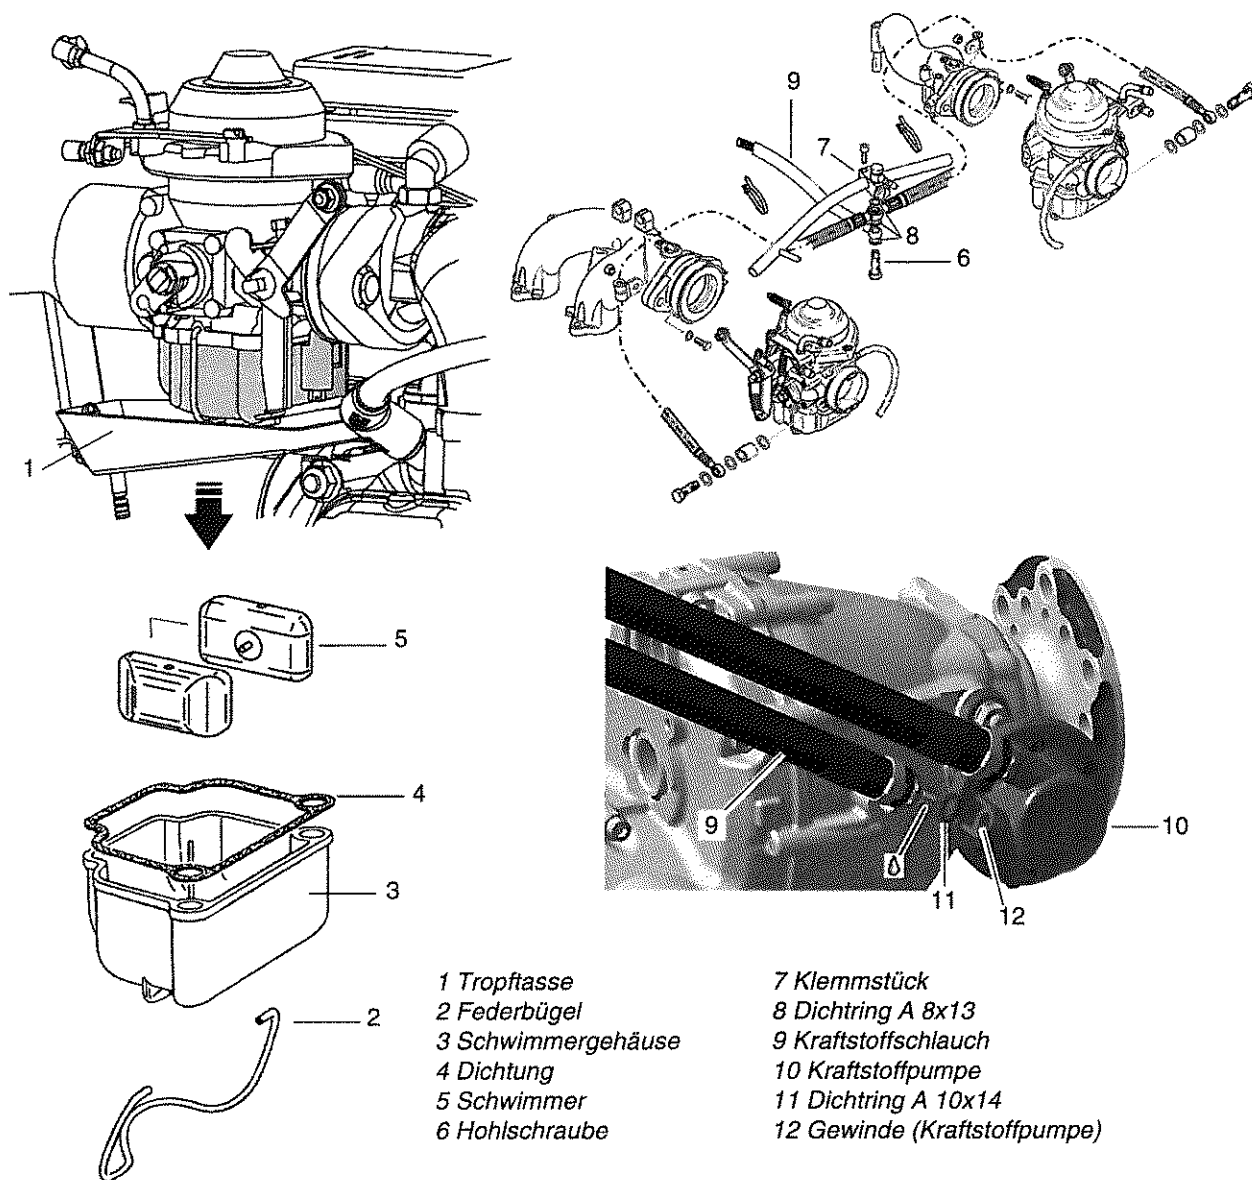
Bild 2

Allgemein Bei einigen Vergasern wurde Verunreinigung (Schmutz, Gummireste von Benzinleitungen usw.) in der Schwimmerkammer festgestellt.

Diese Ablagerungen können möglicherweise Leerlauf- oder Hauptdüse, sowie andere funktionswichtige Kanäle teilweise oder komplett blockieren und zu Leistungsverlust oder Motorstopp führen.

Bei Verunreinigung der Schwimmergehäuse ist zuerst die Ursache festzustellen und die notwendigen Abstellmaßnahmen einzuleiten. Möglicherweise ist das gesamte Kraftstoffsystem inkl. Vergaser zu reinigen und zu kontrollieren.

Schritt	Vorgehen
1	Untere Hohlschraube (6) vom Klemmstück (7) abschrauben und samt 3 Dichtungen (8) entfernen.
2	Kraftstoffschlauch (9) abnehmen.
3	Kraftstoffschlauch (9) von der Kraftstoffpumpe (10) samt Dichtring (11) abschrauben.

Schritt	Vorgehen
1	Anschlussgewinde (12) der Kraftstoffpumpe kontrollieren und gegebenenfalls Dichtungsreste entfernen.
2	Anschlussgewinde (12) der Kraftstoffpumpe entsprechend reinigen und entfetten.

Schritt	Vorgehen
1	An der Kraftstoffpumpe den neuen Kraftstoffschlauch (9) mit LOCTITE 243 sichern und mit einem neuen Dichtring A 10x14 (11) montieren. Anzugsdrehmoment 10 Nm.
2	Kraftstoffschlauch (9) spannungsfrei verlegen und mit Hohlschraube (6) samt neuen Dichtringen (8) am Klemmstück (7) montieren. Anzugsdrehmoment der Hohlschraube (6) 10 Nm.
