## **SERVICE INFORMATION LETTER NO. SIL20A1-019**

FAA Airworthiness Directive 2013-07-12; and  
EASA EAD 2013-0117-E  
ATA-Code: 72-00

### Checking of the cylinder head assy. (2/3) for ROTAX® Engine Type 912 and 914 (Series)

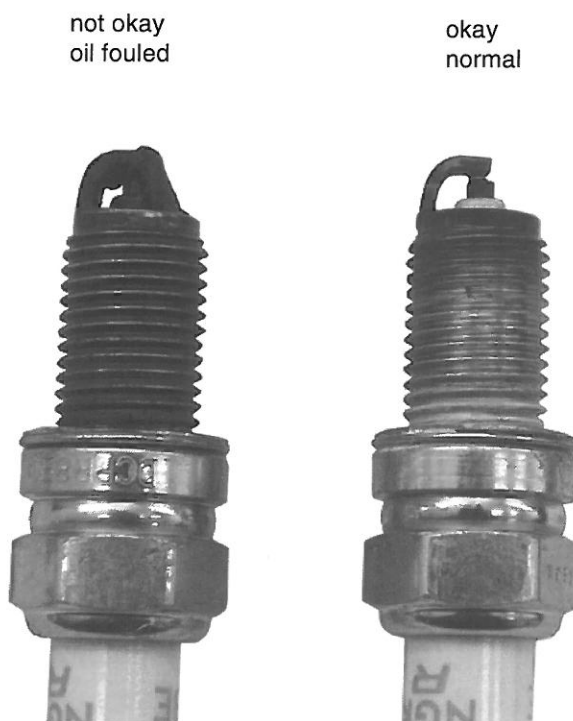
*Fig. 1  
spark plug*

Unusual deposits (excessive carbon or oil) on the spark plugs are an indication of a defective cylinder head which must be replaced. Figure 1 shows comparison between a used spark plug in normal condition and one that is not.

If excessive deposits (oil or carbon) are found on the spark plugs the cylinder head must be replaced in accordance with the relevant Maintenance Manual (Heavy) and any relevant aircraft manufacturer instructions.
