## SERVICE INFORMATION LETTER NO. SIL20A1-020

All DA20-A1 aircraft.

Rotax Mandatory Service Bulletin SB-912-065  
ATA-Code 73-00

## Periodic inspection of the float buoyancy for ROTAX® Engine Type 912 and 914 (Series)

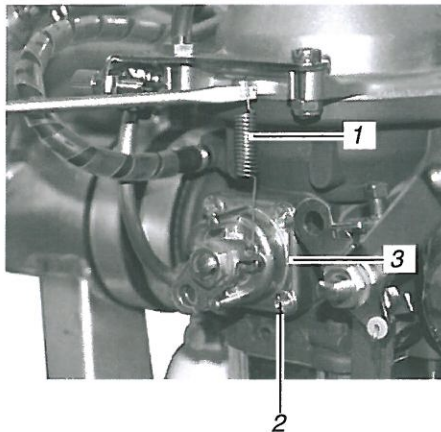
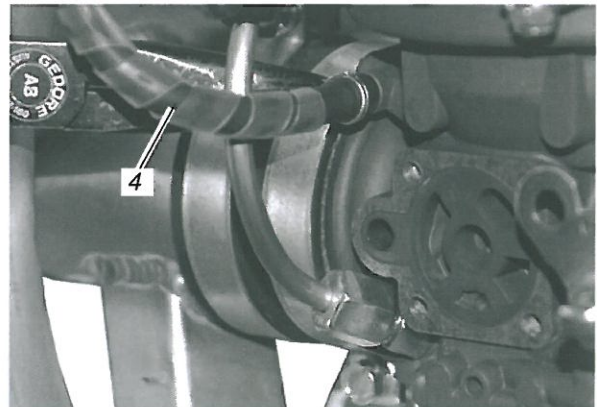
Fig. 1

- 1 Return spring
- 2 Philips head screw M4x14
- 3 Rotary valve housing
- 4 Air vent line

Step	Procedure
1	Bring the float chamber to horizontal position (level the aircraft, if necessary).
2	Let the engine idle for approx. 1-2 minutes. <b>NOTE:</b> Switch OFF the electric fuel pump (at 912 Series).
3	Remove the return spring (1).
4	Remove 4 Philips head screws (2). Remove rotary valve housing (3) with the gasket.
5	Remove the air vent line (4). Installed steel line must not be removed.

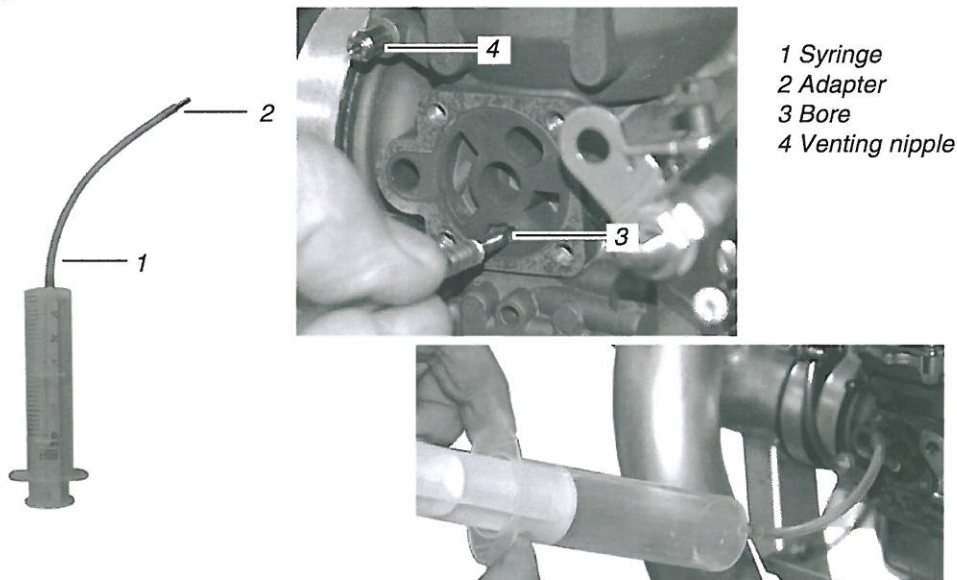
Fig. 2

During the following inspection of the volume, carefully fill the float chamber with a syringe until the fuel leaks from the venting nipple (4). This process should take about 5 seconds. Record capacity before the filling operation. The capacity can be determined by reading the scale of the syringe.

Step	Procedure
1	Fill the syringe (1) with 40-50 ml amount of fuel.
2	Connect syringe with the adapter (2) using a transparent fuel hose
3	Fuel hose and adapter must be free from air bubbles.
4	Insert the adapter (2) in the lower bore (3) of the rotary valve. Ensure a firm fit.

Step	Procedure
5	Fill the float chamber until the fuel leaks from the venting nipple.
6	Determine the volume.
7	Perform the same inspection on the second carburetor.
8	The results of the measurement must be documented in the maintenance records.

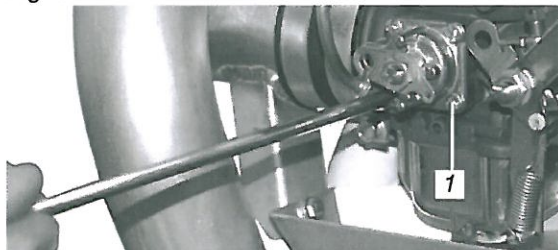
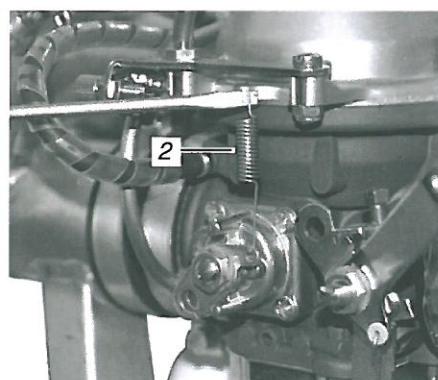
Fig. 3

1 Philips head screw 4x14  
2 Return spring

Step	Procedure
1	Install the venting line.
2	Install rotary valve with new gasket.
3	Secure first 2 threads of the Philips head screw 4x14 (1) with LOCTITE 243.
4	Install the return spring (2).

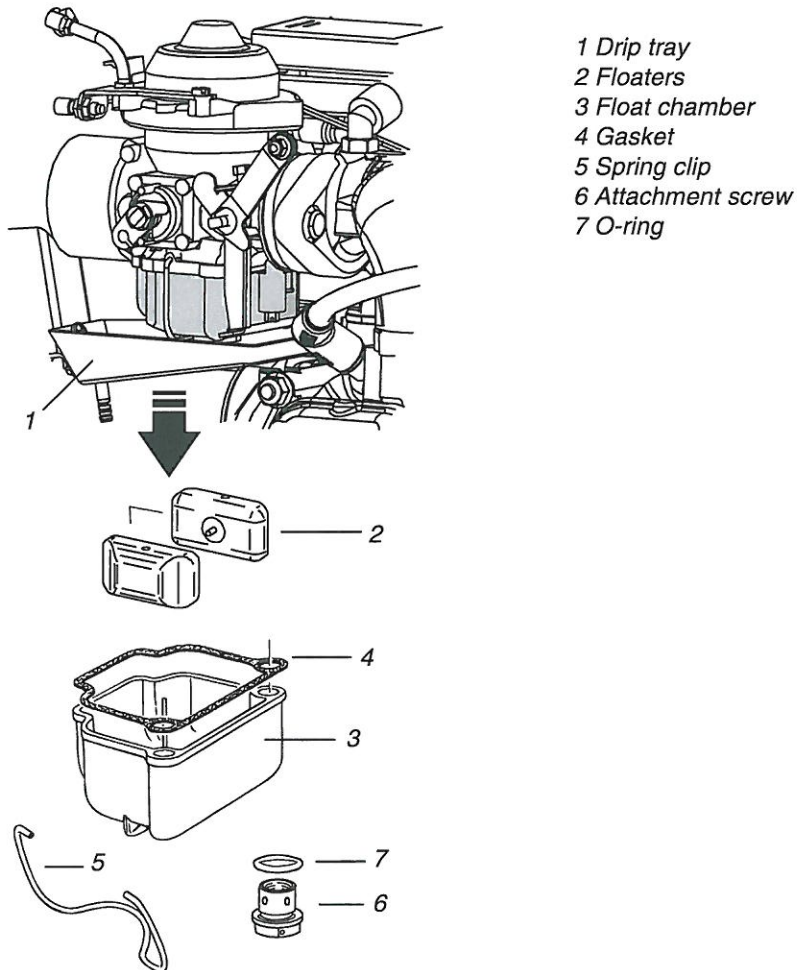
Fig. 4

If the inspection of float buoyancy section 3.5) shows a deviation, a weight control according to section 3.2) is necessary. For this purpose, as described below, the float chamber has to be dismantled.

Step	Procedure
1	Let the floaters dry for 1-2 minutes. Only balance dry floaters.
2	Check the weight of all affected floaters using a calibrated balance (1). Measuring tolerance of the balance: max. 0.1 grams.
3	The results of the measurement must be documented in the maintenance records. The max. allowable weight (of both floaters) is 7 grams.

Step	Procedure
1	Remove drip tray (1).
2	Visual inspection of the carburetor and its mechanical actuation.
3	Remove spring clip (5) and for ROTAX 914 Series loosen cap screw (6) and remove with O-ring (7).
4	Remove float chamber (3), gasket (4) and the two floaters (2)

Renew all floaters which exceed the max. weight.

Step	Procedure
1	Remove the gasket (4) from the float chamber and for ROTAX 914 Series remove the O-ring (7).
2	Install float chamber (3) with gasket (4) and the both floaters (2).
3	Close spring clip (5) or for ROTAX 914 Series install the attachment screw (6) including O-Ring (7).
4	Install drip tray (1).
