# SERVICE BULLETIN

**Service Bulletin No.:** DAC1-11-01 Rev 3

**Title:** Chinese Placards and Markings

- 1. ATA Code:** 1120, 1130
- 2. Effectivity:** All DA20-C1 Aircraft for operation under Chinese registry.
- 3. General:** This Service Bulletin introduces the Chinese Placards and Markings and describes modifications required for aircraft operating under Chinese registry. Revision 1 of this Service Bulletin changes the compliance. Revision 2 of this Service Bulletin adds spinning allowance. Revision 3 of this Service Bulletin corrects parts numbers in Figure 2 (Sheet 2).

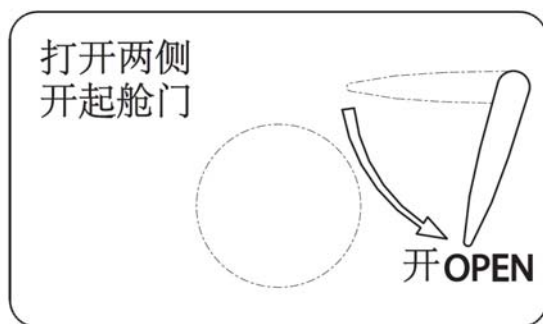
P/N 22-1130-05-12  
Placard, Baggage

最大行李重量-44磅(20公斤)  
MAX.BAGGAGE-44lbs(20kg)  
仅限行李网内 ONLY WITH BAGGAGENET
