# SERVICE BULLETIN

**Service Bulletin No.:** DAC1-24-01 Rev 1

**Title:** Generator Lower Attaching Bolt Replacement

**2. Effectivity:** DA20-C1 aircraft from S/N C0001 to S/N C0031.

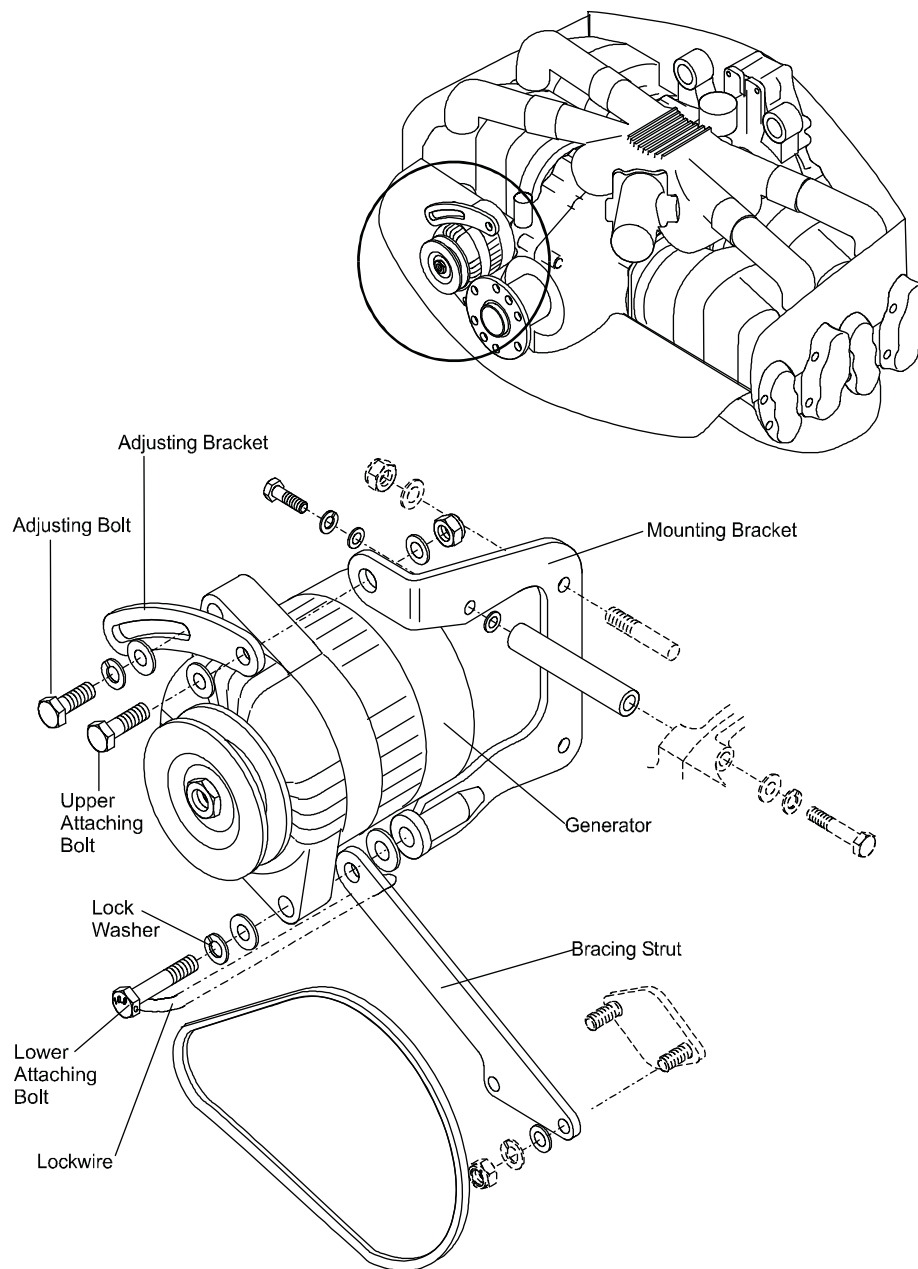
Figure 1: Generator Installation

**3. General:** Excessive generator belt tension can result in fatigue failure of the generator lower attaching bolt. This Service Bulletin (SB) addresses replacement of the existing bolt with a higher strength bolt.

10.6 Lockwire lower attaching bolt to bracing strut as per figure 1.NA.
