# SERVICE BULLETIN

**Service Bulletin No.:** DAC1-24-04 Rev 3

**Title:** Generator Attachment Bracket

- 1. ATA Code:** 2430
- 2. Effectivity:** DA20-C1 aircraft up to and including S/N C0099
- 3. General:** This Service Bulletin addresses replacement of Generator Mounting Bracket P/N 22-2411-10-00 on early serial numbered DA20-C1 aircraft. There have been several cases of cracks developing in the generator mounting bracket. This Service Bulletin supersedes Service Bulletin DCA1-24-04 Rev 2 Issued March 1, 2006.
- 4. Compliance:** Compliance with this Service Bulletin is recommended.
- 5. Approval:** Engineering data referenced or contained in this Service Bulletin is approved as part of the type design.
- 6. Labour:** Approximately 1 1/2 hours will be required to accomplish this Service Bulletin.

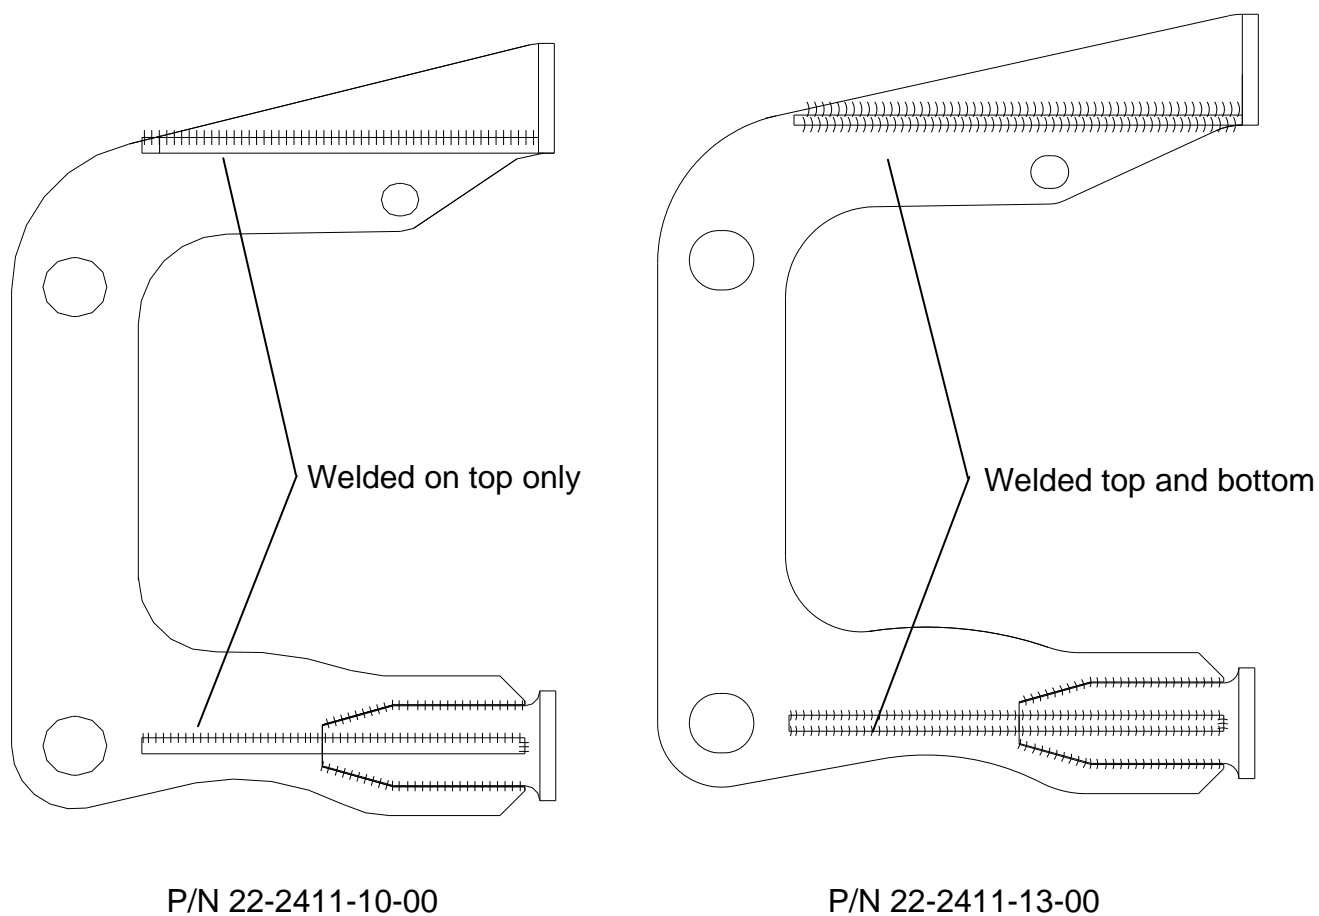
**Figure 1 - Mounting Bracket - Looking Inboard**

- 10.1** Identify which generator mounting bracket is installed. Figure 1 shows identifying details of generator mounting brackets P/N 22-2411-10-00 and P/N 22-2411-13-00.

If P/N 22-2411-10-00 is installed, installation of kit DAC1-24-04-AMK0 is required. Perform steps **10.2** through **10.22** of this Service Bulletin.

If P/N 22-2411-13-00 is installed, no replacement is required. Make a log book entry that this Service Bulletin has been incorporated.
