SERVICE BULLETIN

Service Bulletin No.: DAC1-24-07 Rev 0

Title: Replacement of Battery/EPU Relay Contactor

1. **ATA Code:** 2430
2. **Effectively:** DA20-C1 aircraft, Serial Numbers C0001 through C0625.
3. **General:** This Service Bulletin addresses the installation of the LAMAR relay contactor for the Battery and/or EPU relay in the DA20-C1.
4. **Compliance:** Compliance with this Service Bulletin is Optional.
5. **Approval:** Engineering data referenced or contained in this Service Bulletin is approved as part of the type design.
6. **Labor** For aircraft serial numbers C0001 to C0148 and C0150 approximately 2 hours will be required to accomplish the replacement of either battery or EPU relay contactor.

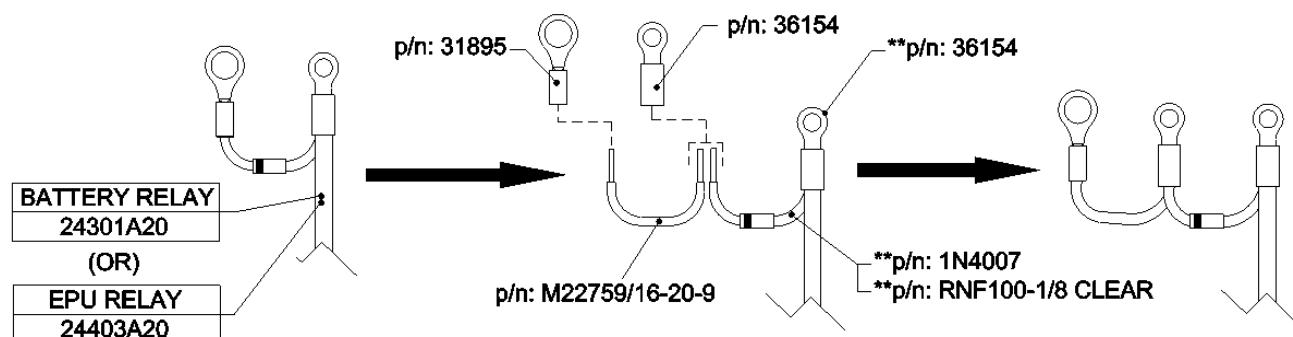
Figure 6: Relay Wire Modification

****PARTS ONLY REQUIRED IF EXISTING DIODE IS DAMAGED OR SHORT.**

- 10.2.3 Disconnect the wires from the relay(s) being replaced. Remove the hardware and the relay(s) from the aircraft.
- 10.2.4 Rework the battery and/or EPU relay wires as shown in Figure 6.
