SERVICE BULLETIN

Service Bulletin No.: DAC1-27-02 Rev 1 Date Issued: 01 February 2008

Title: Flap Actuator Bushing Retainers Page: 1 of 3

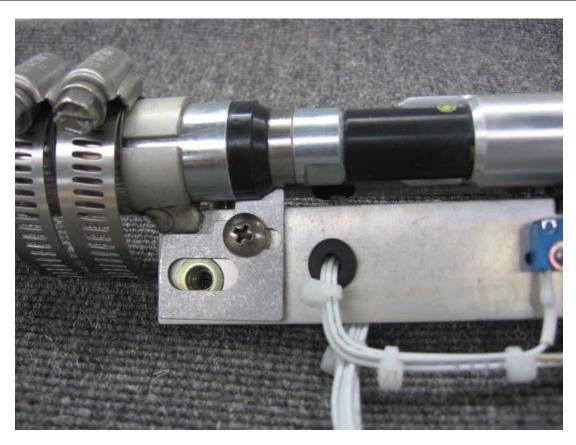
Figure 2 – Seal Retainer Installation (Switch Cover Removed for Clarity)

3. General: This service bulletin allows installation of a pair of retainer clips to

prevent dislodging of the shaft seal on the flap actuator.

Install the flap actuator seal retainers with AN526C832R8 screws and

AN960-8 washers into rivet nuts. Locate seal retainers so that they barely touch the seal on the flap actuator as shown in Figure 2.
