**MANDATORY SERVICE BULLETIN NO. DAC1-27-03 REV. 1**

SUPERSEDES DAC1-27-03 REV. 0

Type: DA 20-C1

Diamond Aircraft Industries  
**MANDATORY SERVICE BULLETIN**  
Model DA 20-C1

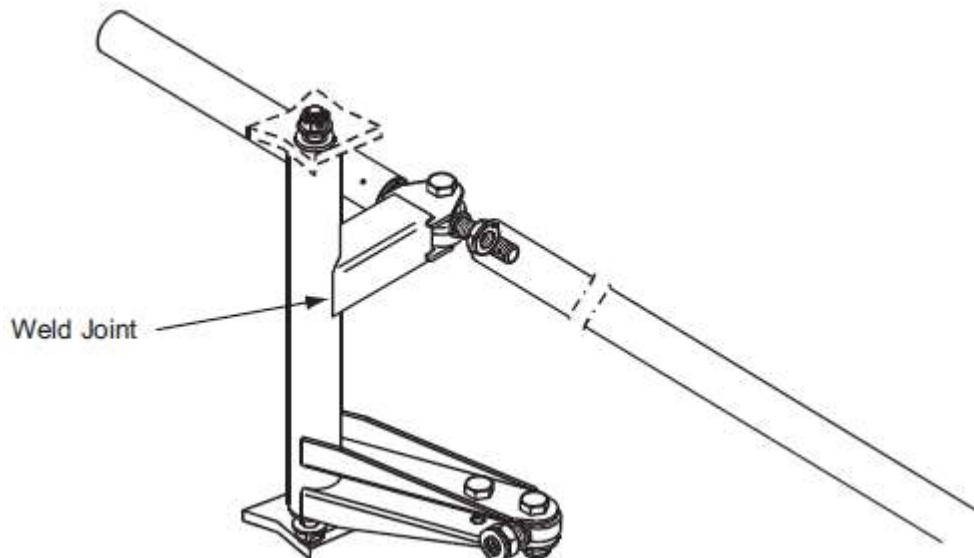
There have been two reported failures of the flap bellcrank (P/N 22-2750-03-00), one at 4500 TTSN and one at 7500 TTSN. This type of failure could result in the flaps being disconnected from the actuator (not asymmetrical) which could result in an unsafe condition for certain phases of flight. Pending further investigation, it is not known if this failure is the result of overload (e.g. flap deployment above  $V_{fe}$ ) or other causes, (e.g. fatigue, corrosion, defect). As a precaution, we are requesting all operators of DA 20 aircraft to inspect the bellcrank in accordance with this MSB.

1. Remove the center fuselage access panels.
2. Inspect the flap bellcrank, P/N 22-2750-03-00 around the weld connecting the top arm to the bellcrank tube. Look for cracks or any other damage in the area around the weld joint from both sides of the bellcrank. In particular, look thoroughly on the left hand side at the base of the vertical weld. Refer to Figure 1.
3. Move the flaps into the landing position in order to inspect fully around the weld joint.

Figure 1 - flap bellcrank.

4. If a crack or damage is found, replace the bellcrank with P/N 22-2750-04-00.
5. Report any findings to Diamond Aircraft Industries Inc. via e-mail at [custsupp@diamondair.com](mailto:custsupp@diamondair.com).
6. Re-install center fuselage access panels.
