Model DA20-C1

# **OPTIONAL SERVICE BULLETIN NO. DAC1-27-05 REV. 0**

Replacement of the flap actuator and installation of the flap resistor assembly.

ATA code: 27-50

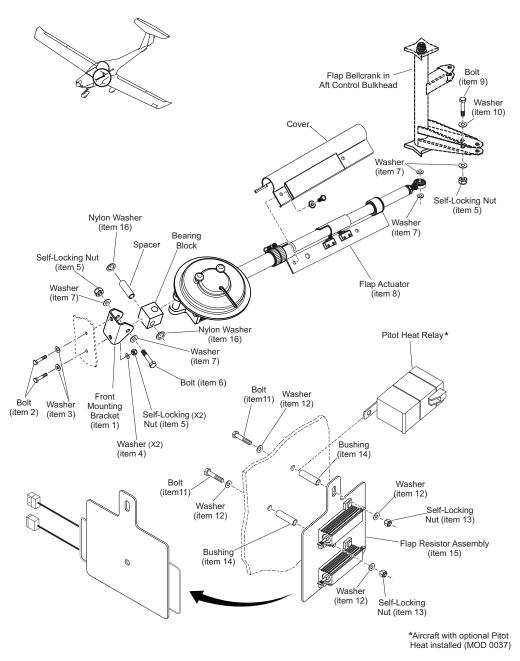
Figure 2. Flap actuator and flap resistor assembly installation

This service bulletin addresses the replacement of the P/N 22-2750-10-00 flap actuator by P/N 22-2750-10-00\_01 and the installation of flap resistor assembly due to the flap actuator motor obsolescence.

- 3. Remove the bearing block from the existing flap actuator. Refer to Figure 2.
- 4. Remove the bolts, washers and self-locking nuts which attach the front mounting bracket. Refer to Figure 2.

- 7. Install the bolts (item 2), washers (items 3 and 4), and self-locking nuts (item 5) which attach the new front mounting bracket (item 1) to the aircraft. Refer to Figure 2.

- 8. Apply Aero Shell Grease 22 to the spacer and the bearing block. Refer to Figure 2.
- 9. Install the bearing block to the new flap actuator (item 8). Refer to Figure 2.

- 10. Put the spacer and the nylon washers (item 16) in the installation position. Refer to Figure 2.
- 11. Install the bolt (item 6), washers (item 7), and the self-locking nut (item 5) which attach the new flap actuator (item 8) to the to the new front mounting bracket (item 1). Refer to Figure 2.

- 14. Install the bolts (item 11), washers (item 12), bushings (item 14) and self-locking nuts (item 13) which attach the flap resistor assembly (item 15), and the two relays (three relays if MOD 0037 Pitot Heat installed). Refer to Figures 1 and 2.
