SERVICE BULLETIN

Service Bulletin No.: DAC1-32-03 Rev 0

Title: NLG Wheel and Fork Installation
Improvements

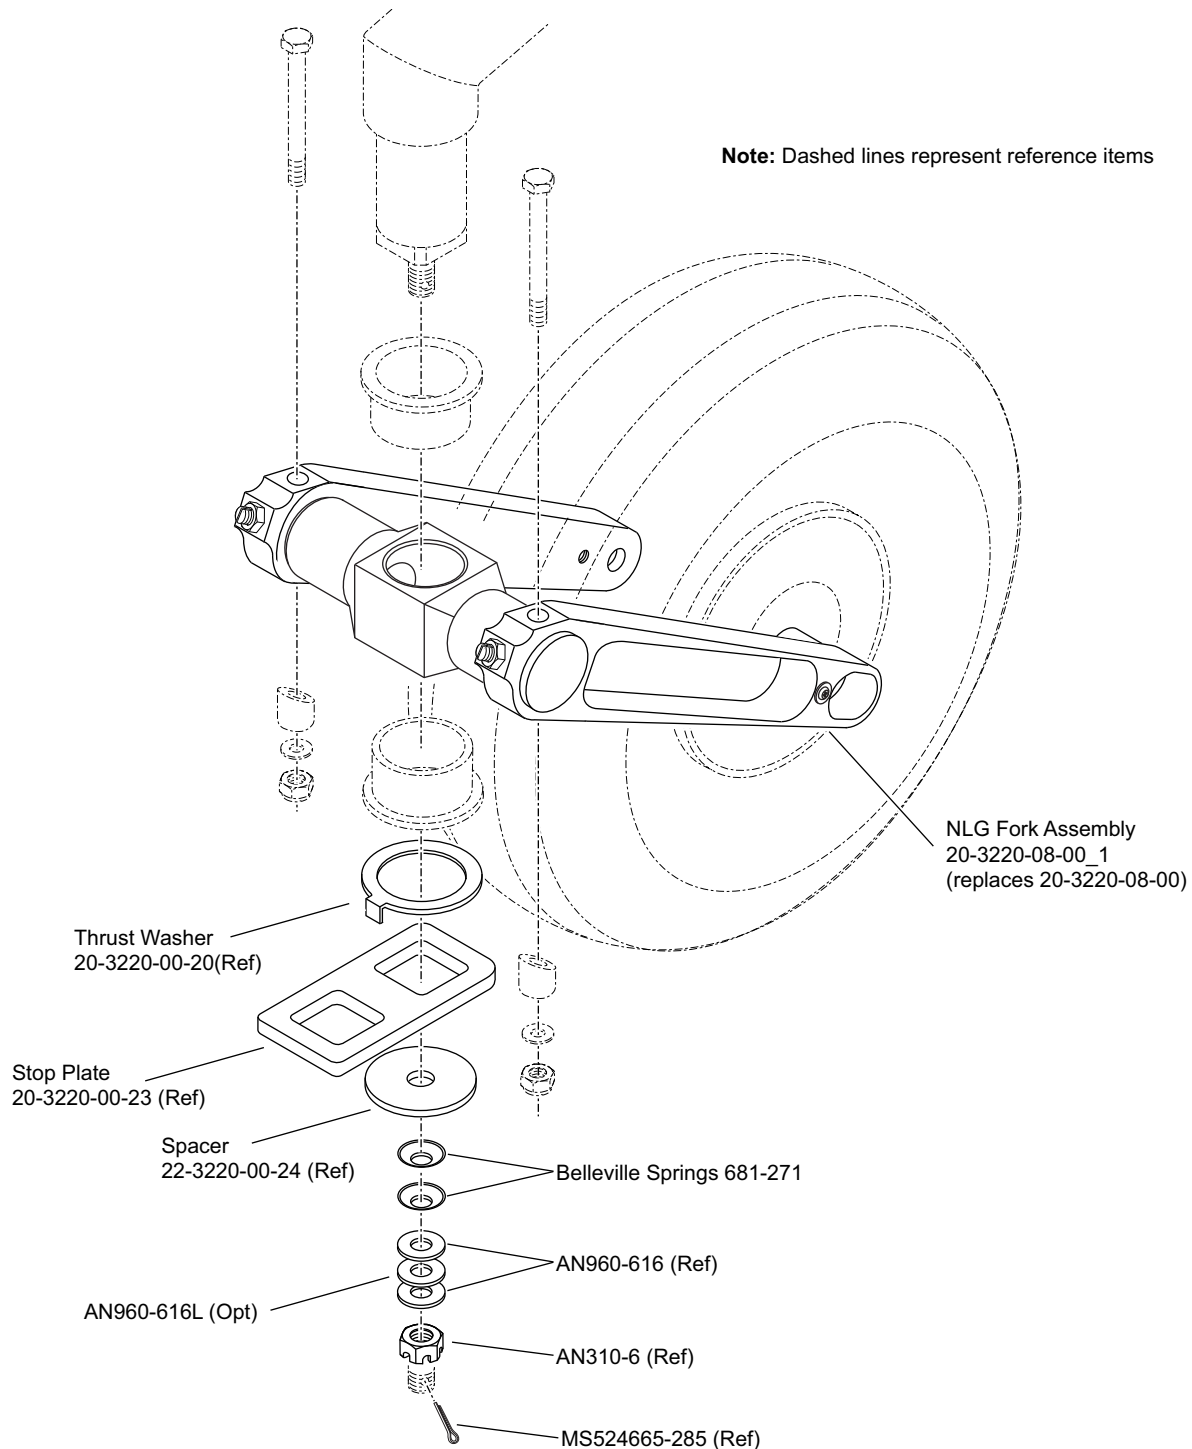
Figure 1 - NLG Fork Assembly Installation

-
- 1. ATA Code:** 3220
- 2. Effectivity:** DA20-C1 aircraft - Serial Number C0001 to C0581.
- 3. General:** This service bulletin provides information regarding updated NLG gear fork and wheel assembly installations to reduce wear and maintain steering friction. It has been noted during service that there has been issues with frequent adjustment of the steering friction and nose wheel shimmy. Incorporation of this service bulletin will assist with these issues.
- 4. Compliance:** This service bulletin is highly Recommended and should be completed at the next 200 hour or annual inspection.
- 5. Approval:** Engineering data referenced or contained in this service bulletin is approved as part of the type design.
- 6. Labour:** Approximate time required to complete the Service Bulletin - 1 hour.

- 10.1** Either jack the aircraft in accordance with DA20-C1 AMM Chapter 07-10-00 or raise the front of the aircraft in accordance with Chapter 32-40-00 3.B. (page 203).
- 10.2** Remove the wheel in accordance with AMM Chapter 32-40-00
- 10.3** Remove NLG fork (A new fork assembly is available see SIL20C1-005) .
- 10.4** Inspect all parts for condition checking for cracks, corrosion and wear. New hardware should be used where necessary (For the fork assembly please review SIL20C1-005).
- 10.5** Apply CRC Corrosion Shell to the stud. Do not contaminate the tire or fiberglass.
- 10.6** Lubricate the axle in accordance with AMM Chapter 12-20-00.
- 10.7** Re install the fork using the new Belleville springs with the rest of the parts listed in figure 1. Be sure that both springs are installed with the open side facing up as per figure 1.
