SERVICE BULLETIN

Service Bulletin No.: DAC1-33-02 Rev 1

Date Issued: 11 Aug 2011

Title: Installation of Replacement EL Flood Light

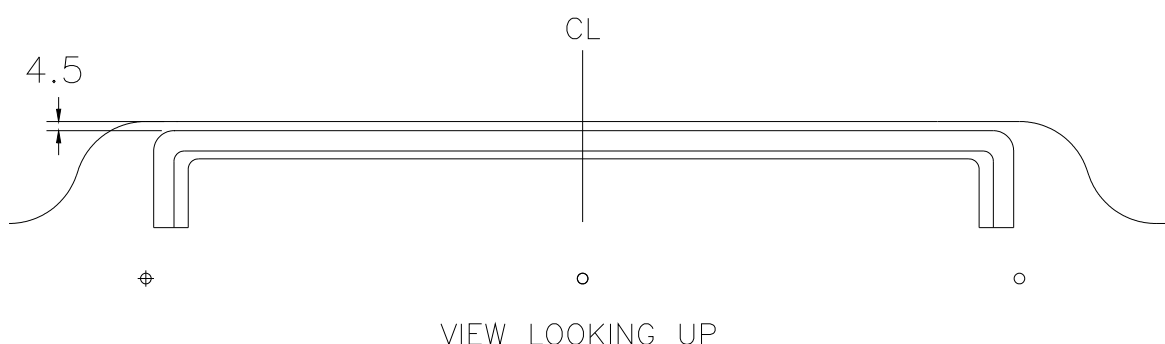
Figure 1: Installation of Bracket to the Instrument Panel Cover

- 1. ATA Code:** 3300
- 2. Effectively:** DA20-C1 aircraft serial numbers C0001 through C0508 (aircraft equipped with the Flood Light option).
- 3. General:** This Service Bulletin addresses replacing the UV250-1 flood inverter and lamp, which are no longer available, with a better Electro Luminescent (EL) Flood light inverter and lamp.
- 4. Compliance:** Compliance with this Service Bulletin is optional to the serial numbers provided above.
- 5. Approval:** Engineering data referenced or contained in this Service Bulletin is approved as part of the type design.
- 6. Labor:** Approximately 3 hours will be required to accomplish this service bulletin.

- 10.9** Remove peel ply from composite flood lamp bracket.
- 10.10** Mix resin (reference NOTES located under Table 1), wet all bonding surfaces with mixed resin prior to paste application.
- 10.11** Mix paste as per Table 1. Apply paste to fill flood lamp attaching screw holes.
- 10.12** Apply paste to bonding surface on flood lamp bracket.
- 10.13** Bond bracket onto Instrument panel cover (See Figure 1).

10.14 Clean excess paste and ensure that flood lamp groove is free of paste.

10.15 Cure and post-cure. Pre-curing temperature: 20-25 °C (68-77 °F), Time: 24 hours. Post-curing temperature: 60 °C (140 °F), Time: 15 hours
