MANDATORY SERVICE BULLETIN NO. DAC1-34-10 REV. 0

Type: DA 20-C1

GTx345 and TAS605 audio lines.

ATA code: 34-50

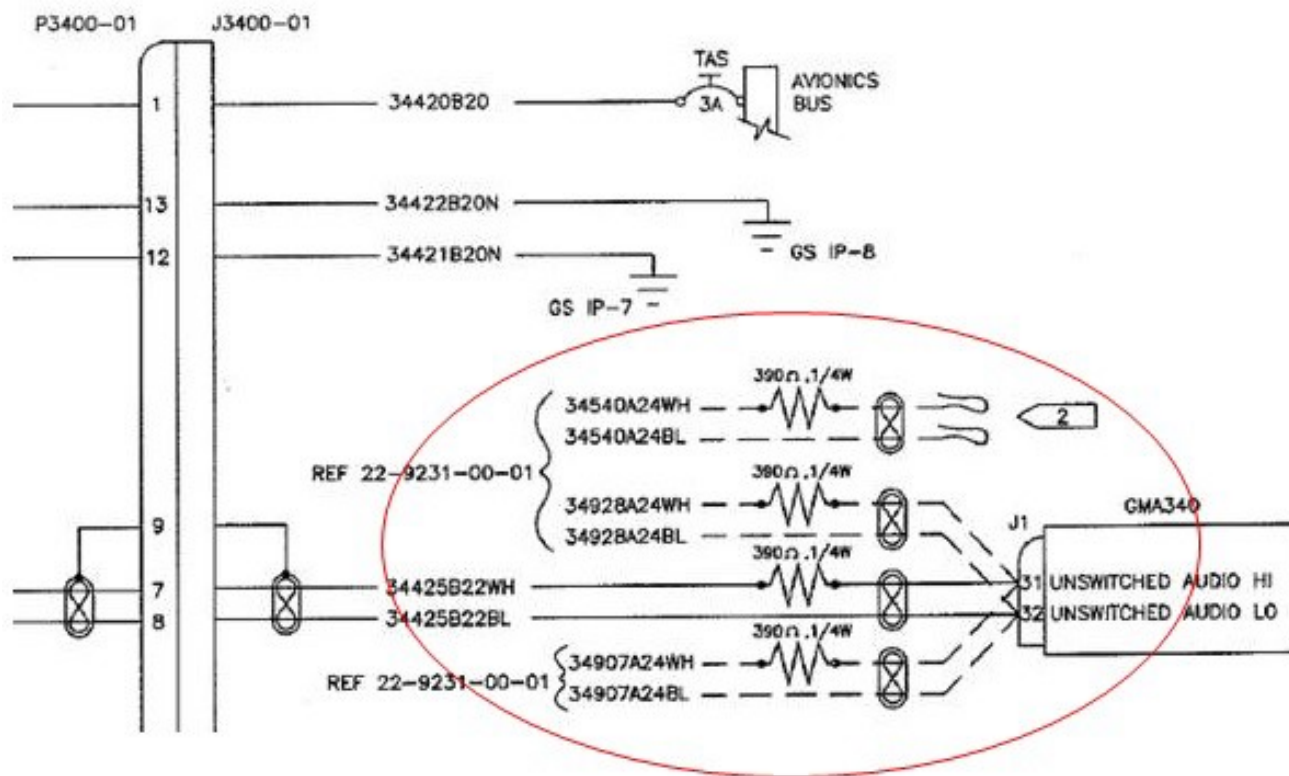
Figure 1. Reference for steps 4 to 6.

The affected aircraft by this service bulletin have had their GTx345 audio line capped and stowed instead of the TAS605 audio line. This service bulletin provides instructions for correcting the wiring.

1. Pull the battery circuit breaker located on the right side of the instrument panel.
2. Disconnect the aircraft battery as per AMM Chapter 24-31-00.
3. Remove the instrument panel cover as per AMM Chapter 25-10-00.
4. Cut all the tie wraps along the top of the avionic radio rack behind the GMA340 audio panel.
5. Pull out all four resistors and associated splices from the wire bundle. See Figure 1, below.
6. Locate wire 34425B22 and remove splice between the white wire and the resistor. Take care to keep the resistor leg as long as possible.
