SERVICE BULLETIN

Service Bulletin No.: DA C1-52-01 Rev. 0

Title: Canopy, Seal Replacement

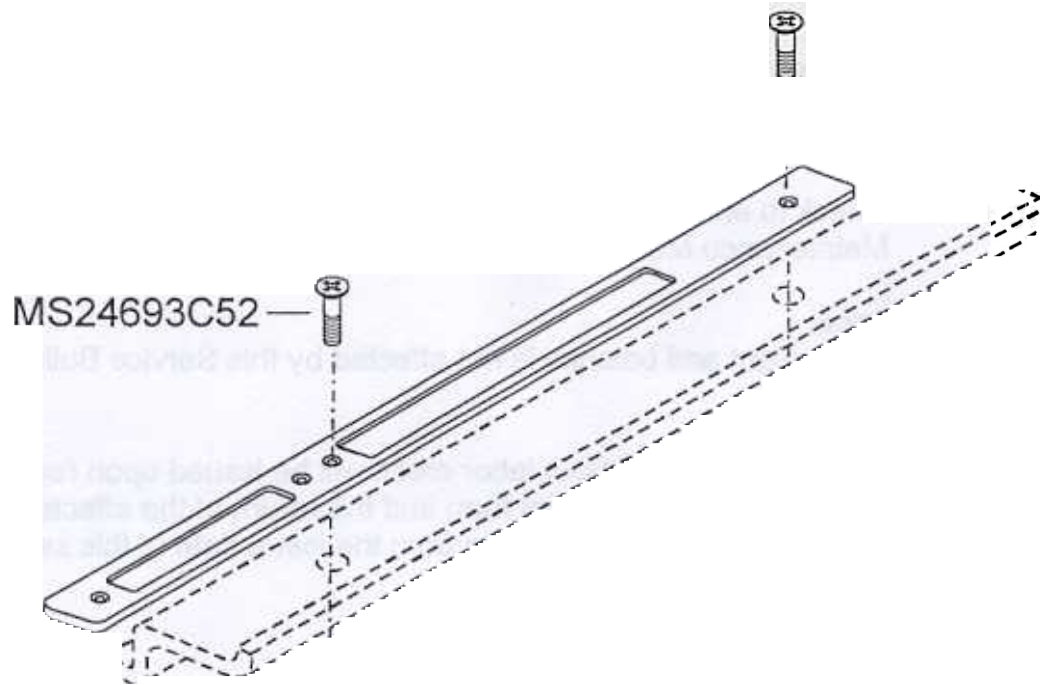
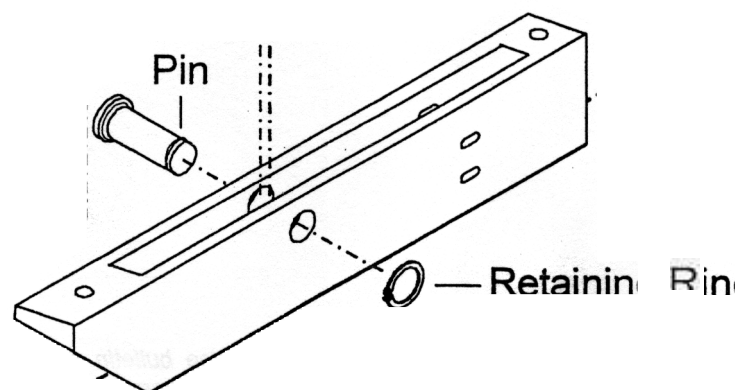
- 1. ATA Code:** 5200
- 2. Effectivity:** DA20-C1 aircraft S/N C0001 to C0055
- 3. General:** This service bulletin addresses air leaks between the canopy and fuselage resulting from slight flexing of the canopy in flight. The existing canopy seal is replaced by a thicker seal, the canopy latching forces are adjusted and the ball bearing in the latch strike is replaced by a solid bearing assembly.
- 4. Compliance:** Compliance with this service bulletin is optional.
- 5. Approval:** Engineering data referenced or contained in this service bulletin is approved as part of the type design.

Replace canopy strike ball bearing: (see figure 1)

- Remove canopy strikes by removing two MS24693C52 screws on each strike. Retain any composite shims between strike assembly and fuselage.
- Remove retaining ring and pin from each strike.
- Remove and discard ball bearing, but retain nylon washers.
- Install washers, solid bearing (22-5600-63-00), pin, and retaining ring on each strike.
- Reinstall canopy strike using MS24693C52 screws. Ensure that any shims are reinstalled in correct orientation.

If required, adjust latching forces using the shims. Remove strike assembly (as in 10.5 above). To reduce force, remove material from shims by sanding. To increase force, add a shim, or replace shim with thicker one. It may be necessary to taper shims slightly to ensure that the strike is parallel to the latch hook when the canopy is closed. When force is within acceptable limits, install MS24693C52 screws with Loctite 222.
