# ALERT SERVICE BULLETIN

**Service Bulletin No.:** DAC1-61-00A Rev 1

**Title:** Spinner Rear Bulkhead Replacement

**2. Effectivity:** Diamond Aircraft Model DA 20 C1 aircraft Serial Numbers C0001 to C0108 with a Sensenich model W69EK-63 propeller installed (3/8" attachment bolts).  
This Service Bulletin is not applicable if Diamond Aircraft Service Bulletin DAC1-61-01 has been complied with.

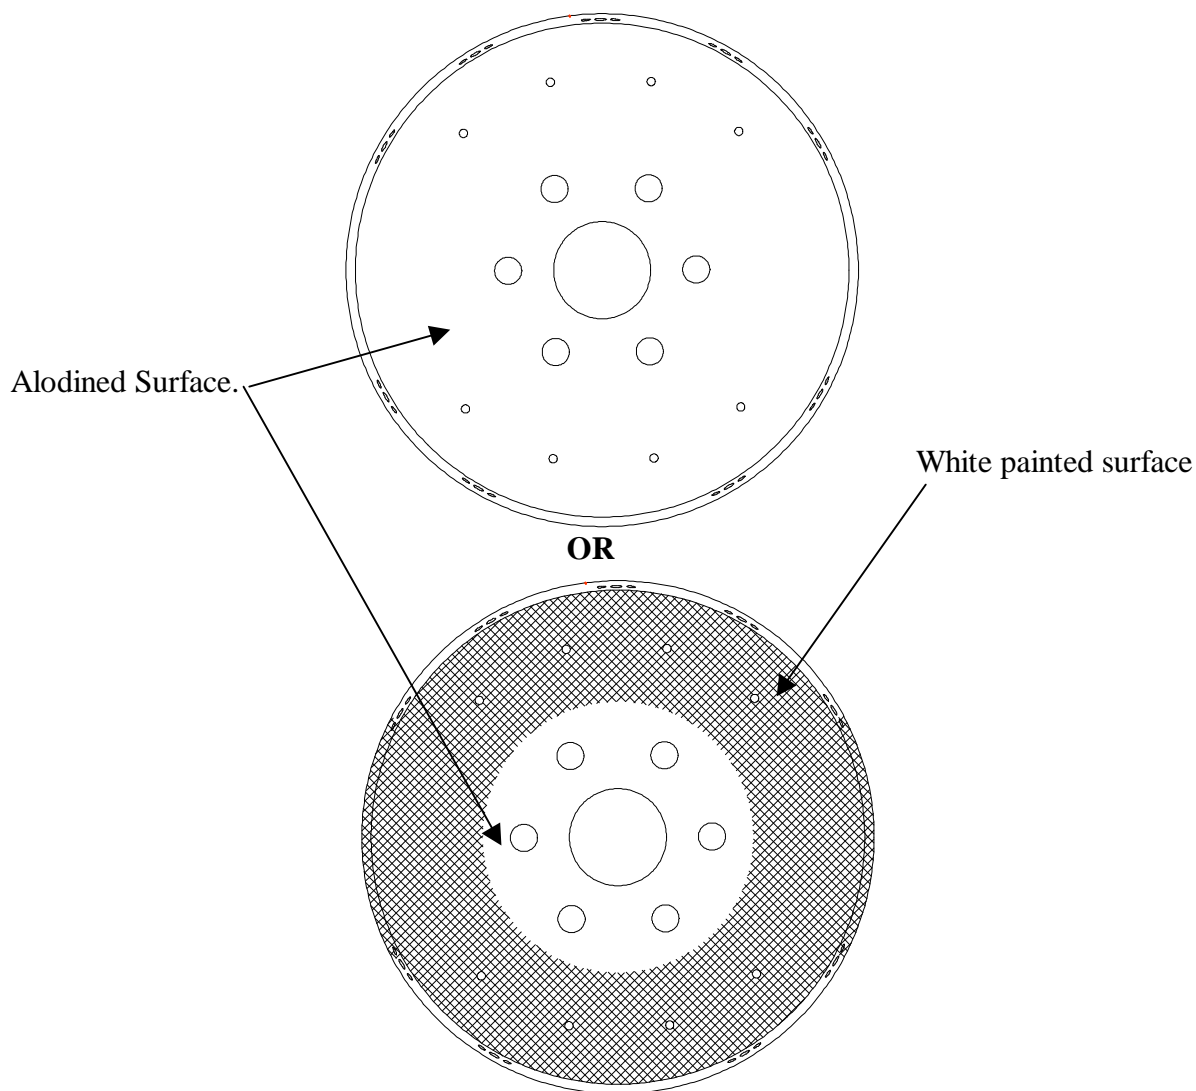
**Figure 1**  
**Obsolete Rear Spinner Bulkheads**  
**Looking Forward**

**10.2.** Examine aft face of rear spinner bulkhead. If the aft face of the bulkhead does not have white paint on it where the propeller extension attaches to the propeller or is completely bare of paint, **PART 2 must be accomplished**. If positive identification can not be determined the propeller must be removed and rear bulkhead identified. **Refer to figure 1.**

- 10.11. Install the painted rear spinner backing plate, propeller and spinner following the instructions provided in the Sensenich Installation Operation & Maintenance Manual.
- 10.12. Following the propeller installation the attachment bolt torque must be checked following the Sensenich Installation Operation & Maintenance Manual.
- 10.13. **Upon completion, the assembly should have a completely painted rear bulkhead with no shim.**

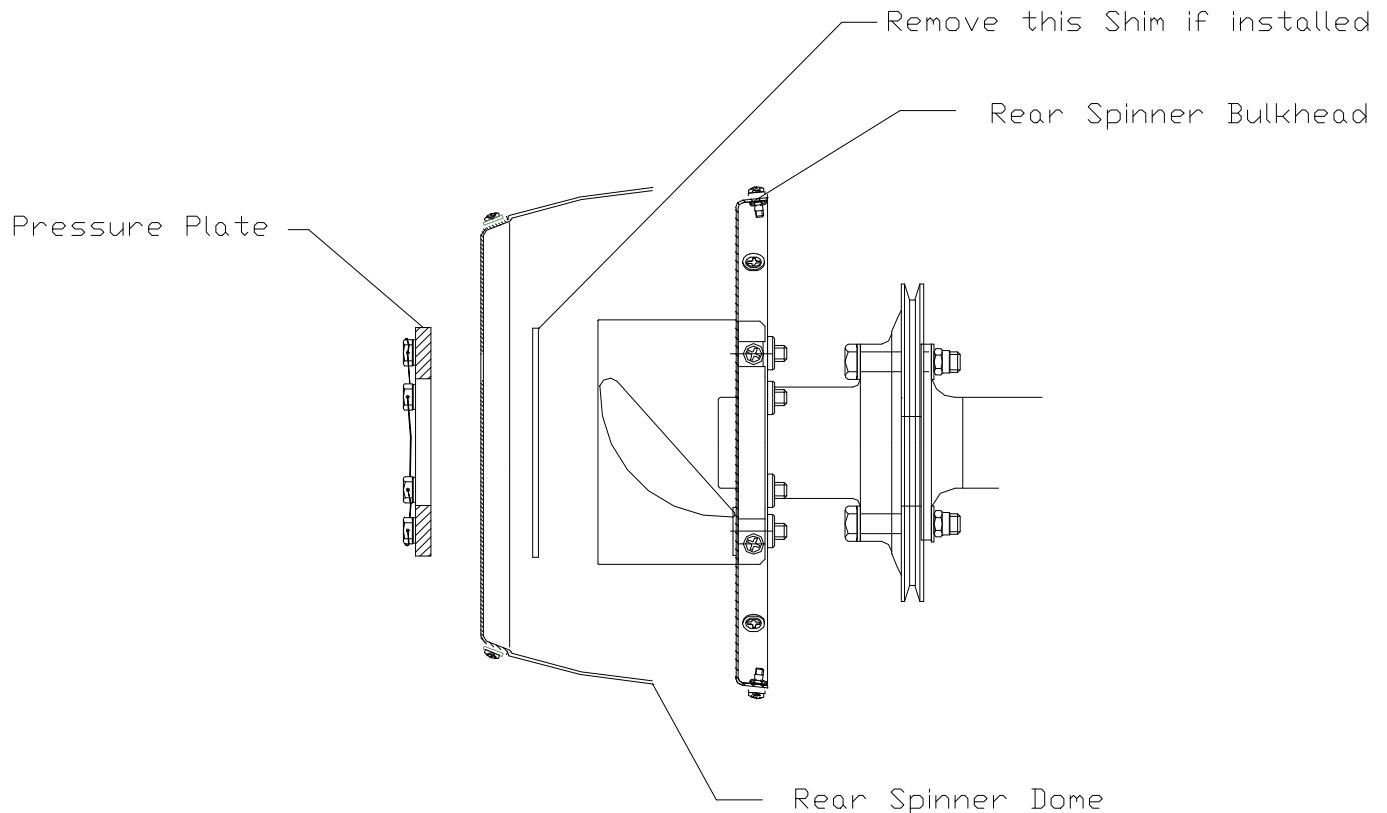
**Figure 2**  
**Side View**

**10.4.** Remove the forward spinner dome. Look to see if there is an anodized aluminum shim located between the rear spinner dome and the propeller, this shim if present has a smaller center hole than the hub bore in the propeller and will be readily visible. If the shim is present it must be removed. Follow the procedure in Part 2 with the exception of the rear spinner bulkhead replacement. **Refer to figure 2.**
