**OPTIONAL SERVICE BULLETIN NO. DAC1-61-01 REV. 5**

SUPERSEDES DAC1-61-01 REV. 4

Type: DA 20-C1

This service bulletin addresses the Sensenich propeller installation.

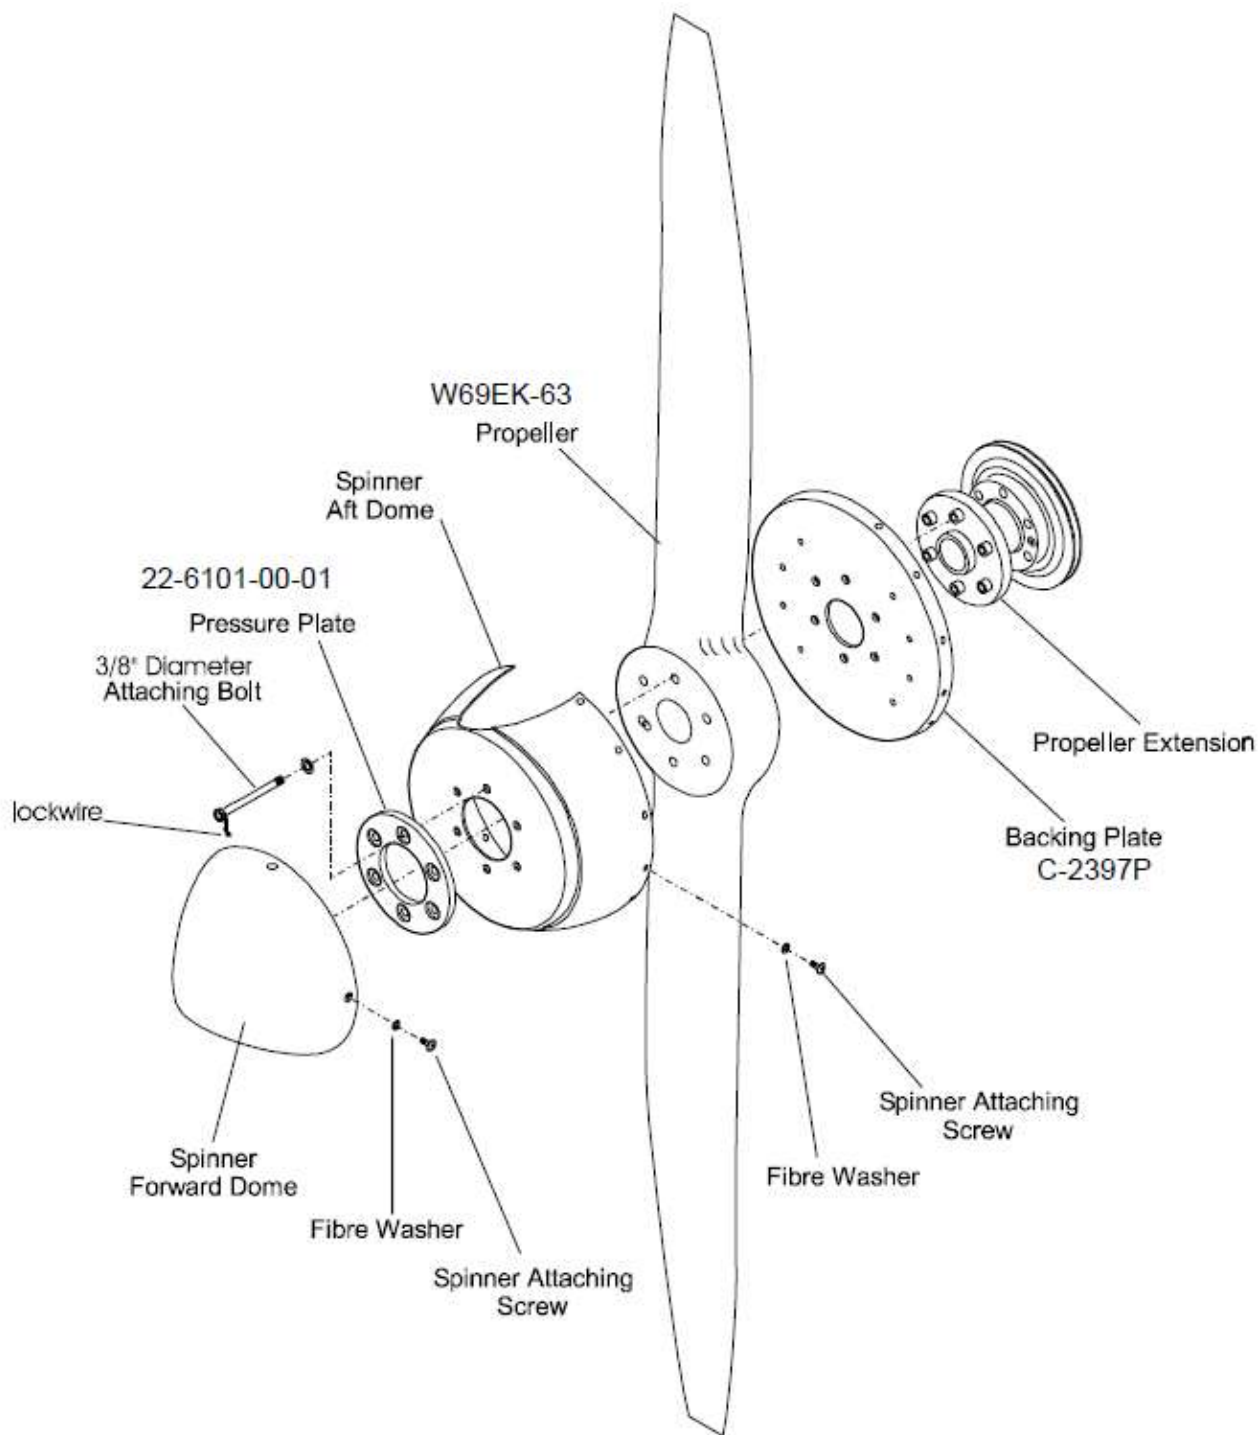
Figure 1. Original configuration, Sensenich W69EK-63, 3/8" diameter attachment bolts.

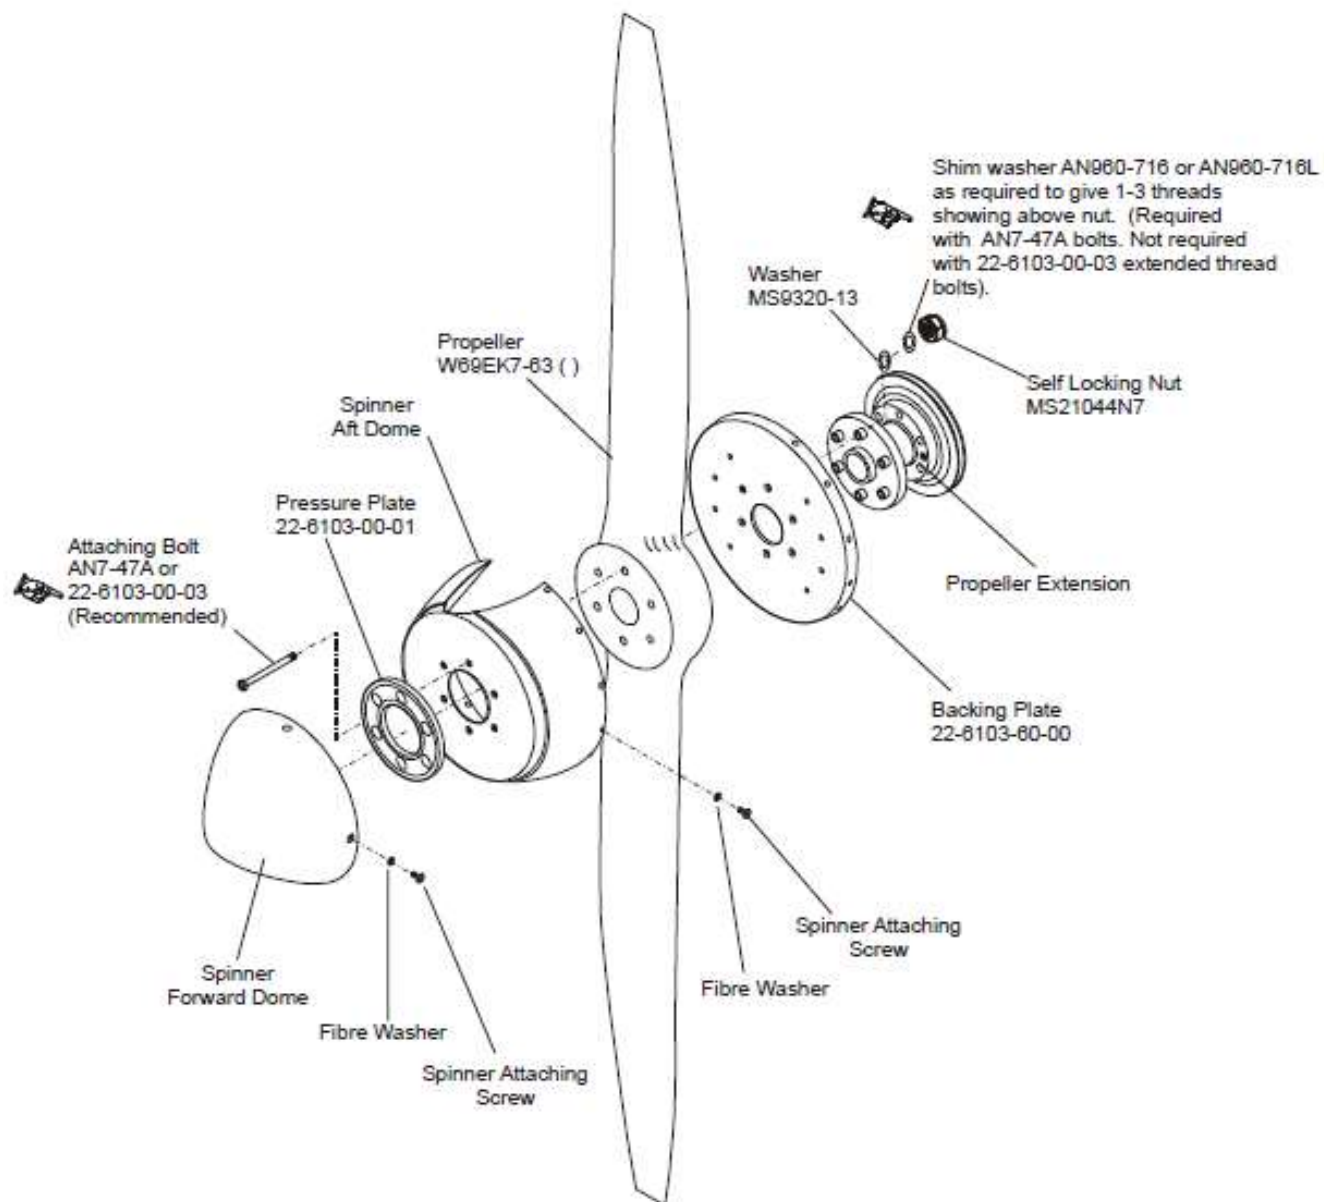
Figure 2. Recommended configuration, Sensenich W69EK-63, W69EK-63G, or W69EK7-63GM, 7/16" diameter attachment bolts.

PART I – Describes the procedure for the replacement of propellers with 3/8" attachment bolts with a propeller that uses 7/16" diameter attachment bolts (AN7-47A or 22-6103-00-03). This installation increases the clamping force of the propeller and allows torque inspection without the removal of the forward spinner dome.

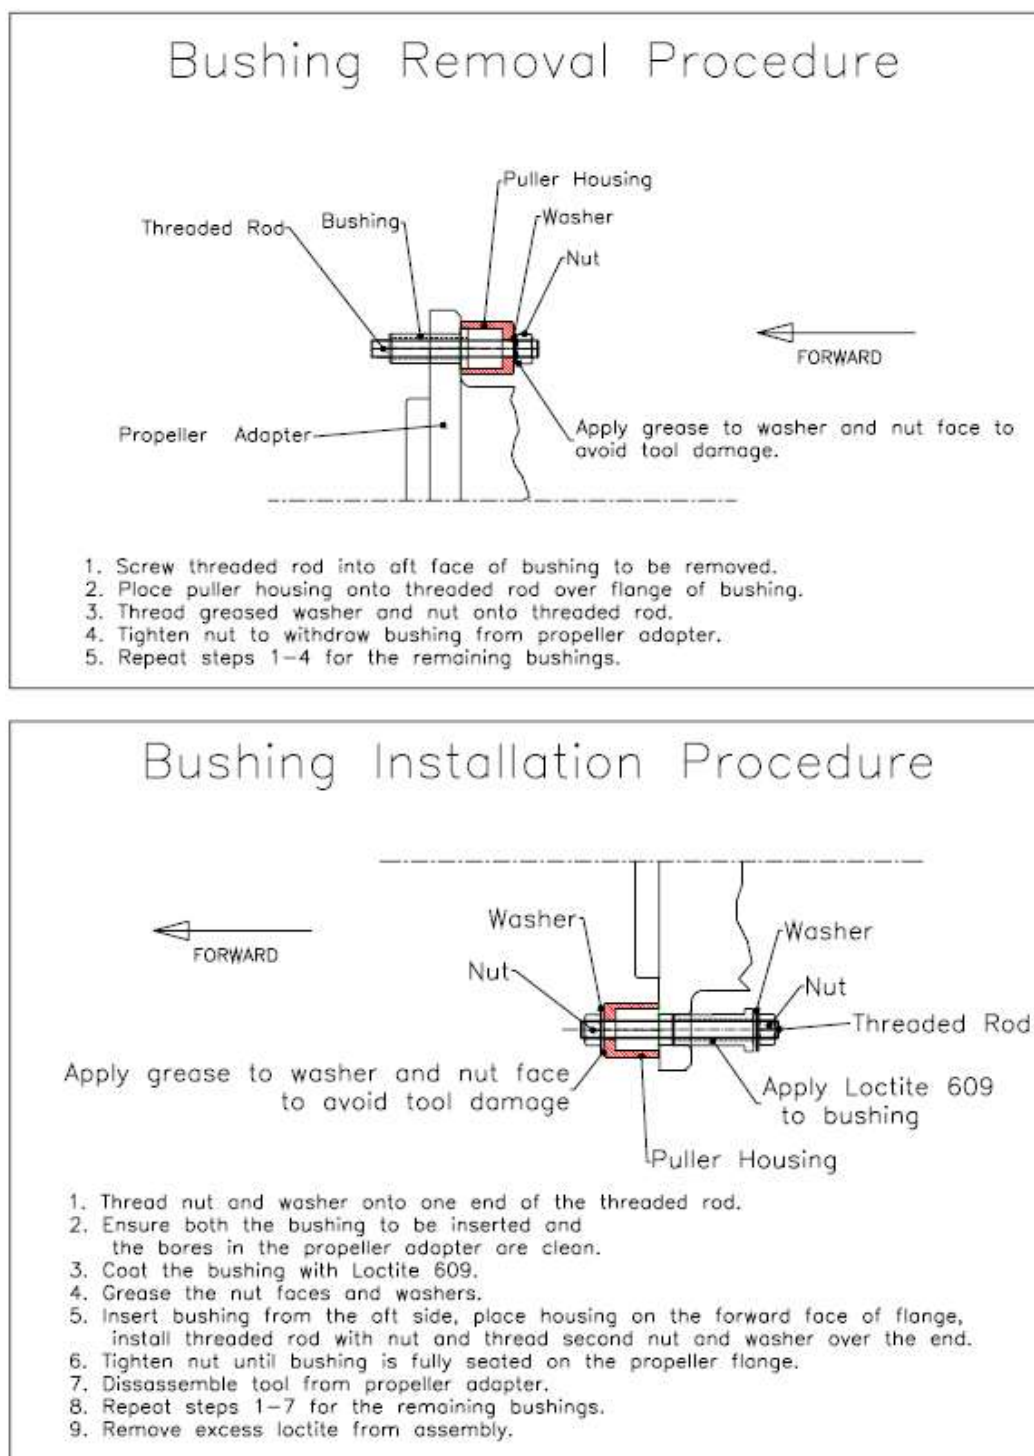
Figure 3. Instructions for step 6.

1. Remove the engine cowlings.
2. Remove the W69EK-63 propeller as per AMM Chapter 61.
3. Remove the six bushings in the propeller flange using the removal/installation tool as shown in Figure 3.

5. Clean the bushings and the bushing bores in the propeller adapter using denatured alcohol.
6. Install the new (7/16" ID) bushings into bores using Loctite 609 and the installation tool. Ensure the bushings are completely pulled through the propeller flange. Reference Figure 3 for these instructions.
