MANDATORY SERVICE BULLETIN

Service Bulletin No.: DAC1-73-05 Rev 1

Title: Operating Limitations with Altitude
Compensating Fuel Systems

2. Effectivity: DA20-C1 aircraft, serial number C0001 to C0473 if equipped with altitude compensating fuel systems (TCM IO-240-B13B and B17B engine configurations).

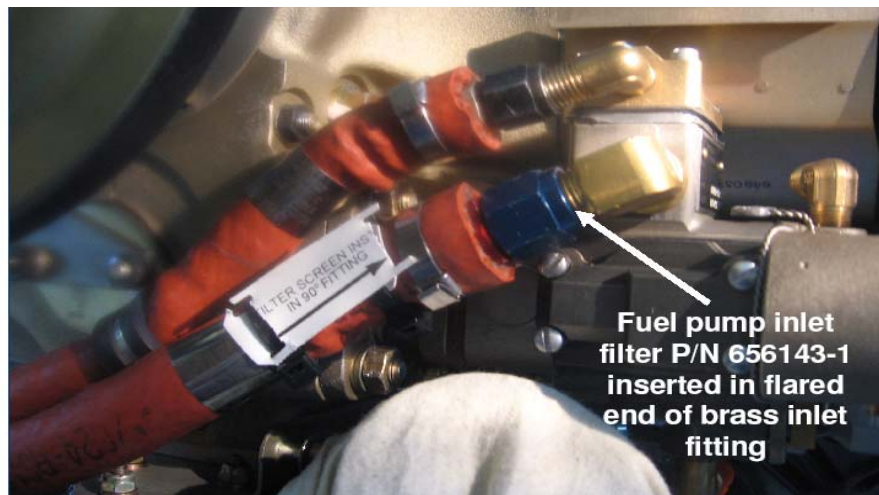
- 10.3** If the mechanical fuel pump (part number 649368-49A1, 649368-52A1, or 649368-54A1) has been replaced since delivery; remove mechanical fuel pump inlet hose to verify installation of filter element P/N 656143-1. If filter is installed, do not remove (see photo of installed filter). Inspect filter with a flashlight and mirror for contaminants. If clean, then reattach fuel line. If required, remove and clean filter. Reinstall filter and reattach fuel line.

- 10.3.1** If filter is not installed, install P/N 656143-1. Ref SIL05-6
