SERVICE BULLETIN

Service Bulletin No.: DAC1-74-01 Rev 1

Title: Ignition Harness Routing

- 1. ATA Code:** 7420
- 2. Effectivity:** Diamond Aircraft Model DA20-C1 serial numbers C0001 to C0150.
- 3. General:**

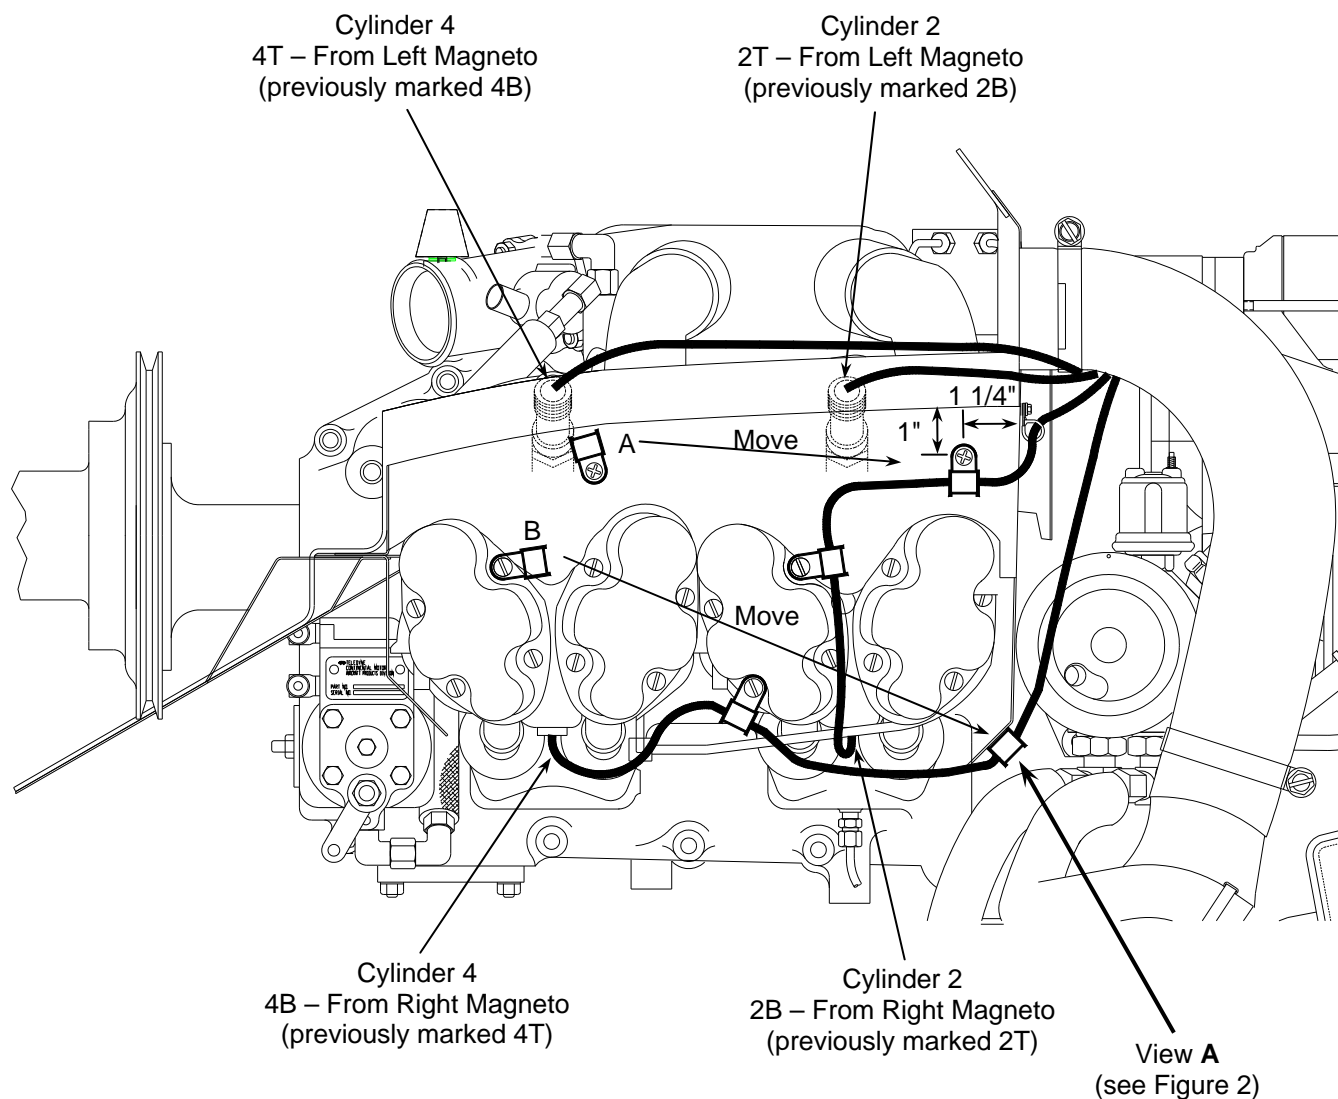
Figure 1
Left Side View of Engine

This Service Bulletin addresses a revision of the ignition harness wiring to improve cold weather starting. The revision consists of switching the spark plug leads from the top to the bottom.

- 10. Accomplishment Instructions:**
 - 10.1** Remove the cable ties from the harness behind the engine (Note the locations).
 - 10.2** Drill a #10 diameter hole 1¼" forward and 1" down from the upper aft corner of the right baffle (Figure 1).

- 10.3** Remove the cable clamp from location A and move it to the new location (Figure 1). The hole at location A may be sealed with suitable hardware or left open (cooling air leakage is negligible).

- 10.8** Reroute the harness as shown in Figure 1 and 3.

10.9 Re-identify the ignition harness as shown in Figures 1 and 3. Vibropeen an "X" through the original lead location and on an adjacent nut flat Vibropeen the new location. As an example, number 4 cylinder upper lead will be changed from "4T" to "4B".
