SERVICE BULLETIN

Service Bulletin No.: DAC1-76-01 Rev 1 Date Issued: 29 January, 1999

Title: Mixture Cable Kinking Page: 1 of 3

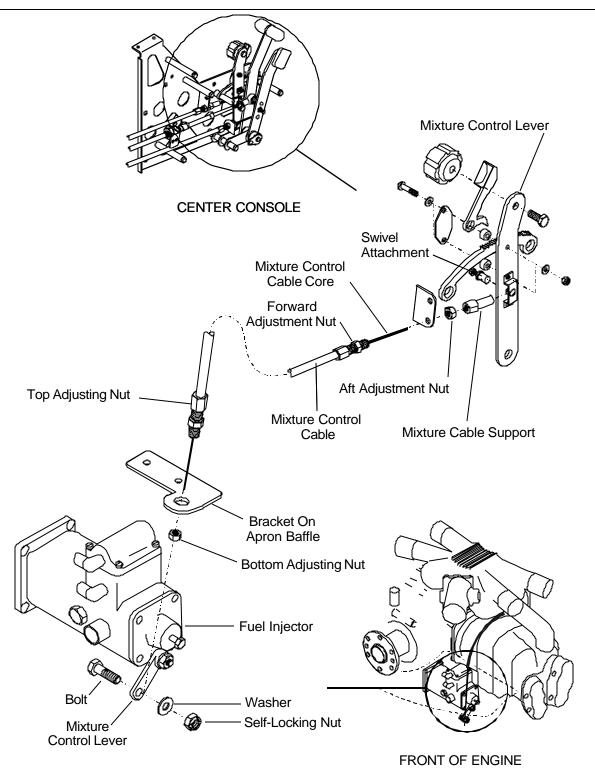
3. General: This service bulletin addresses the installation of a mixture cable

support to reduce the possibility of the mixture cable kinking

10.4 Disconnect the cable core end of the mixture cable from the mixture

lever by loosening the swivel attachment (see figure 1).

10.5	Remove the old cable core from its sheath and install the new cable core in its place.
10.6	Install mixture control cable support over cable core end, threaded end first (see figure 1).
