# SERVICE BULLETIN

Service Bulletin No.: DAC1-76-02 Rev 0

Title: Mixture Cable Routing

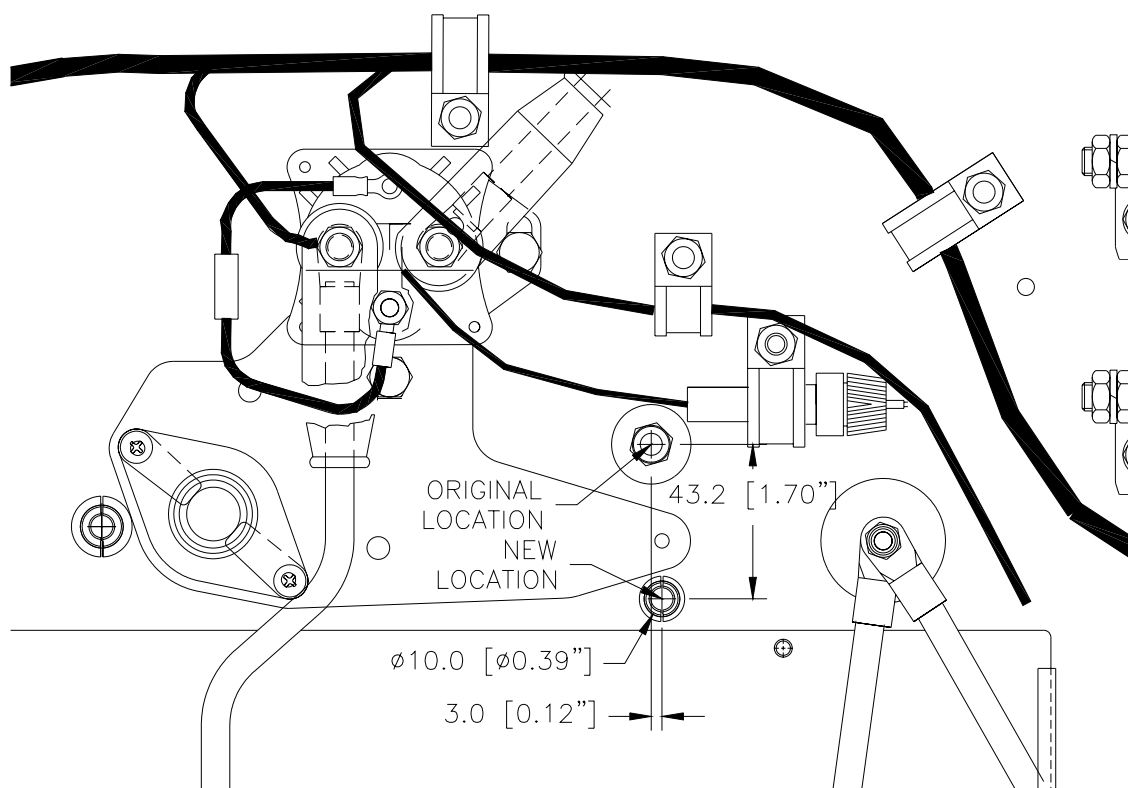
Figure 1 – Looking Aft on Firewall

1. **ATA Code:** 7611
2. **Effectivity:** DA20-C1 aircraft.
3. **General:** This service bulletin addresses the relocation of the firewall penetrations for the mixture cable to reduce the possibility of the cable kinking.
4. **Compliance:** Compliance with this service bulletin for aircraft with MOD0085 Reversed Instrument Panel and MOD0137 Garmin GTX330 is highly recommended. Compliance for other aircraft is at the owner's discretion.
5. **Approval:** Engineering data referenced or contained in this service bulletin is approved as part of the type design.
6. **Labour:** Approximately 3 hours will be required to accomplish this service bulletin.

- 10.1 Remove the mixture cable by performing steps 1-17 in section 3 A, "Remove the Mixture Control Bowden Cable", chapter 76-00 of the Maintenance Manual.
- 10.2 Mark the location of the new firewall hole as shown in Fig. 1. Drill a pilot hole from the front side. Open the hole to the final diameter 10mm (0.40") using a step drill. Use care not to damage the surrounding firewall or equipment.
- 10.3 Plug the original hole in the firewall by installing an AN3 bolt from the front, with two AN970-3 washers and one MS21044N3 nut. Ensure the AN3 bolt has sufficient thread engagement. Use firewall sealant (MIL-S-38249 Type 1).
