# SERVICE BULLETIN

**Service Bulletin No.:** DAC1-76-04 Rev 1

**Title:** Throttle Cable Firewall Feed-Thru

**2. Effectivity:** DA20-C1 aircraft.

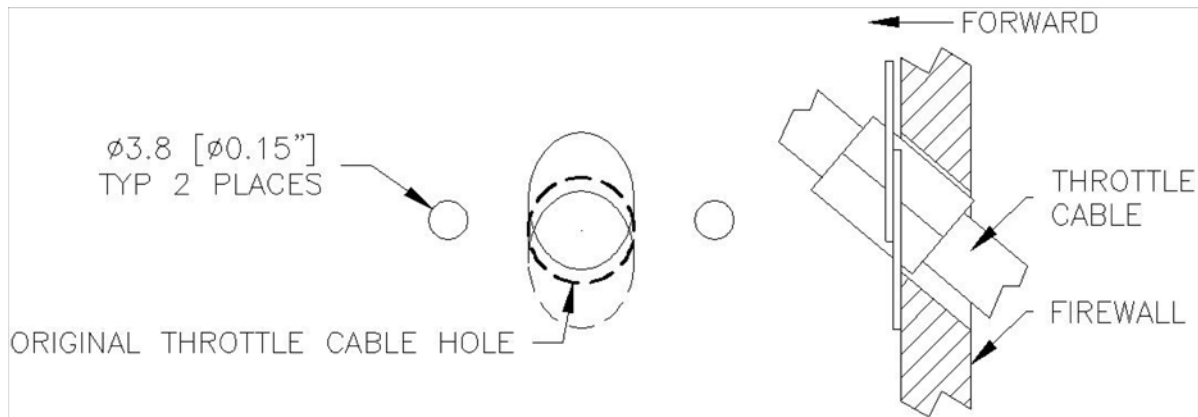
**Figure 1 – Angled Split Bushing Installation**

**3. General:** This service bulletin addresses the replacement of the original throttle cable firewall feed-thru with one that allows an inclined passage through the firewall to reduce the bend in the cable and consequently the possibility of the cable kinking.

- 10.2 Open the existing mixture cable hole at a 45 degree angle (aft and down) using a round file, so that the angled split bushing fits in the hole with the flange sitting flat on the firewall (See Figure 1). Make sure that the throttle cable is secured out of the way of the work area. Use care not to damage the surrounding firewall or equipment.

- 10.3 Locate the new holes in the firewall using the bushing and drill two holes, diameter 0.15" (3.8mm), as shown in Figure 1.
- 10.4 Put the throttle cable back through the firewall.

- 10.5 Perform Steps 5 – 8 of Section 2B, "Install the Throttle Bowden Cable," chapter 76-00 of the Maintenance Manual.
- 10.6 Install the two angled split bushing halves around the throttle cable, as shown in Figure 1, using two AN526C632R8 screws, AN960C6 washers and MS21042-06 nuts.
