# SERVICE BULLETIN

Service Bulletin No.: DAC1-79-01 Rev 0

Title: Powerplant Cooling

- 1. ATA Code:** 7920
- 2. Effectivity:** All DA20-C1 Aircraft.
- 3. General:** This service bulletin addresses improvements to engine cooling, specifically the lowering of the engine oil temperatures when operating in high ambient temperature conditions.  
This service bulletin consists of two parts:

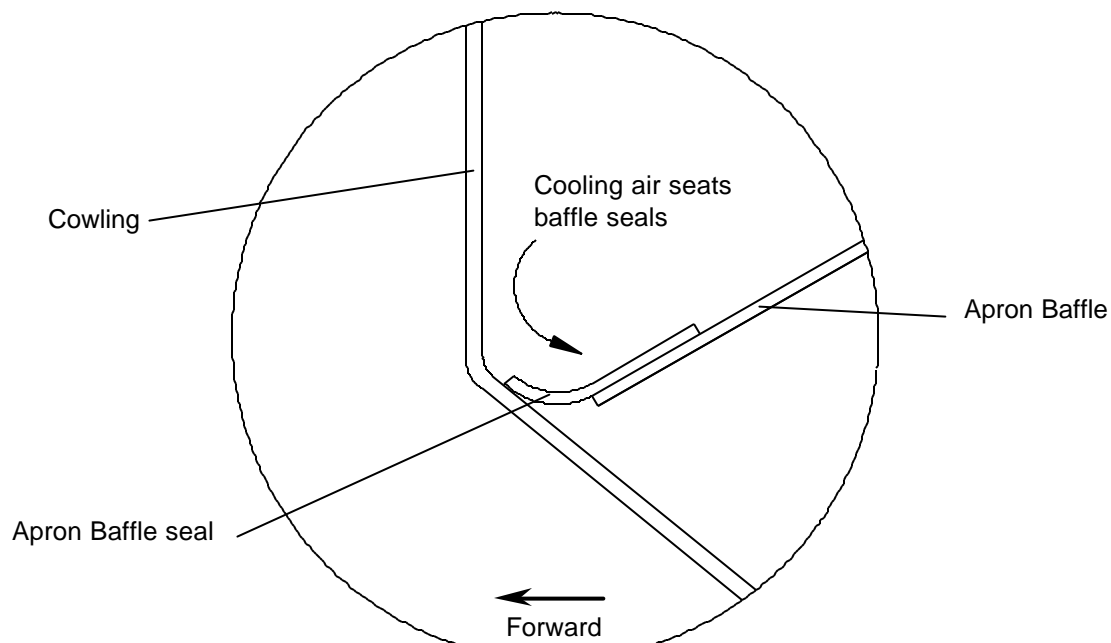
**Figure 1a**  
Seal Aligned Correctly

**10.1 Part One:** For efficient and consistent airflow through the cooling passages, it is important to ensure the correct alignment of the baffle seals. All unfastened seal edges must be turned toward the inside of the cooling passages (Figure 1). This is particularly important in the areas where the seal goes around sharp corners like the extreme left and right edges of the apron baffle.

**10.1.1.1** The unfastened seal edges should seat on the cowling as shown in Figure 1a.

- 10.1.2.6 Install the lower and upper cowlings. Ensure all the seal edges are turned in toward the cooling passages.
    - 10.1.3 Install the Apron Baffle Support Bracket (P/N 22-7123-10-00).

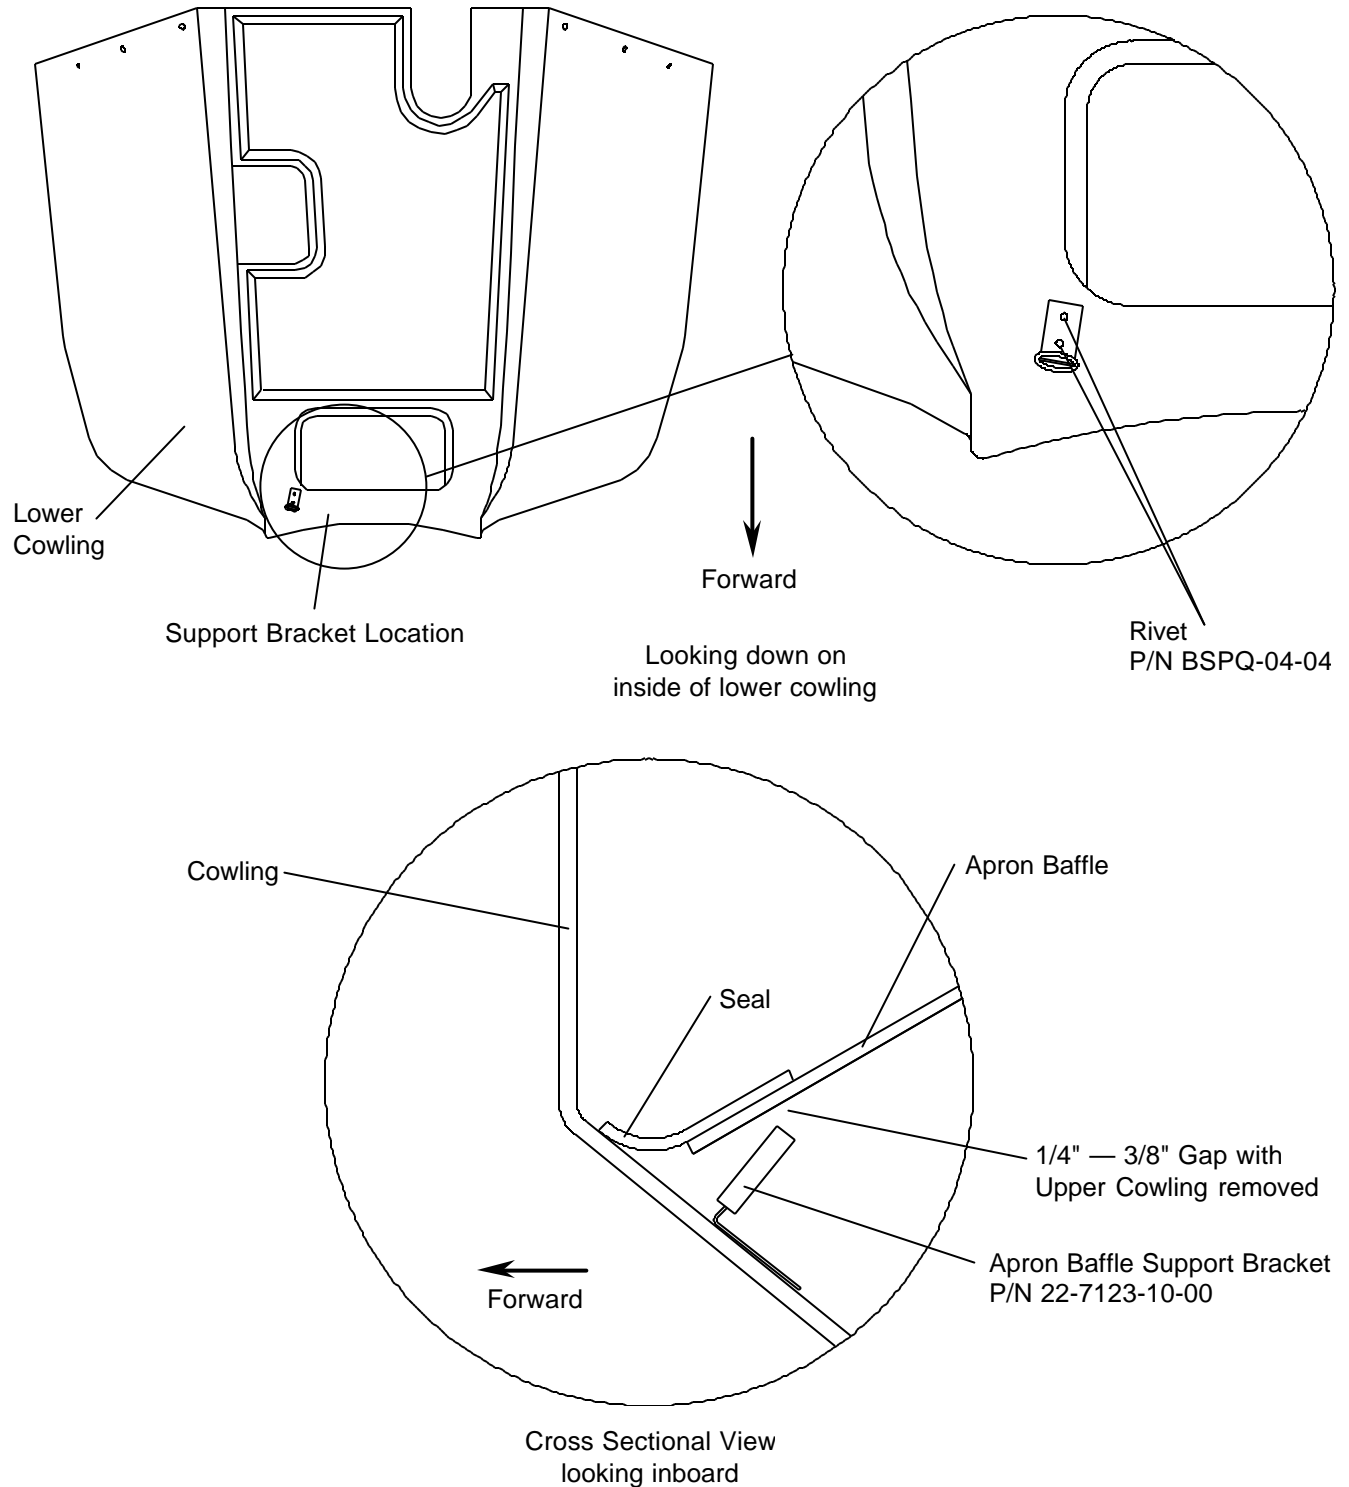
**Figure 2**  
Apron Baffle Support Bracket

To prevent excess deflection of the apron baffle, which can result in the unseating of the baffle seals, it is recommended to install the apron baffle support bracket, as detailed in 10.1.3.

- 10.1.3.1 Remove the upper cowling.
      - 10.1.3.2 Put the Apron Baffle Support Bracket (P/N 22-7123-10-00) in its correct position (Figure 2) and temporarily fasten it to the cowling with adhesive tape. Ensure the support bracket is aligned as square as possible to the surface of the apron baffle and leave a gap of 1/4" to 3/8" between the tip of bracket and the underside of the baffle.

- 10.1.3.5 Install the bracket with two rivets (P/N BSPQ-04-04) (Figure 2).
      - 10.1.3.6 Install the lower and upper cowlings. Ensure all the seal edges are turned in toward the cooling passages.

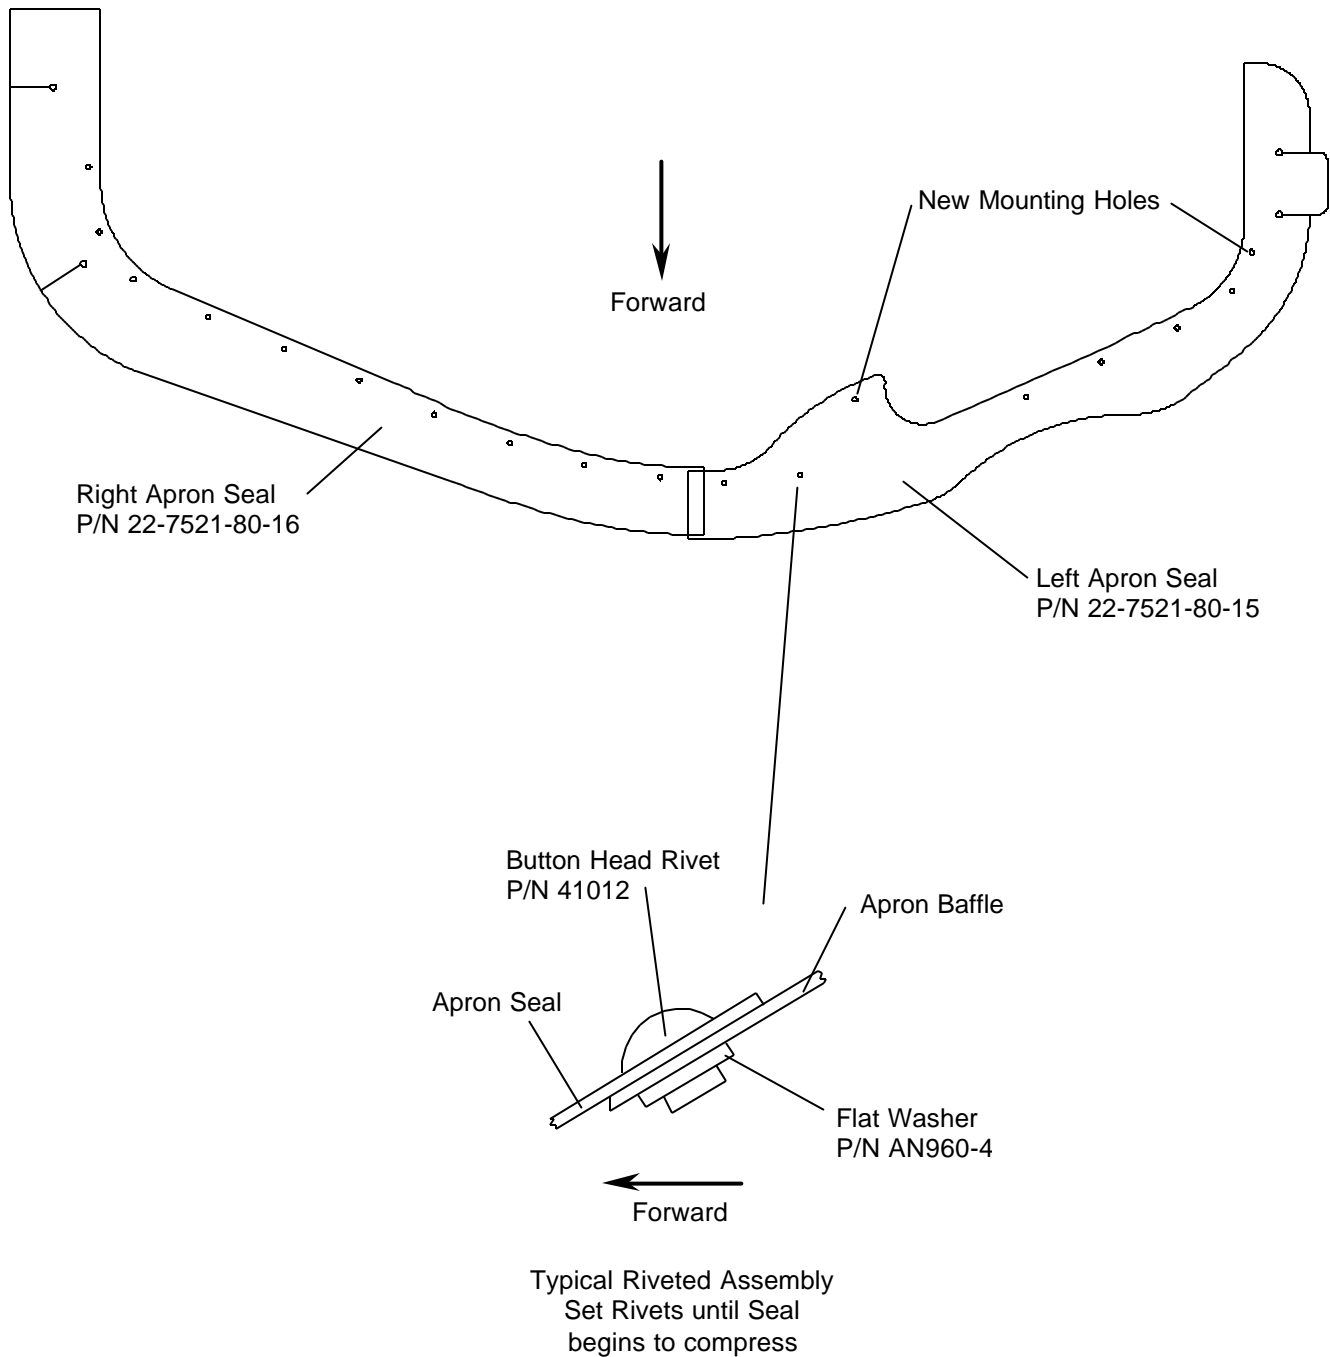
**Figure 3**  
Apron Baffle Seals

**10.1.1.2** If the seating is unsatisfactory, an improved fitting baffle seal configuration (Figure 3) is available. Installation of these seals is detailed in 10.1.2

**10.1.2.4** Install the right Apron Baffle Seal (P/N 22-7521-80-16) and the left Apron Baffle Seal (P/N 22-7521-80-15) by stretching each hole over its matching existing rivet head. Use the Left Apron Baffle Seal as a template to drill the two new mounting holes in the apron (Figure 3). Install the rivets (P/N BPSQ-04-04) and the washers (P/N AN960-4) into the new holes.
