SERVICE BULLETIN

Service Bulletin No.: DAC1-79-02, Rev. 0

Date Issued: April 10, 2001

Title: Oil Filler Neck Bracket Installation

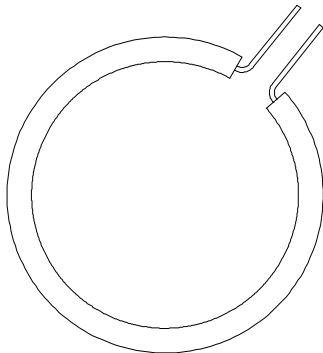
Clamp Forming Detail

- 1. ATA Code:** 7900
- 2. Effectivity:** Diamond Aircraft DA20-C1 serial numbers C0001 to C0138 inclusive.
- 3. General:** There have been several cases of the oil filler neck support bracket (Teledyne Continental Motors P/N 632072) cracking due to fatigue. An additional bracket is required to eliminate this condition. This bracket is to be installed in conjunction with the existing support bracket.
- 4. Compliance:** Compliance with this service bulletin is recommended.
- 5. Approval:** Engineering data referenced or contained in this service bulletin is approved as part of the type design.
- 6. Labor:** Approximately .5 hour will be required to accomplish this service bulletin.
This estimate is for direct labor performed by a technician and it does not include setup, planning, familiarization, cure time, part fabrication or tool acquisition.

- 8. Special Tools:** N/A
- 9. References:** DA201-C1 Aircraft Maintenance Manual
- 10. Accomplishment Instructions:**
- 10.1** Remove, rotate 180° and re-install the existing oil filler neck bracket. Orient the hardware as it was removed (some engines may already have this accomplished). Reference Figure 1.
 - 10.2** Form P Clamp and install additional support bracket as shown in Figure 1. The bracket attaches to the existing screw that connects the side baffle to the aft baffle.
- 11. Weight and Balance:** This service bulletin does not affect the aircraft's weight and balance.
- 12. Availability:** Contact Diamond Aircraft Parts Department.
