SERVICE BULLETIN

Service Bulletin No.: DAC1-92-03, Rev. 0

Title: Certification, Mexican Import Requirements

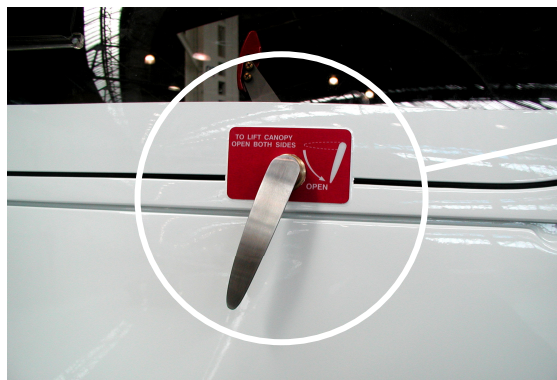
Right Side - Exterior Canopy Frame

22-1120-03-20

- 10.1** Replace the English language placards with the Spanish language placards as shown in Figures 1 through 5. Refer to Aircraft Maintenance Manual DA201-C1 for the instructions to remove and re-install the canopy lock and canopy handles.

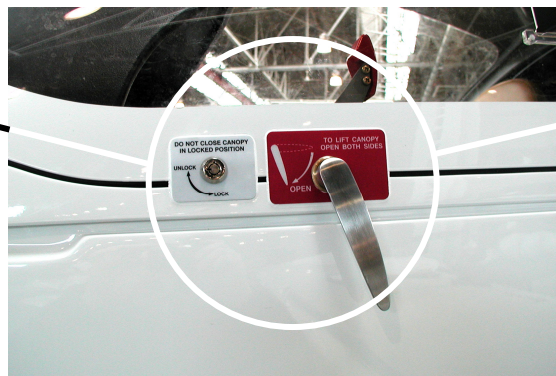
Left Side - Exterior Canopy Frame

22-1120-03-01

22-1120-03-19

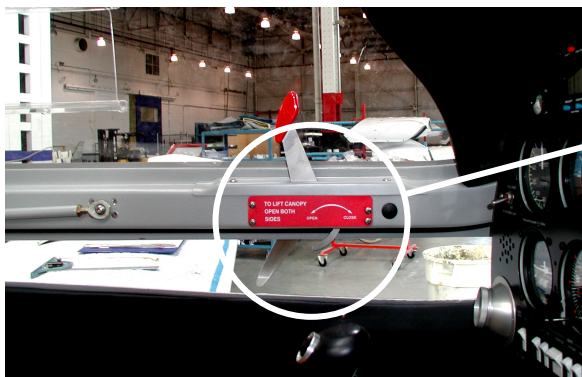
Left Side - Interior Canopy Frame

22-1130-03-31

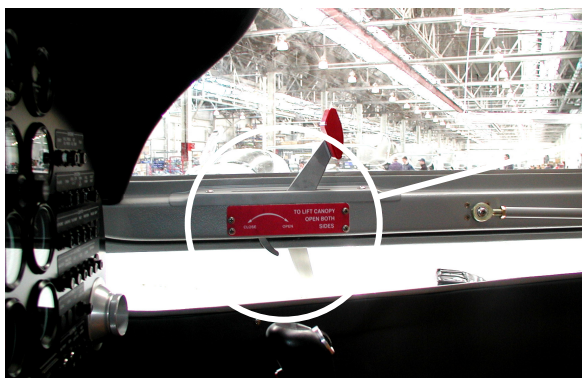
Right Side - Interior Canopy Frame

22-1130-03-32

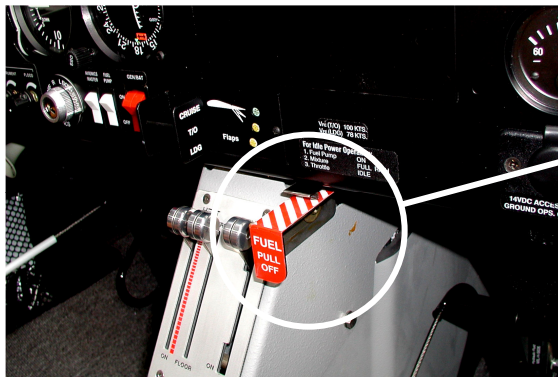
Figure 3
Fuel Pull-Off Placard Installation

22-1130-03-20

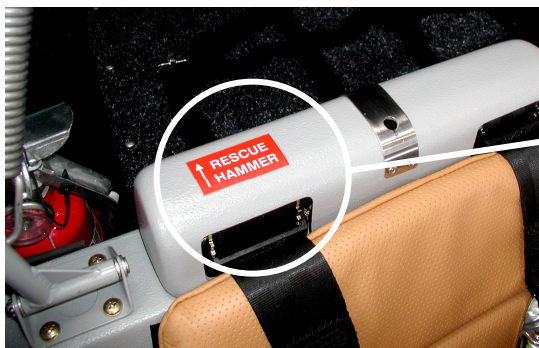
Figure 4
Rescue Hammer Placard Installation

22-1130-03-05

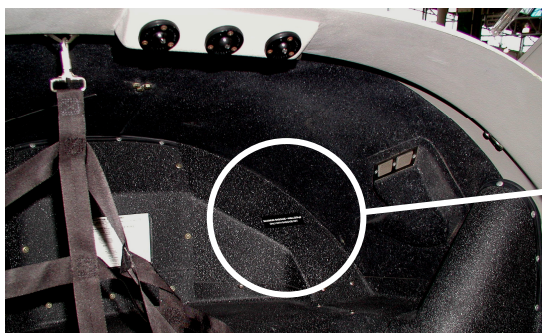
Figure 5
Baggage Placard Installation

22-1130-03-12
